MEMORANDUM

RE: 10th Ave NE from NE 165th St. to NE 175th St.

Roadway Drainage Review Shoreline On-call Services SvR Project No. 13044.10

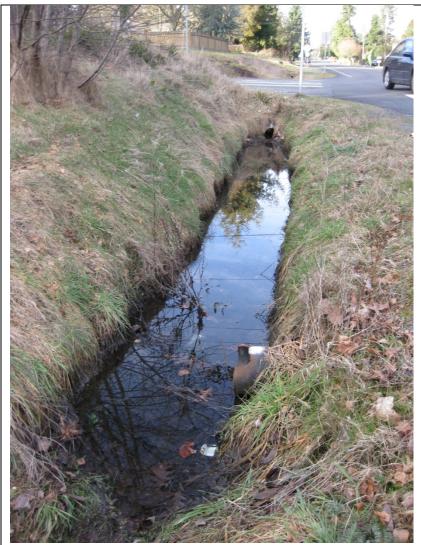
Photo 2: Standing water within open conveyance along the west side of 10th Ave. NE just south of NE 170th St. (February 13, 2014)

Survey information indicates that the pipe and open channel conveyance has little slope in the direction of flow (from north to south) ranging from 0.5% to 1.5% and in some cases both pipes and conveyance channels are back sloped from south to north. Along the west side of the street no evidence that stormwater flows from the culvert and open channels have passed onto private property, such as sediment deposits from flow paths or sandbags, was observed. It is possible that nuisance ponding could occur at driveway entrances or within conveyance swale during prolonged storm events.

- Cleaning leaf debris and litter from the open channel to reduce the risk of clogging the downstream inlets and promote natural infiltration. Increasing the maintenance schedule, particularly in the fall when leaf debris is significant.
- Performing public outreach identifying to the neighborhood the importance of keeping the gutter line and flow channel free of debris, such as promoting the City's Adopt-A-Drain program, would encourage community involvement in the maintenance and care of the drainage system.
- Amending soils within the existing open conveyance channels or remove soils and install a bioretention facility to promote treatment and infiltration.

Along the west side of the roadway, we recommend that the City increase maintenance frequency to reduce blockages and ponding within the open channels. At the locations identified in Table 1, soil amendment within the open conveyance systems would encourage infiltration of stormwater into the native soils. This mitigation strategy would not limit the future opportunities to regrade and reinstall the conveyance system to provide positive drainage. Geotechnical data collection is recommended to determine the feasibility of infiltration facilities.

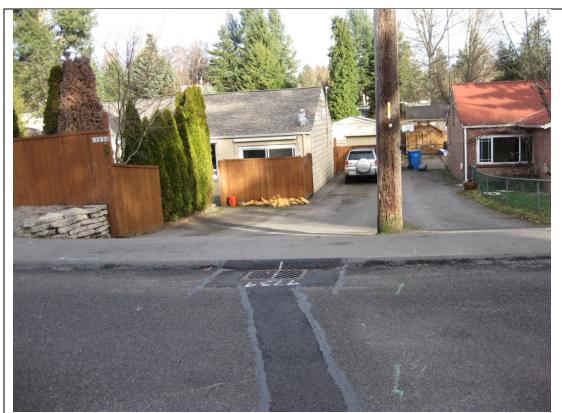
At the east side of the street there is evidence of previous gutter line flows entering onto private property, with one residence (lot #1270) barring flows at their driveway with sandbags (see Photo 3). Additionally a new rolled curb further north in front of lot#1292 indicates attempts to capture flows within the boundaries of the gutter line.

Photo 3: Residence #17030 10th Ave NE, lot#1270, with sandbags. New asphalt patch shows installation of catch basin at gutter flow line. (February 13, 2014)

- Installing asphalt berms downstream of the existing catch basin structures or installing additional drainage structures immediately upstream of the driveway curb cuts would reduce the risk of drainage bypassing collection.
