Technical Memorandum

To: Cory Nau, City of Shoreline
From: Dave Stewart, PE
Gwyn Perry, PE
Kevin O'Brien, PhD
Copies: Tyson Hounsel, PE
Date: May 29, 2019
Subject: South Branch of Boeing Creek Near M-1 Dam Channel Study and Recommendations
Project No.: 32713.C21

To: Cory Nau, City of Shoreline
From: Dave Stewart, PE, Brian Clarke, PhD, Kevin O'Brien, PhD,
Copies: Tyson Hounsel, PE, Gwyn Perry, EIT
Date: May 7, 2019
Subject: Existing Conditions Observations for the South Branch of Boeing Creek Near M1 Dam
Project No.: 32713.C21

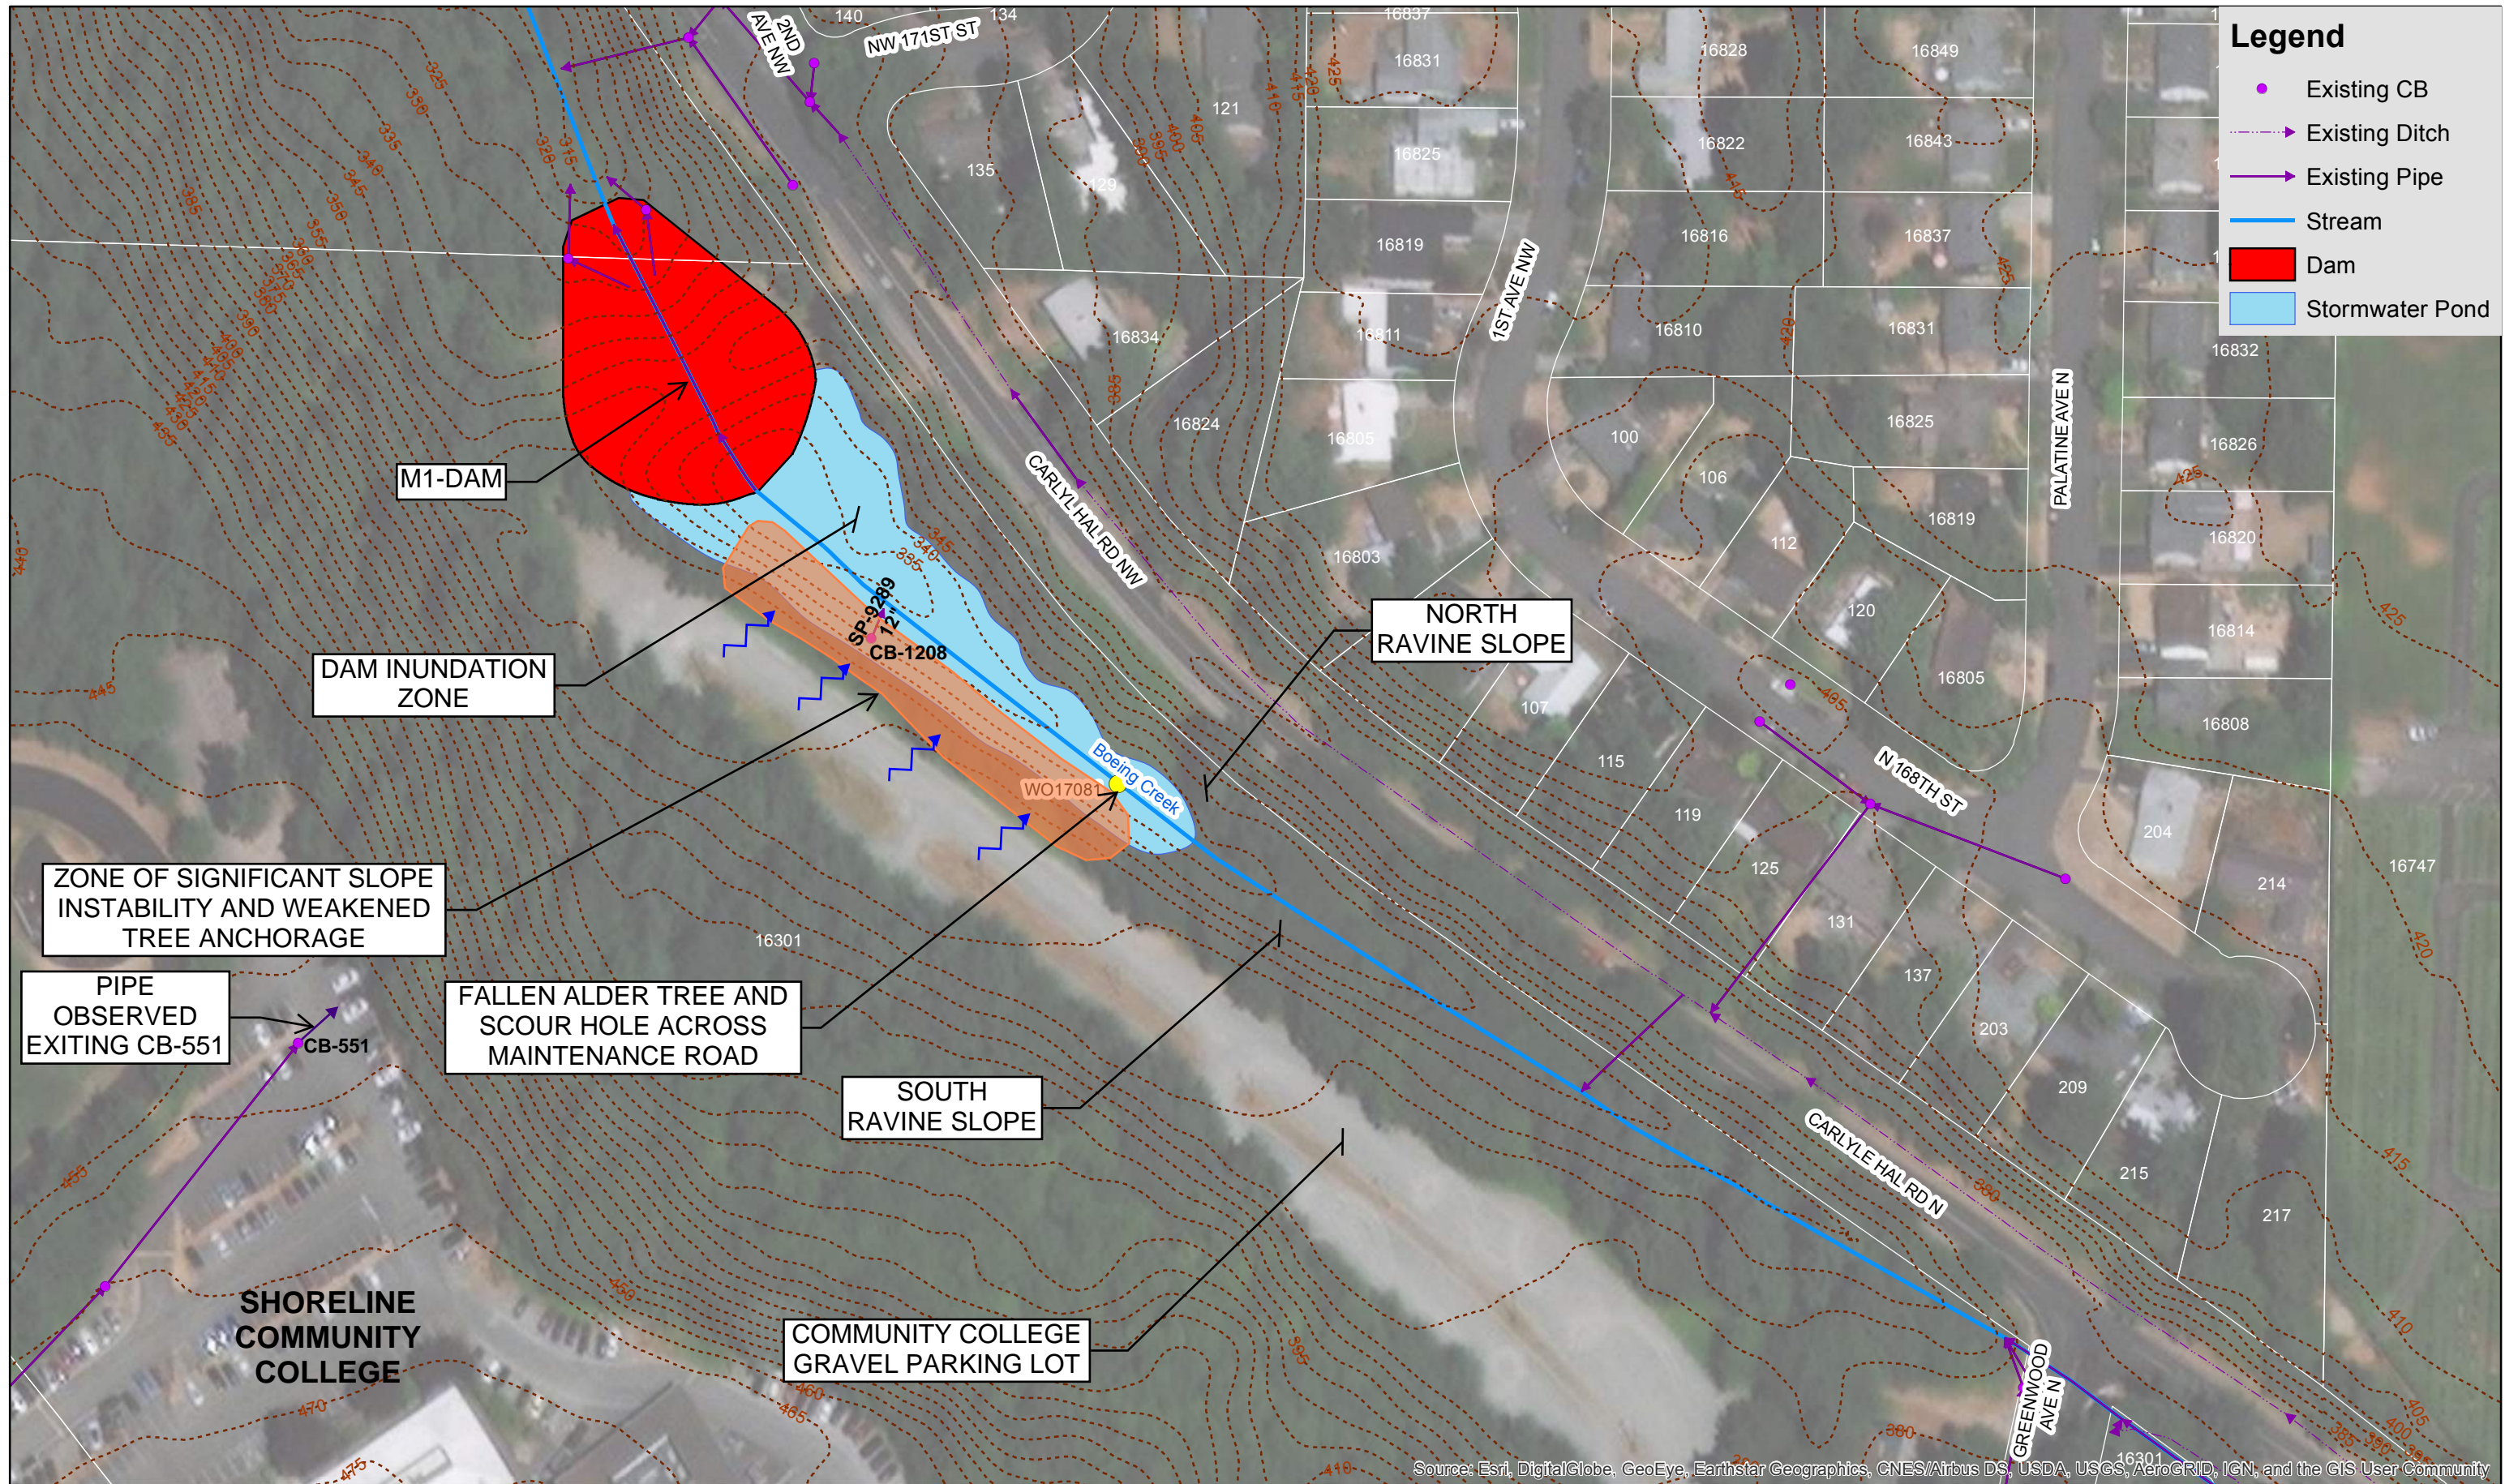
Figure 2 - Existing Site Conditions

The outfall pipe SP-9289 is labeled as a 12-inch diameter pipe in City GIS data, but was observed to be an 18-inch diameter pipe in the field. Discharge from SP-9289 most likely originates from catch basin CB-551 (see Figure 2), which collects stormwater runoff from Shoreline Community College buildings and paved parking area which is uphill from the gravel parking lot. During a site inspection, Otak staff observed an 8-inch diameter pipe exiting CB-551 to the north. The continuation of this pipe and connection to SP-9289 is not available in GIS and further indications of the pipe alignment such as junction structures were not found. Although not located in the field, there are likely junction structures between CB-551 and CB-1208 that provide transition in horizontal and vertical alignment and in pipe size. Based on the available GIS data, parking lot runoff contributing to this system currently discharges to the channel untreated and unattenuated.

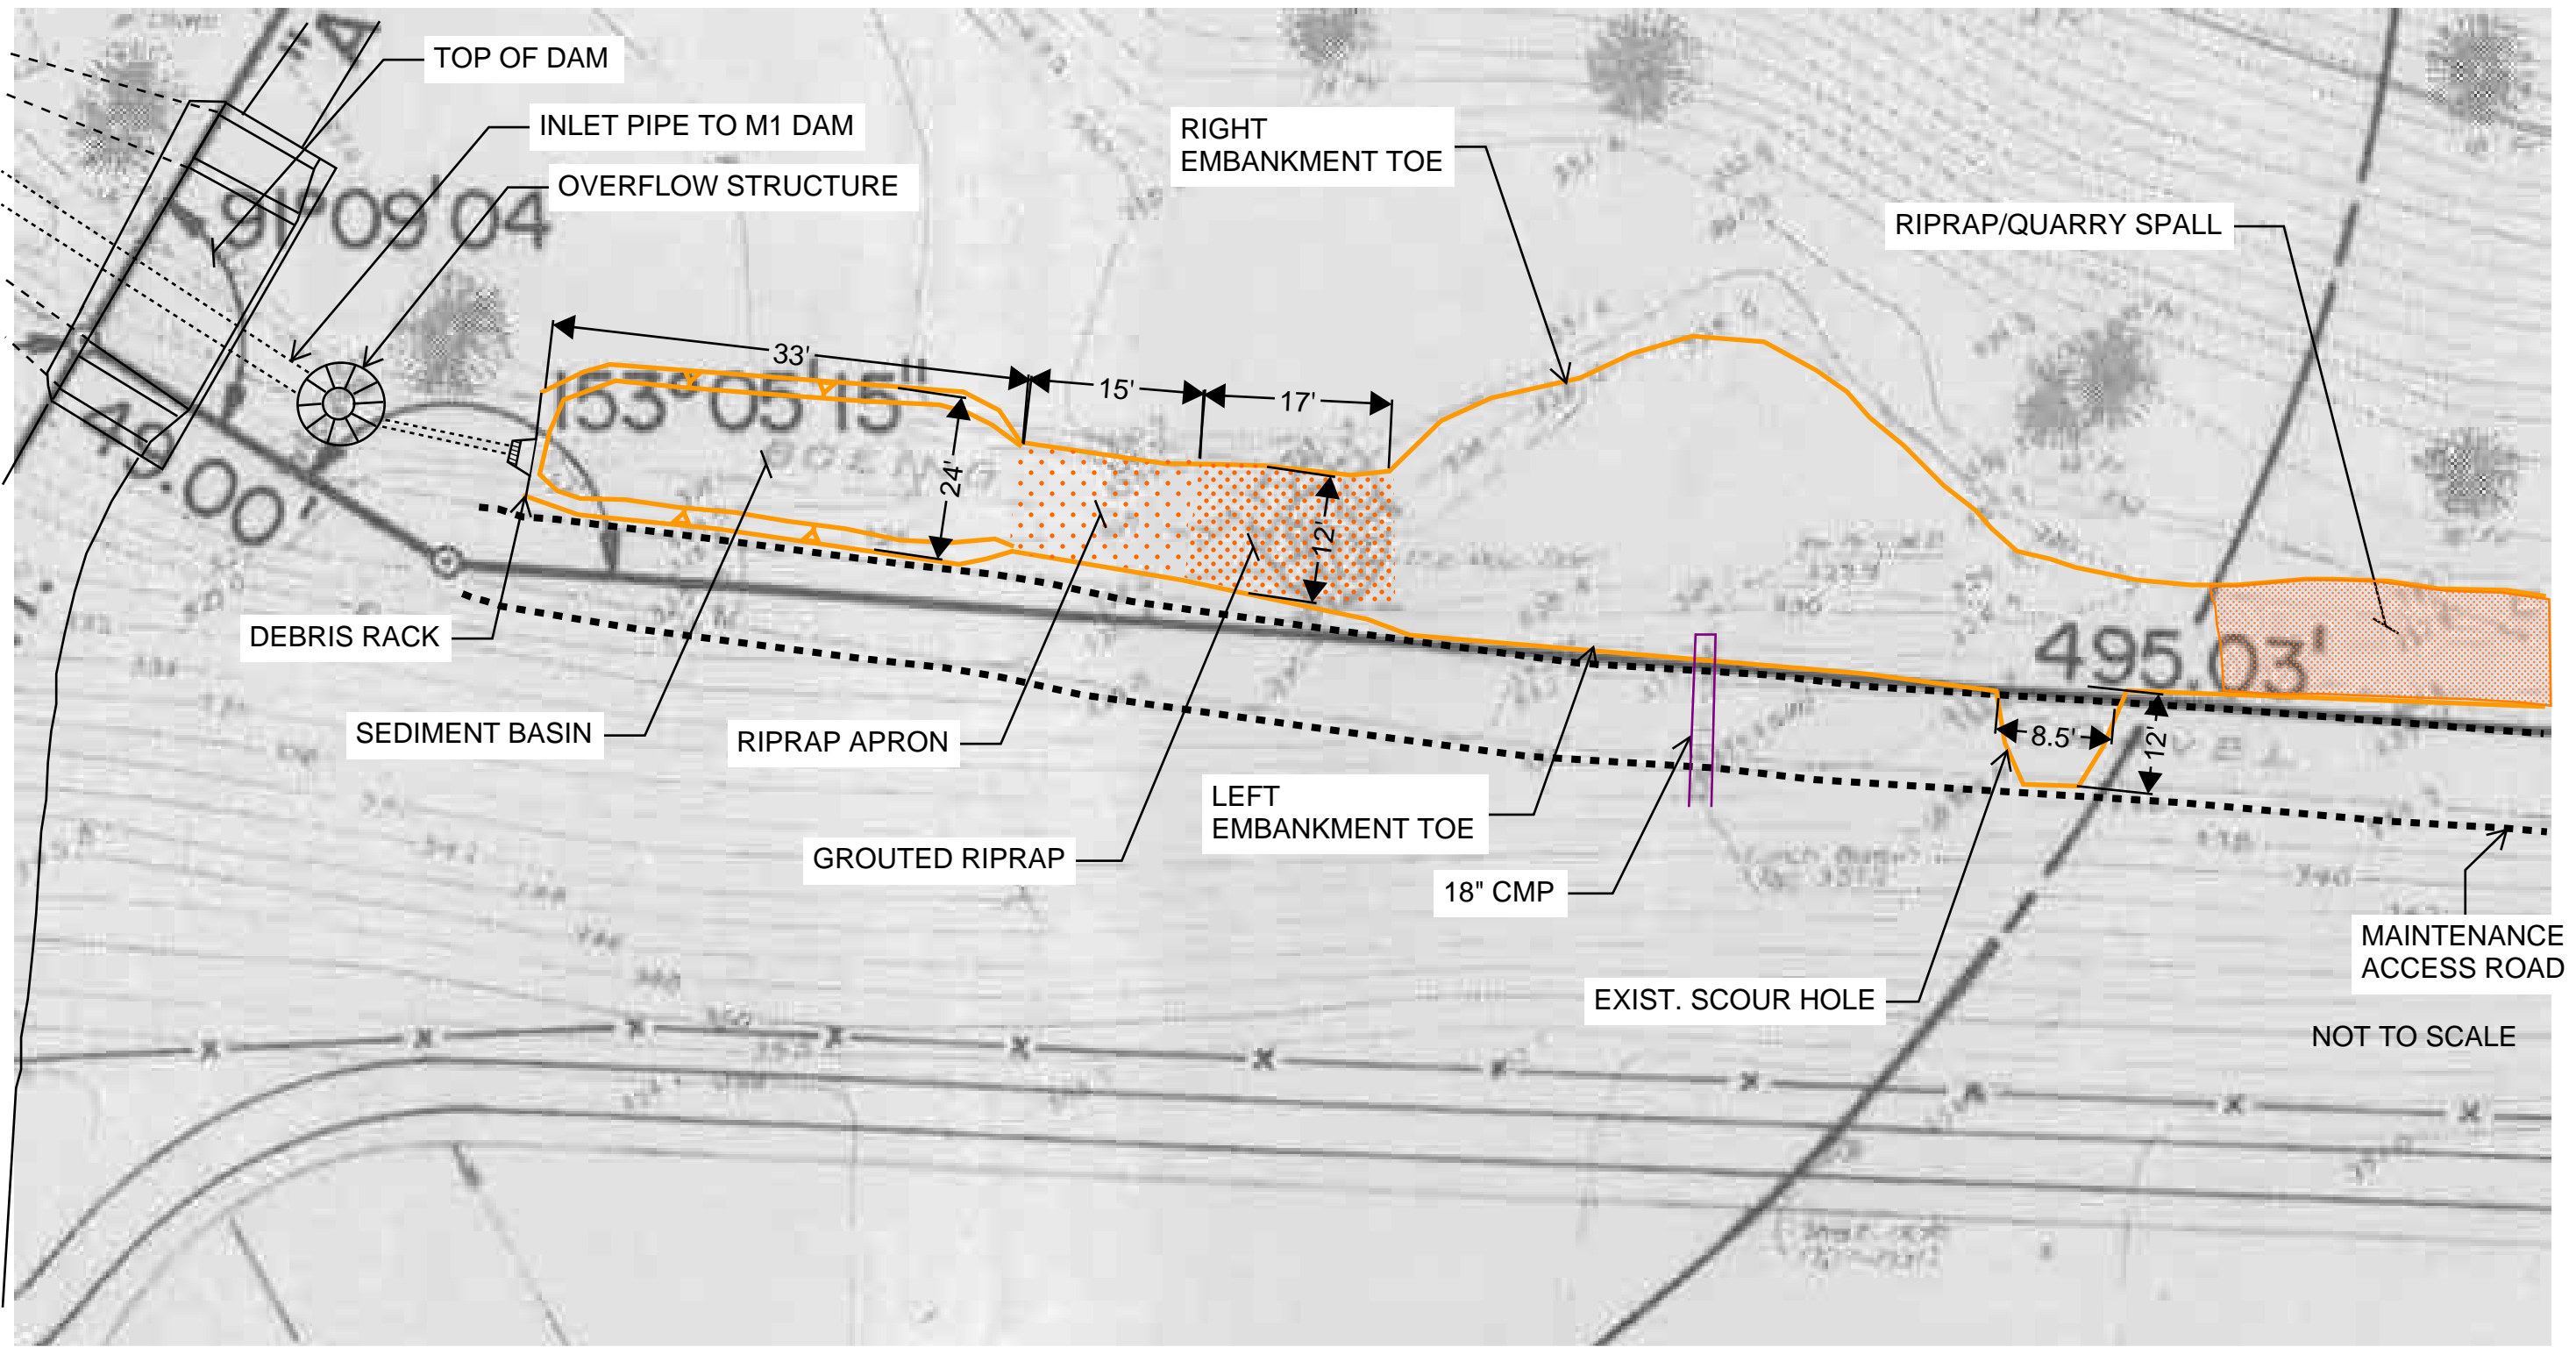
FIGURE 4. ENLARGED PLAN VIEW AT SCOUR HOLE LOCATION

In the downstream reach, the scour hole in the maintenance access road with the fallen tree in the channel was measured as about 12 feet into the width of the access road and left bank of the channel, and about 9 feet in length along the access road (Figures 3 and 4, and Photo 5). The height of the drop from the top of the access road to the bed surface was measured as 5.5 feet. The material of the eroded bank was observed to consist of silt interspersed with cobbles about 1" – 4" in diameter. The typical riprap and gravel gradation within the channel bed near the scour location are shown in Photo 6.

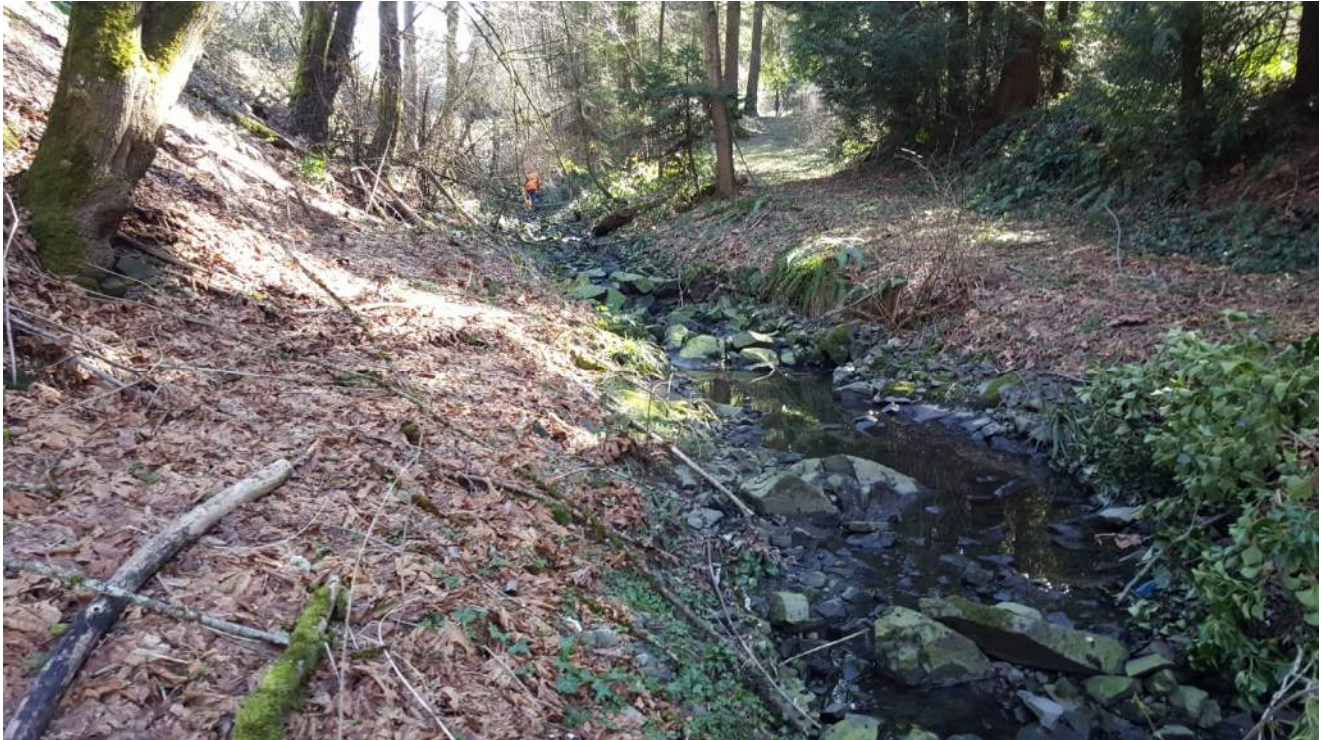
project area (Photo 1). The flow was observed to gradually seep through the porous channel substrate and become subsurface near the middle of the project reach. No surface flow was evident for the reach from approximately 500 feet upstream of the M1 Dam to the dam. Snow had accumulated to a depth of 20" approximately two weeks prior to the site visit and had melted into groundwater by the time of the site visit. Otherwise, no significant precipitation had occurred in at least the two weeks preceding the site visit.

Photo 1. Upstream reach of the South fork of Boeing Creek with riprap armoring, with above ground flow, looking upstream towards the culvert outlet under Greenwood Ave N.

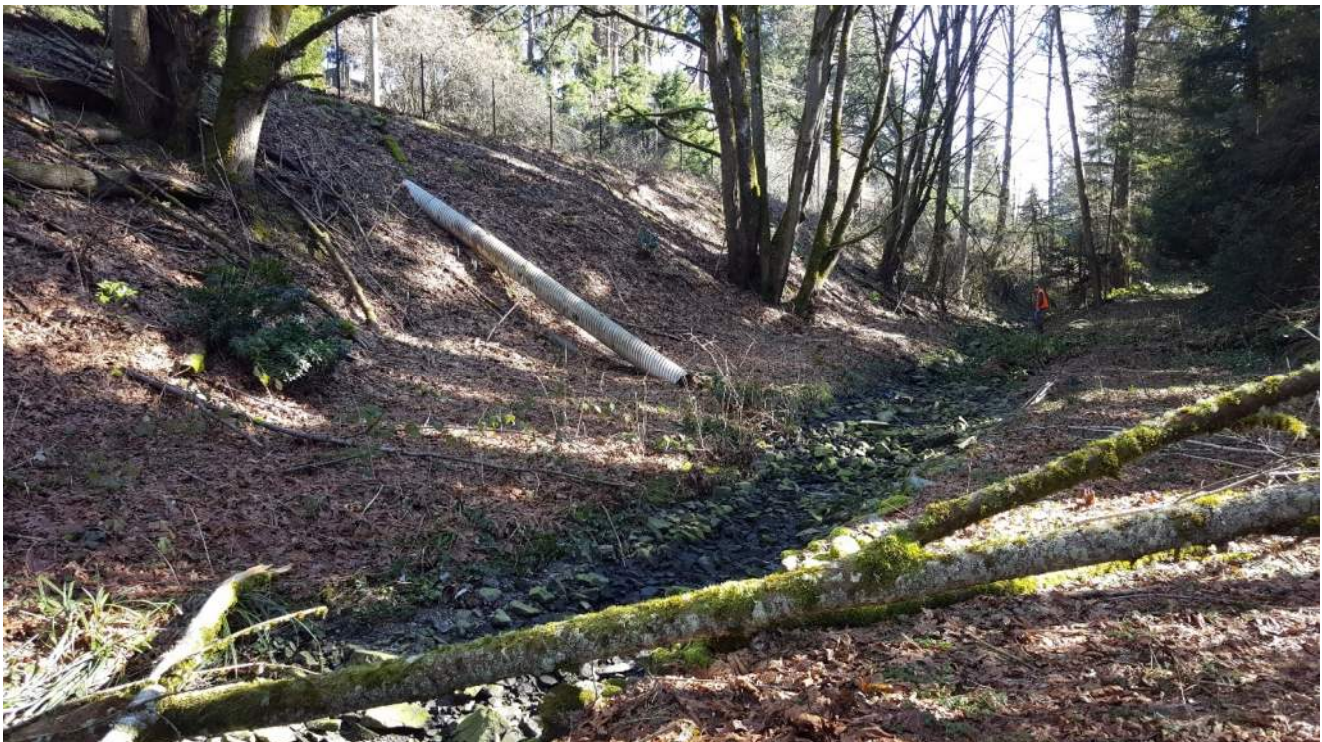
Photo 2. Looking upstream, the maintenance access road abuts the channel on the right side, the exposed 18" CMP is on the left side, and tree have fallen across the access road and channel in the foreground.

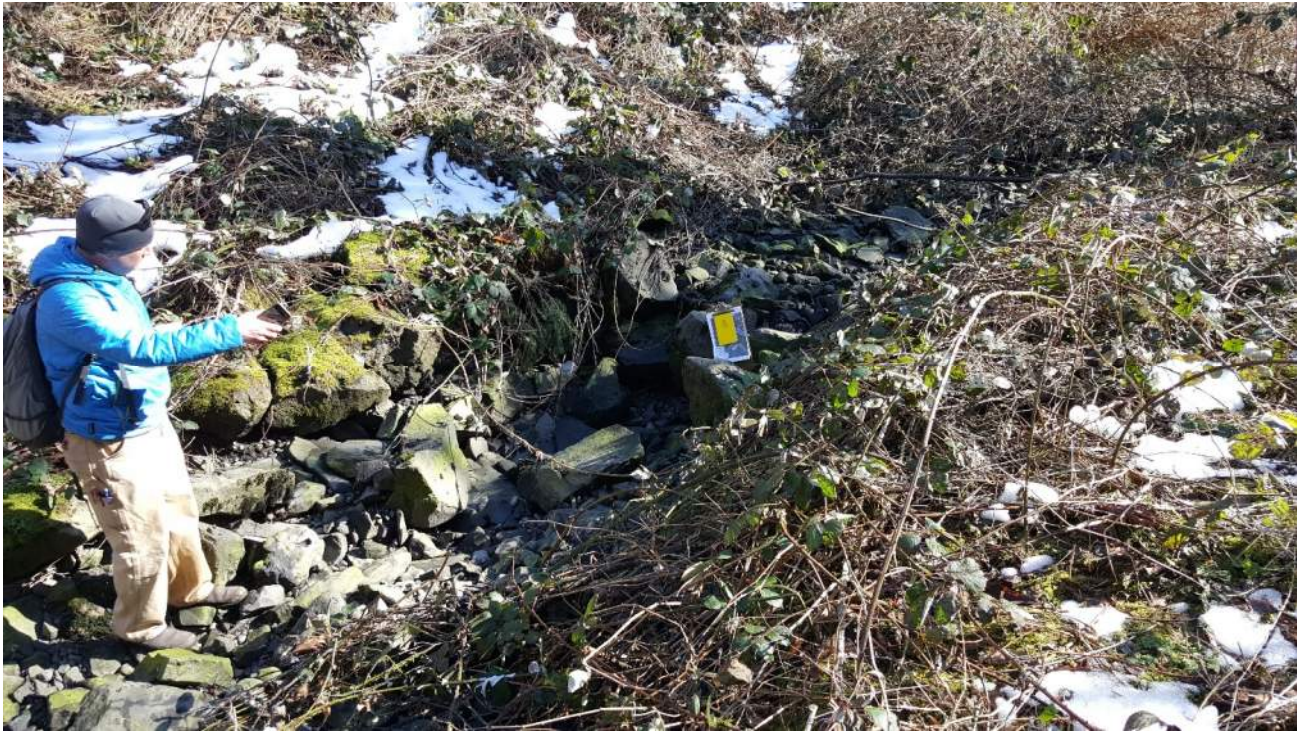
Photo 3. Entrenched channel with rock drop structure near the middle of the project area.

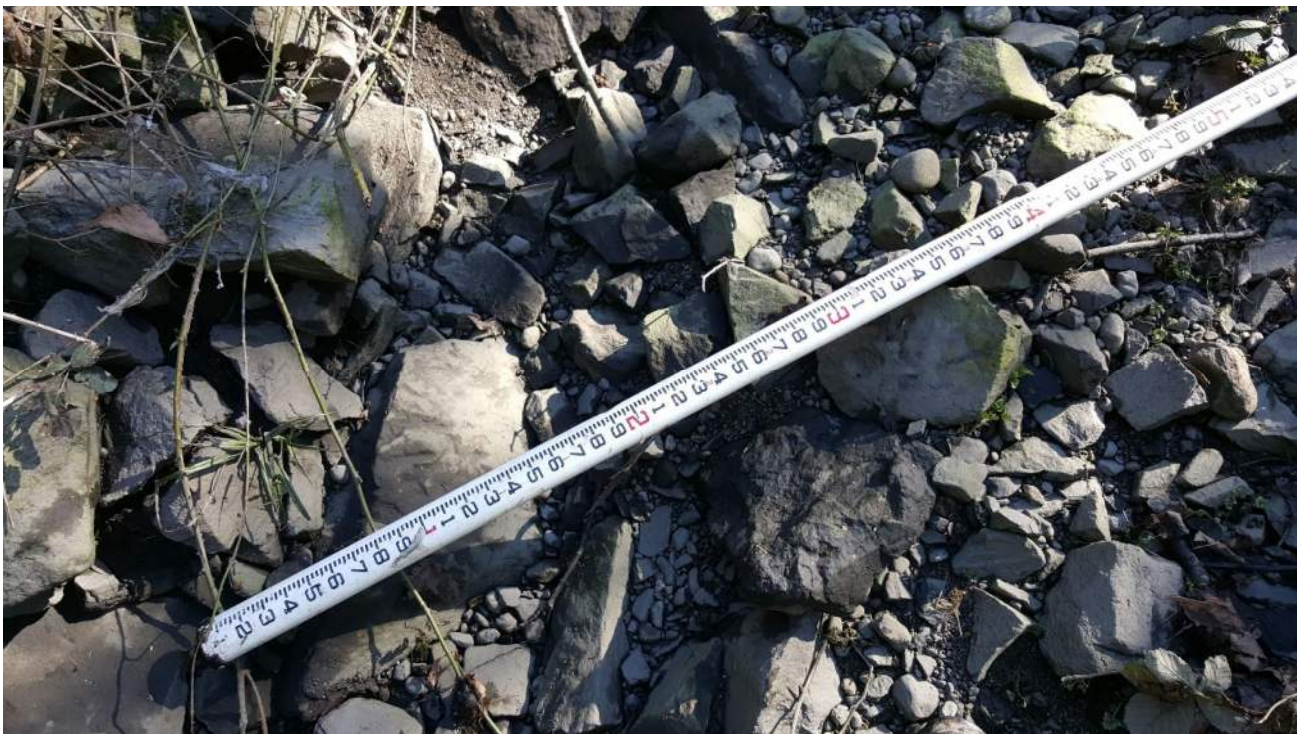
Photo 4. Typical riprap gradation within the entrenched channel reach, near the middle of the project area.

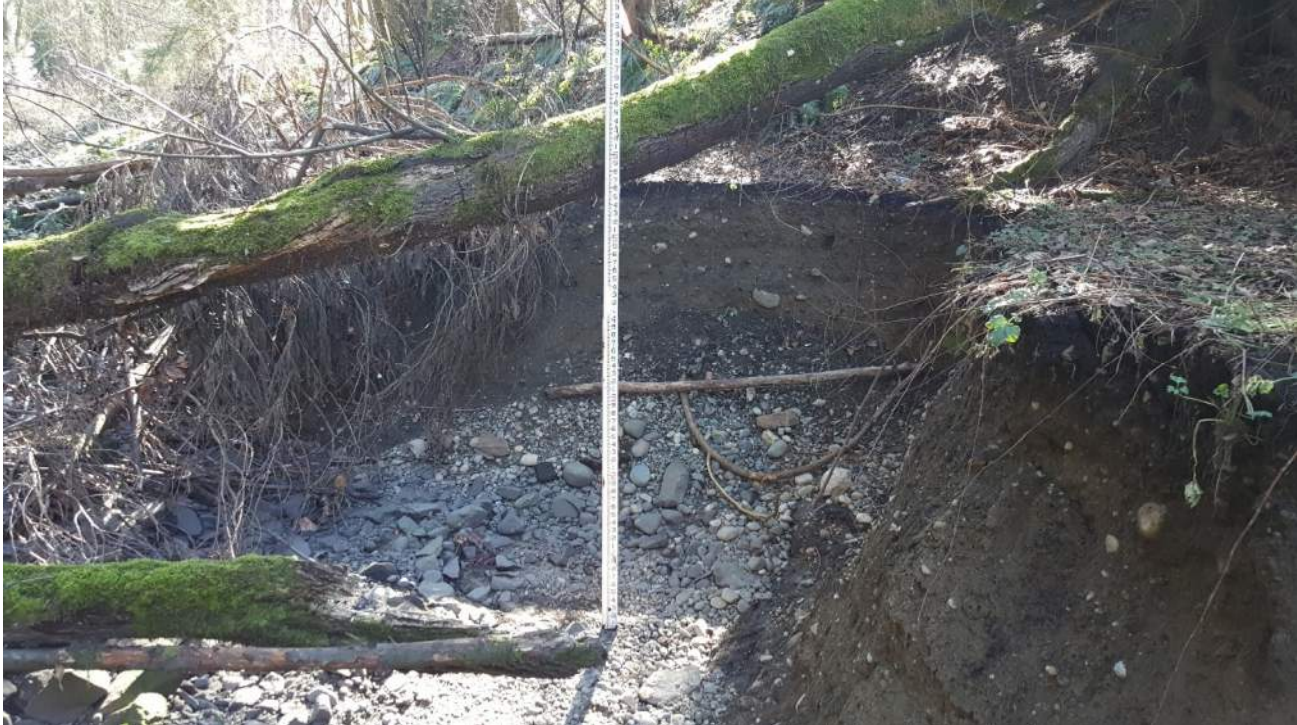
Photo 5. Scour in the left bank of the channel and access road, beneath the tree fallen into the channel.

The fallen tree that is approximately 200 feet upstream of the dam will need to be removed and the scour hole within the maintenance access road will need to be repaired to restore access. The fallen tree is decomposing and unsuitable for use as the proposed deflector log. All vegetation and woody debris removed from the channel can be placed within the ravine, outside of the dam inundation zone.

The concept exhibits provided in Appendix D show the proposed repairs. The area of the road should have the surface material stripped, and the embankment re-built following the requirements of WSDOT Standard Specifications Section 2-03 for embankment construction, using gravel borrow material to restore the road prism at the scour location. Near the area of the scour location, the channel is confined, and a steeper road embankment slope of 1H:1V is required to maintain the bottom width of the channel. In the next phase of design, geotechnical recommendations and further stability analysis will confirm the final extents of embankment grading. Larger material for steep channel side slopes or regrading of the channel to allow for less steep side slopes may be required. Geotextile fabric should be placed to separate the gravel borrow embankment material from the surface material that will be placed above it. Quarry spalls should be placed on the roadway embankment side slope to prevent erosion of the embankment material from channel flow. Quarry spalls are also recommended for surfacing the repaired roadway to resist flotation within the dam inundation zone.

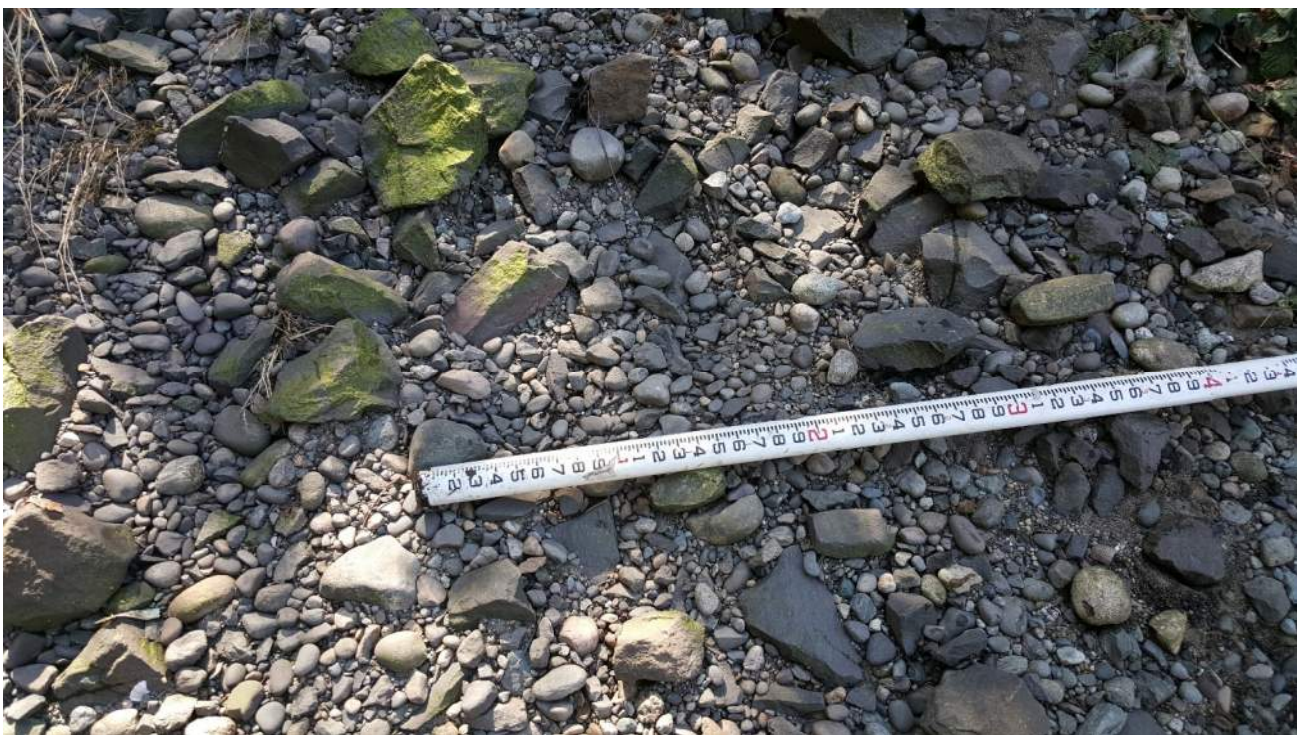
Photo 6. Typical riprap, cobble, and gravel gradation of the channel bed, near the scour hole location.

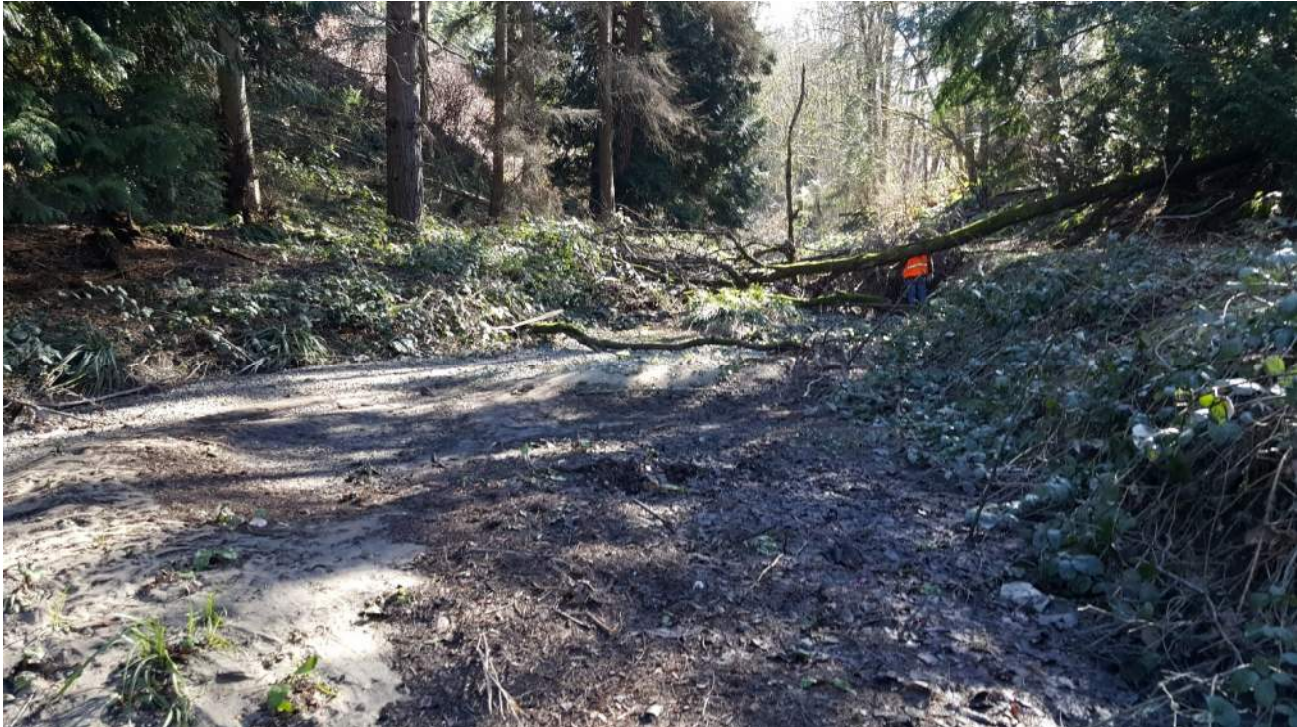
Immediately downstream of the scour hole, there is a bend in the low flow channel, and the total channel width increases to approximately 40 feet (Photo 7). An 18" corrugated metal pipe (CMP) enters from the left bank within this wider section of channel. The 18" CMP was observed to be crushed and broken, with erosion occurring around where the pipe emerges from the bank (Photo 8). The pipe connects to a catch basin on the south side of the access road, that connects to a storm drain pipe within the steep ravine slope. Erosion and rilling was also evident along the steep ravine slope in this area, including erosion around the roots of trees on the slope.

Photo 7. Looking upstream at the bend in the channel, downstream of the scour hole location.

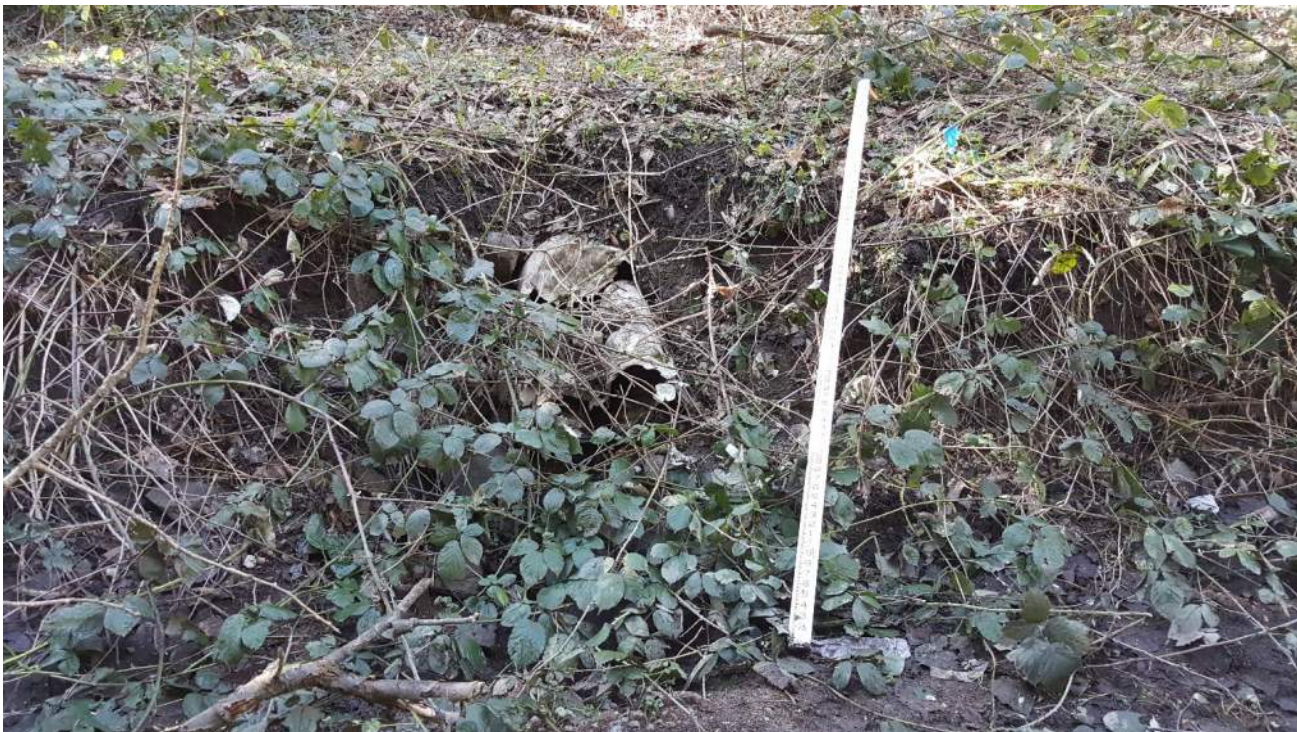
Photo 8. Crushed 18" CMP and bank erosion on the left bank at the bend in the channel.

The 18" CMP pipe downstream of the scour hole location is crushed, and erosion is occurring around the pipe outlet. The road should be excavated to replace the pipe and catchbasin, and the road embankment re-built.

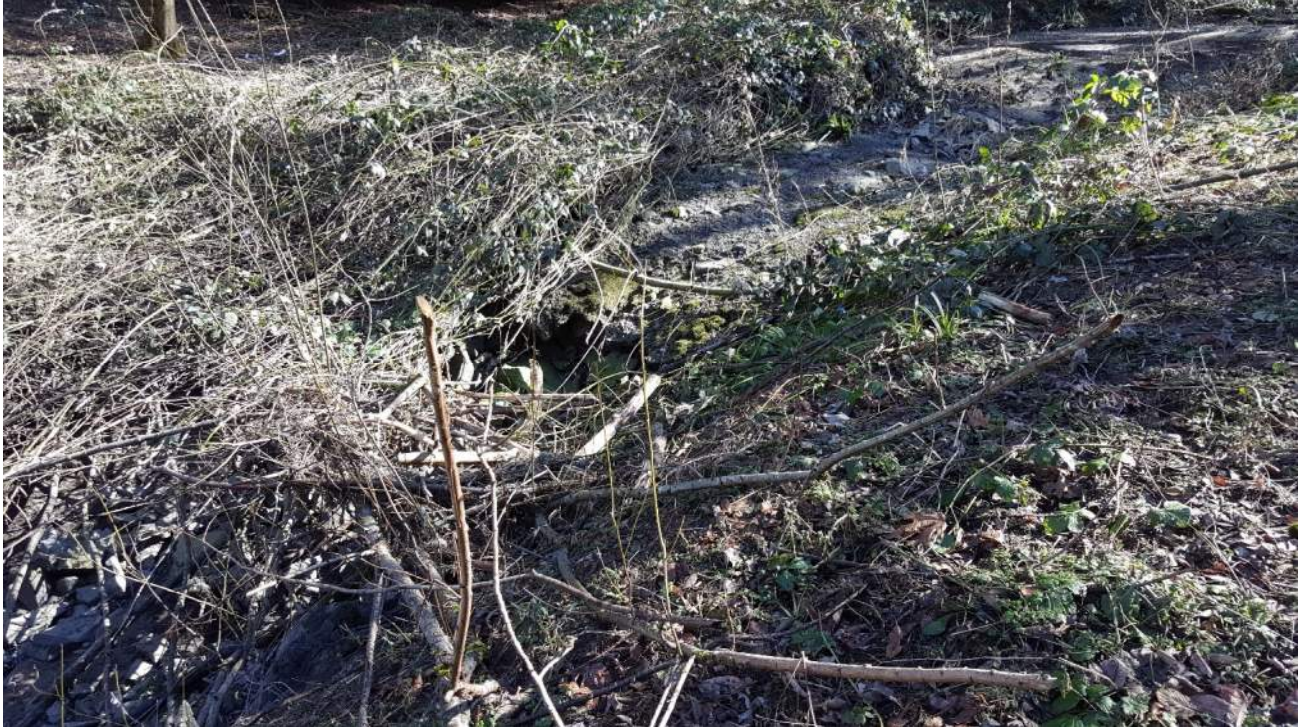
Photo 9. Looking upstream at the gouted riprap grade control structure, upstream of the sediment basin for the M1 Dam.

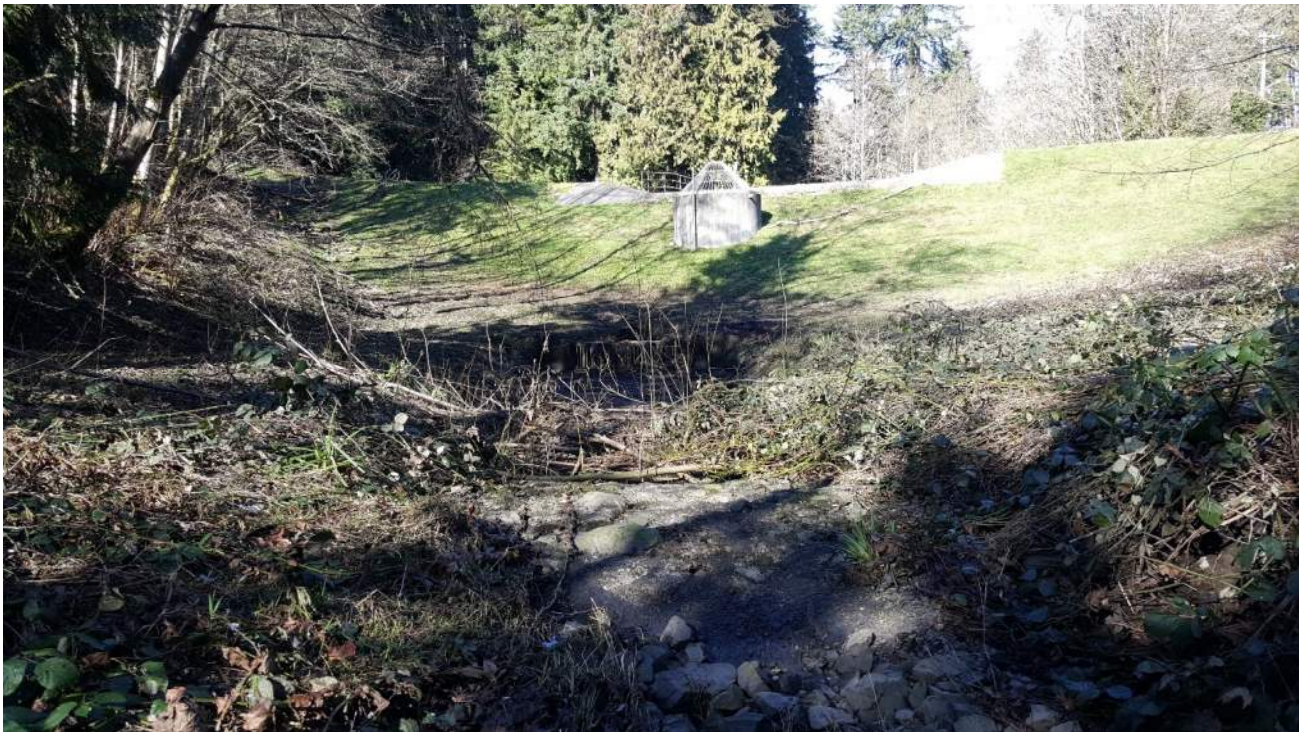
Photo 10. Looking downstream, at the gouted riprap grade control structure, and the M1 dam.

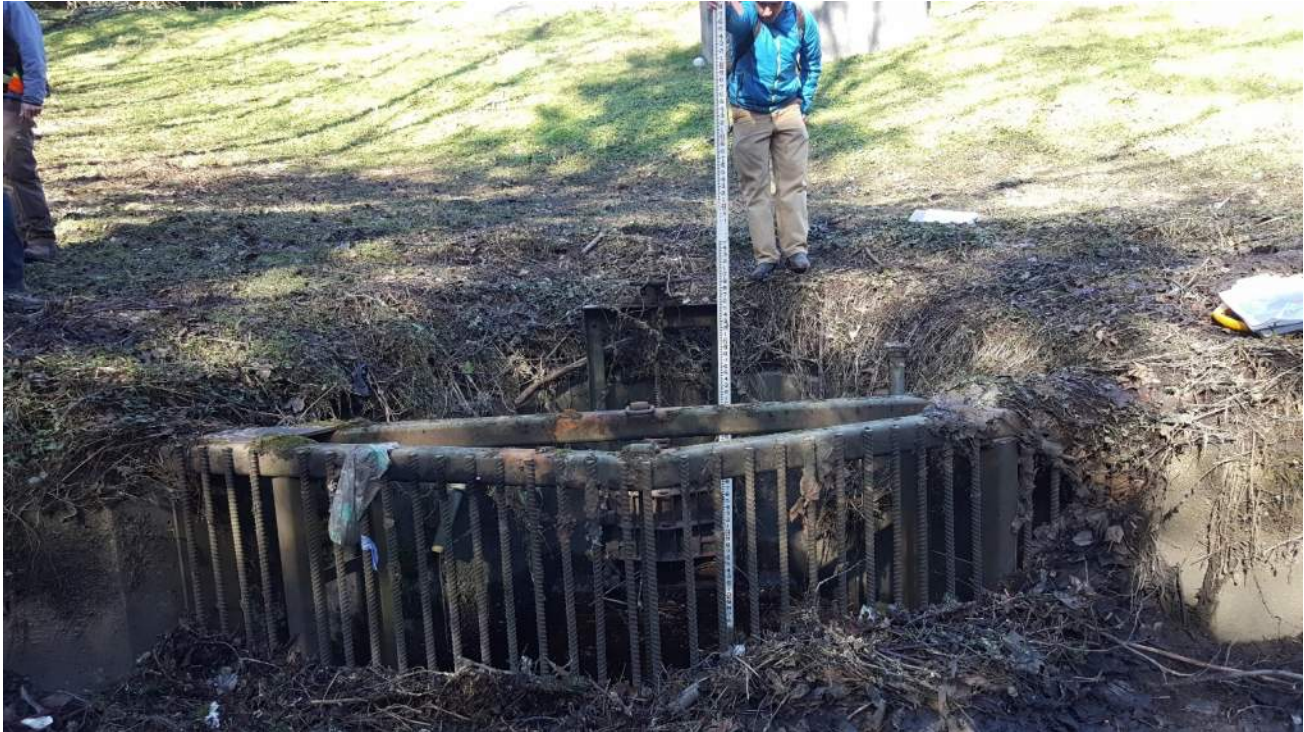
Photo 11. Sluice gate at the outlet pipe of the M1 Dam.

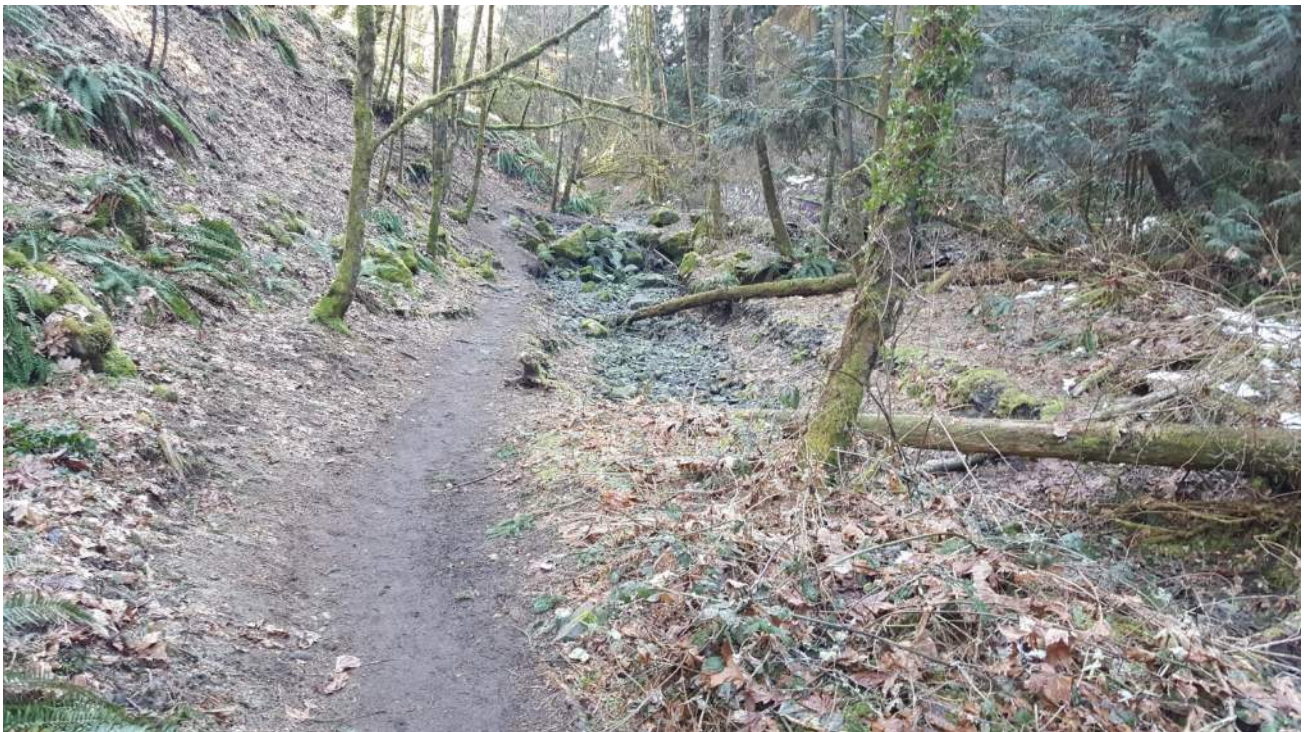
Photo 12. Looking upstream, at a rock weir grade control structure and eroded channel several hundred feet downstream of the M1 Dam.

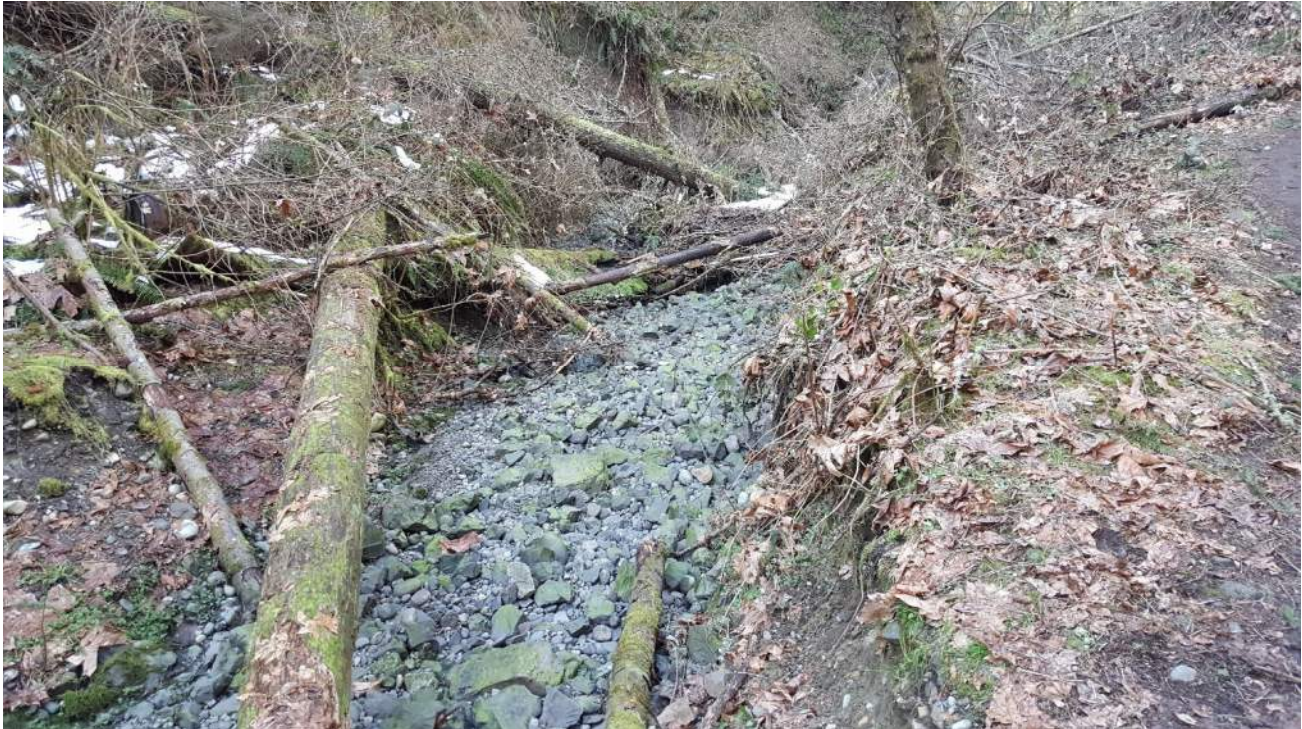
Photo 13. Looking downstream, at the eroded channel, eroded ravine slopes and fallen trees downstream of the M1 Dam.

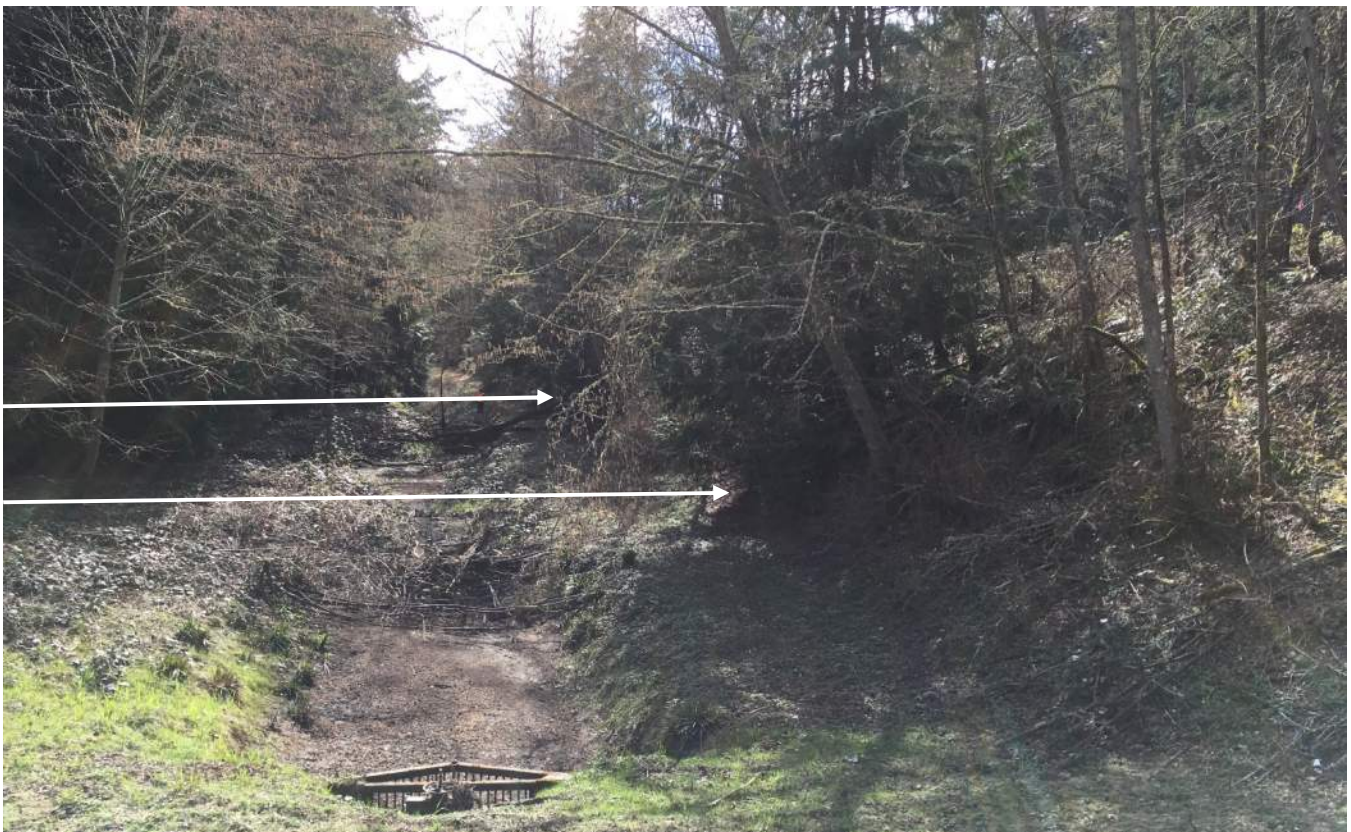
Slope instability was observed in two sections of trees on the south ravine side slopes (see Figure 2 and Photo 14). Each section is approximately 30' long. The instability is likely due to a combination of slope erosion and periodic soil inundation when the dam is storing water. The upper section of the slope contains the location where the alder tree fell into the stream and caused the scour hole. This area also contains two western red cedar trees along with a red alder tree. The roots of the two western red cedar trees are exposed due to surface erosion. The trees in this area are approximately 60' to 80' tall.

Photo 14: areas of tree instability one (upstream) and two (downstream) indicated with white arrows

In order to stabilize the slope and reduce on-going maintenance from clearing fallen trees and repairing the damaged roadway, it is recommended that the trees and vegetation is cleared and grubbed from the unstable area of the slope. The slope should be excavated into benches, and gravel borrow material compacted to
