Technical Memorandum

To: Cory Nau, City of Shoreline
From: Dave Stewart, PE
Gwyn Perry, PE
Kevin O'Brien, PhD
Copies: Tyson Hounsel, PE
Date: May 29, 2019
Subject: South Branch of Boeing Creek Near M-1 Dam Channel Study and Recommendations
Project No.: 32713.C21

To: Cory Nau, City of Shoreline
From: Dave Stewart, PE, Brian Clarke, PhD, Kevin O'Brien, PhD,
Copies: Tyson Hounsel, PE, Gwyn Perry, EIT
Date: May 7, 2019
Subject: Existing Conditions Observations for the South Branch of Boeing Creek Near M1 Dam
Project No.: 32713.C21

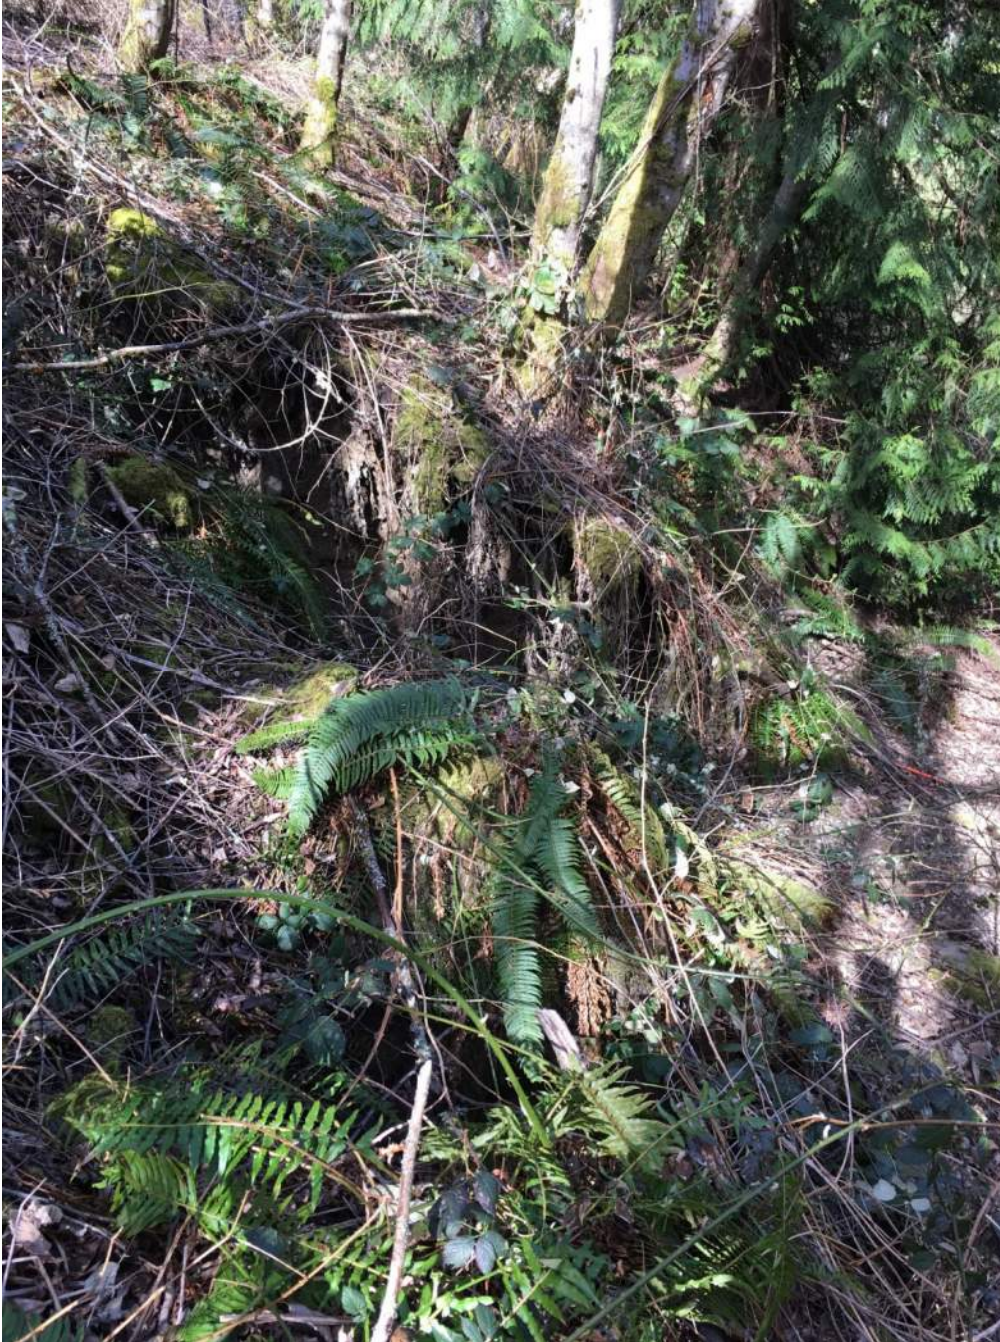
Photo 15: drainage caused ~1 to 1.5' channel on left bank slope in area two of tree instability

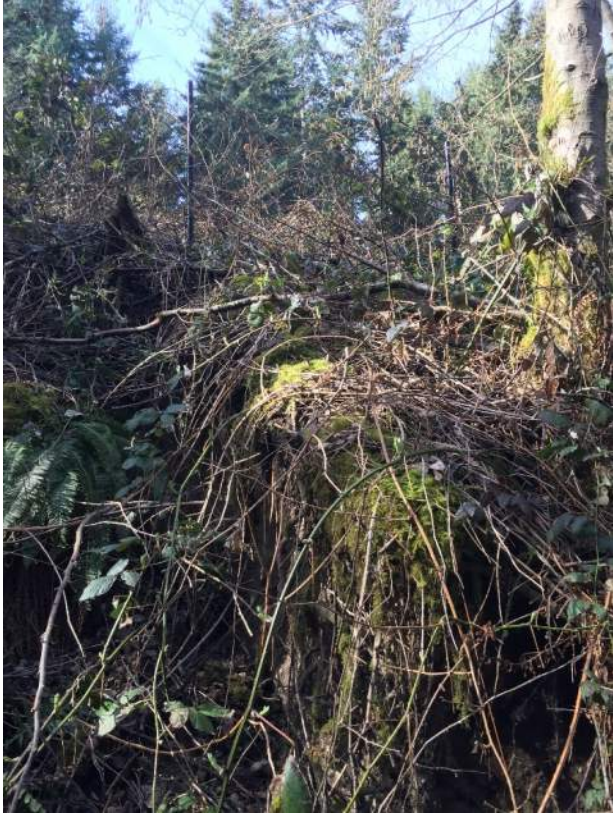
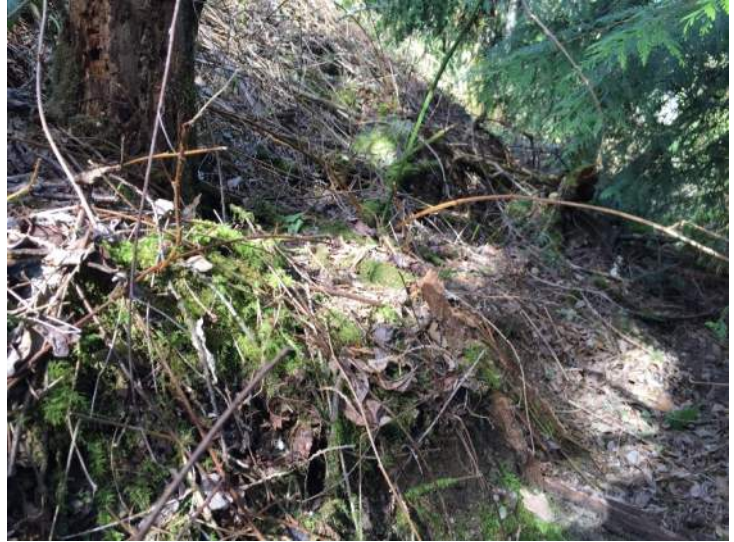
instability and weakened anchorage caused by erosion from surface runoff and cycles of saturation within the dam storage zone during large storm events (Photos 16 and 17). Tree failures on the south ravine slope outside of the dam inundation zone may also be indications of erosion issues caused by surface runoff from the Community College parking lot, although, the ravine slopes in this area are not as steep and instabilities are not as evident.

Photos 16 and 17: Soil erosion around tree root zones on south ravine slope within dam inundation zone

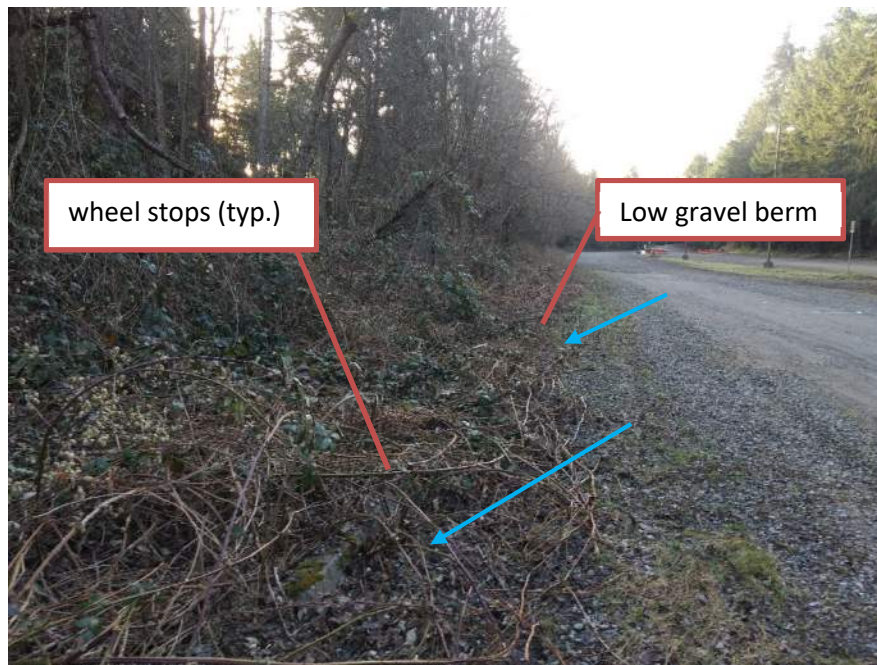
Photo 18: Northeast edge of gravel parking lot (facing southeast)

The parking area above the eroding ravine side slope drains towards the top of slope, is slowed by a berm near the edge of the parking area, and eventually drains around the berm and over the slope. It is recommended that coordination occur with the Community College to review the drainage pattern and maintenance of their parking area, and that an improvement is made to safely convey the runoff to the bottom of the slope to reduce impacts to the City's property and facility. The improvement could consist of installing a new catchbasin with grate inlet near the low point of the edge of the gravel parking area, with the catchbasin connecting to the existing pipe that discharges into the creek near the access road repair.
