Drainage Assessment Summary – Work Order 17081

South Branch of Boeing Creek, upstream of M-1 Dam
Near Greenwood Ave N and Carlyle Hall Rd N
Boeing Creek Basin

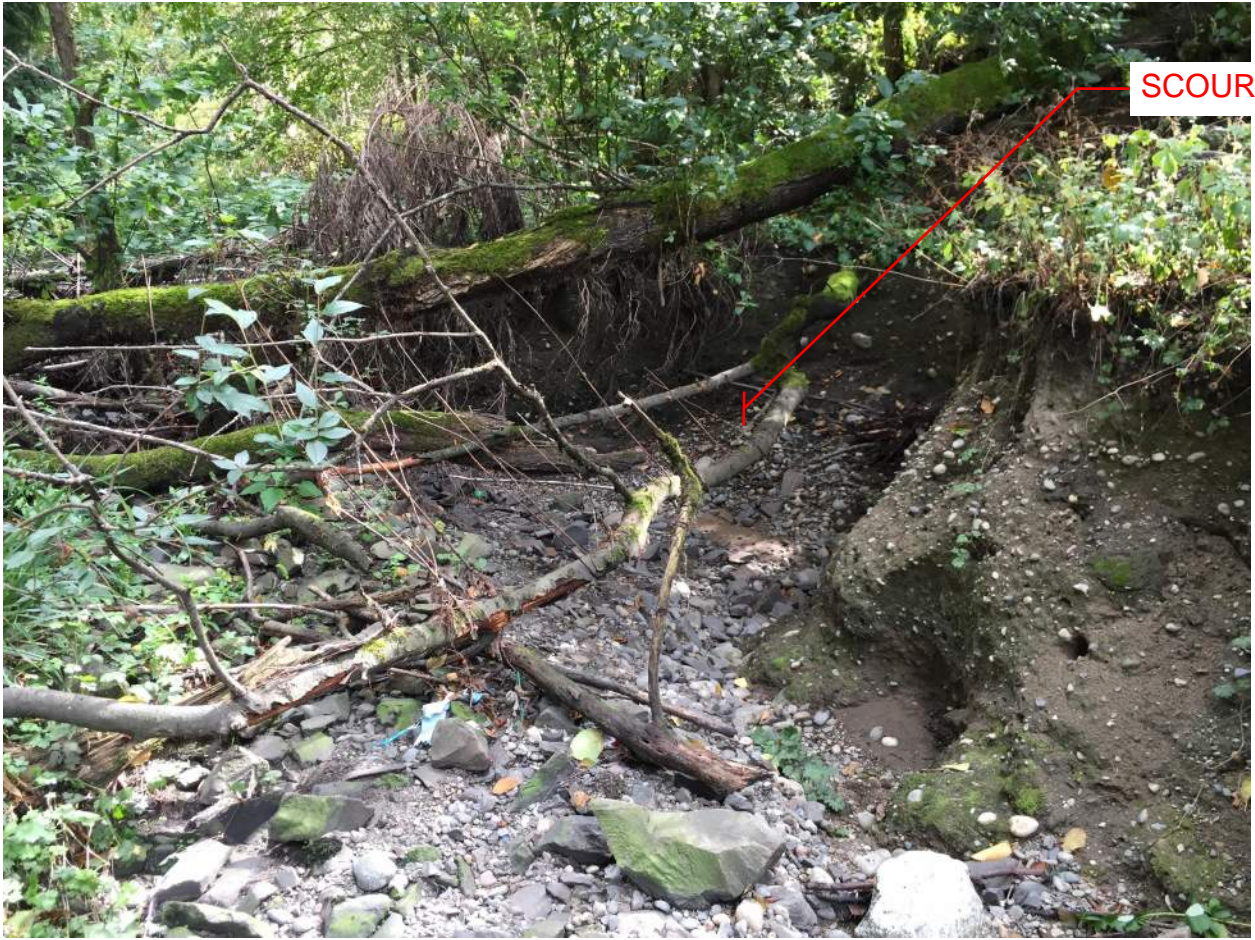
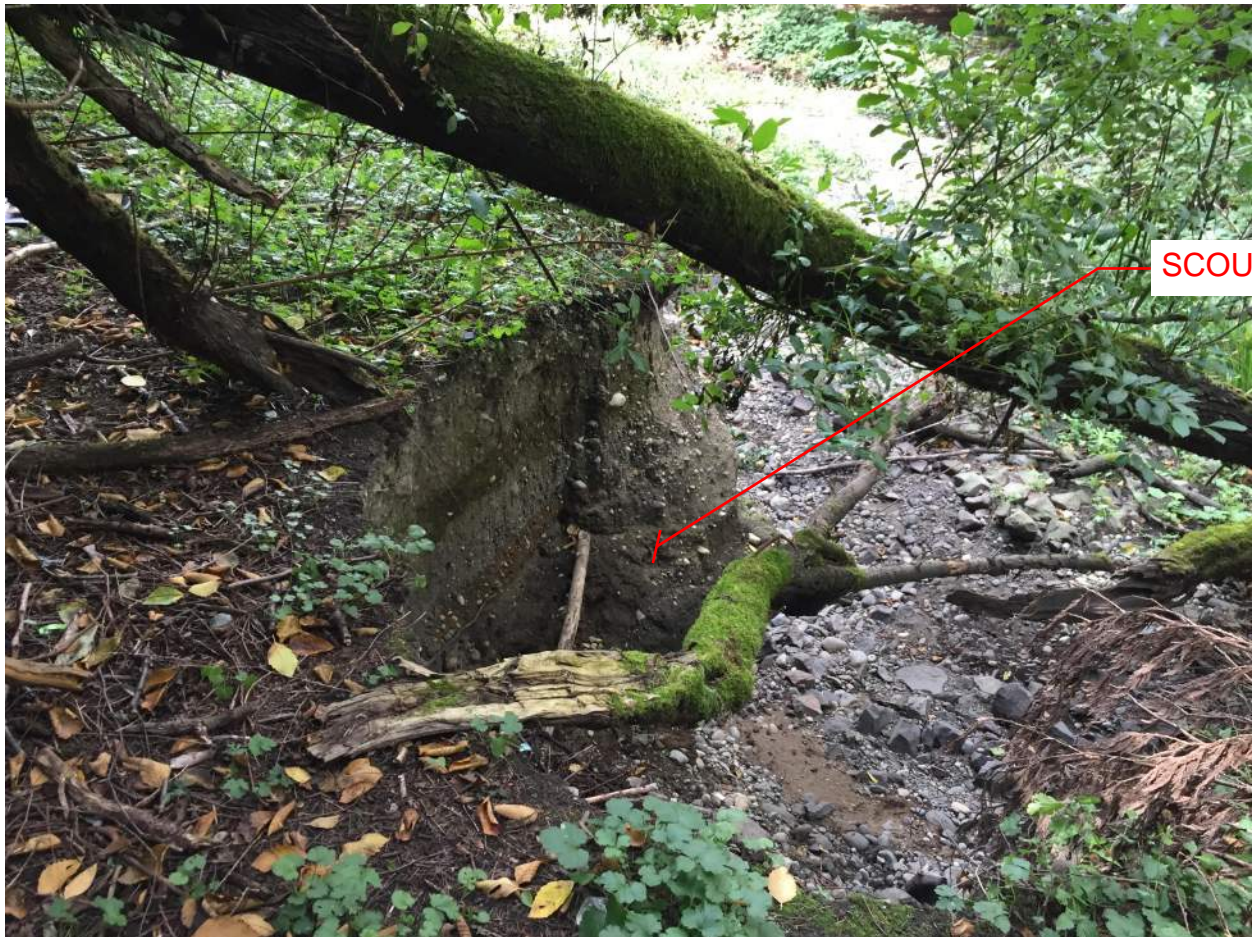
FIGURE 2. EXISTING SITE PHOTOS

At some point during the winter of 2017-2018, a mature tree fell from the south hillslope into the channel, blocking flow. The tree appears to have caused debris and sediment to build up in the center of the channel, forcing most of the flow to the south, creating a scour hole in the south embankment (see Figure 2). The scour hole is approximately 15 feet long along the channel and 11 feet wide across the access road embankment. A small 3-foot wide low flow channel has scoured down an additional 1-foot depth into left embankment toe at the erosion failure location. It does not appear that the erosion issue is due to a pocket of poor embankment material.

FACING EAST

FACING NORTHWEST, FROM TOP OF EXISTING ACCESS RAMP

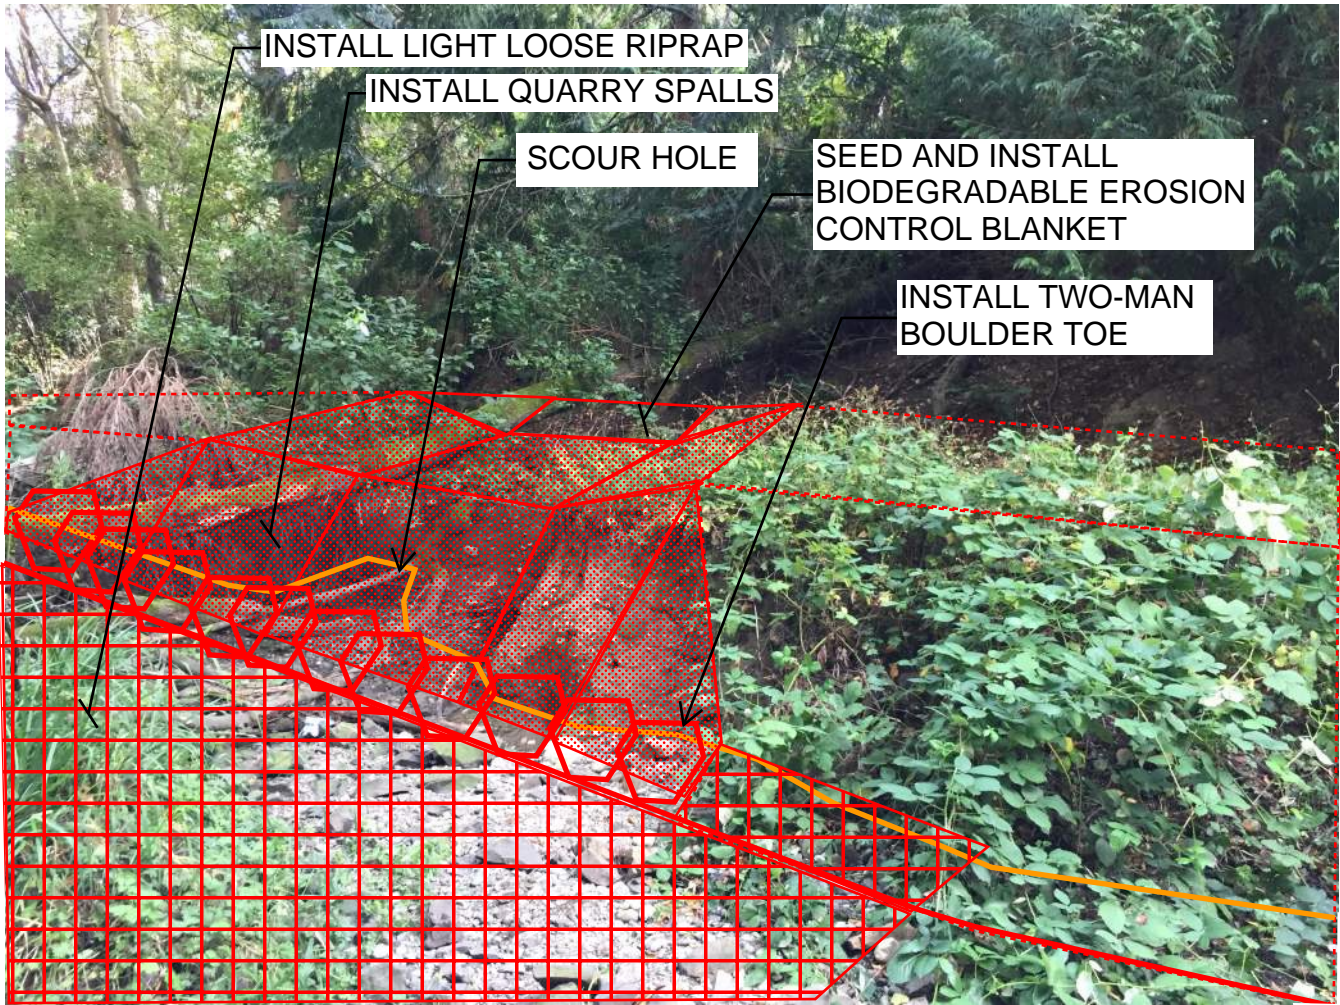
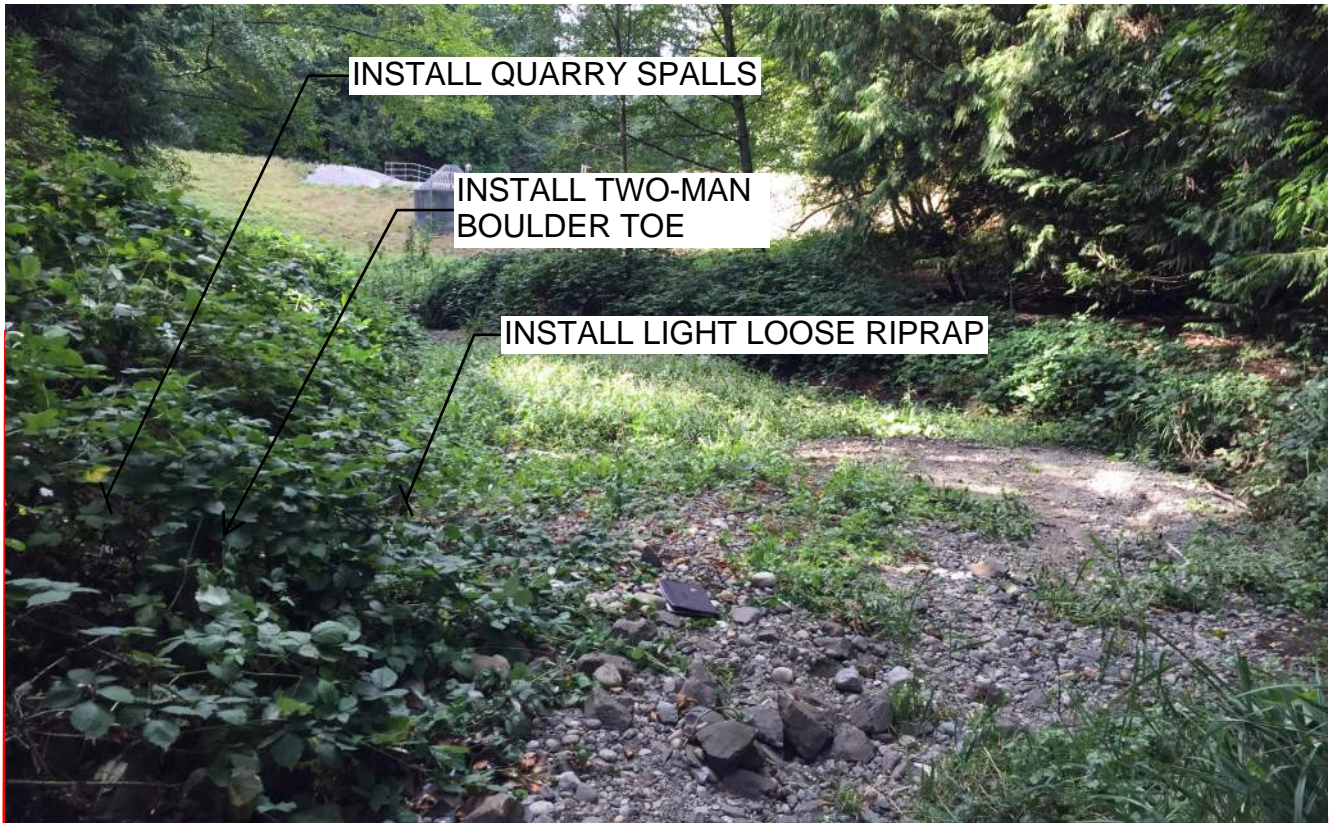
FIGURE 6. SITE PHOTOS WITH TEMPORARY STABILIZATION CONCEPT

FACING EAST

FACING WEST, DOWNSTREAM OF SCOUR HOLE

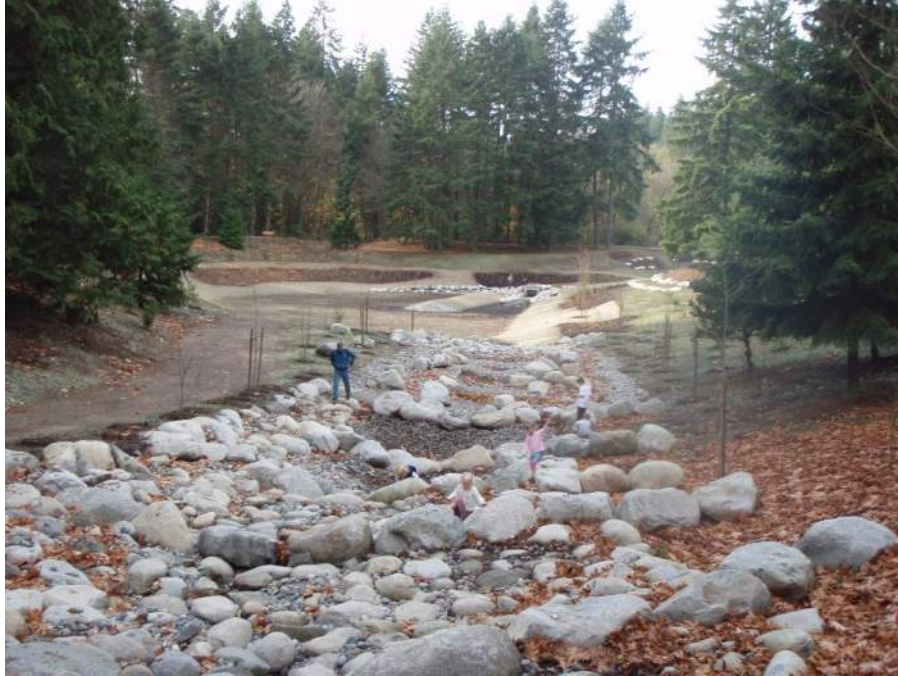
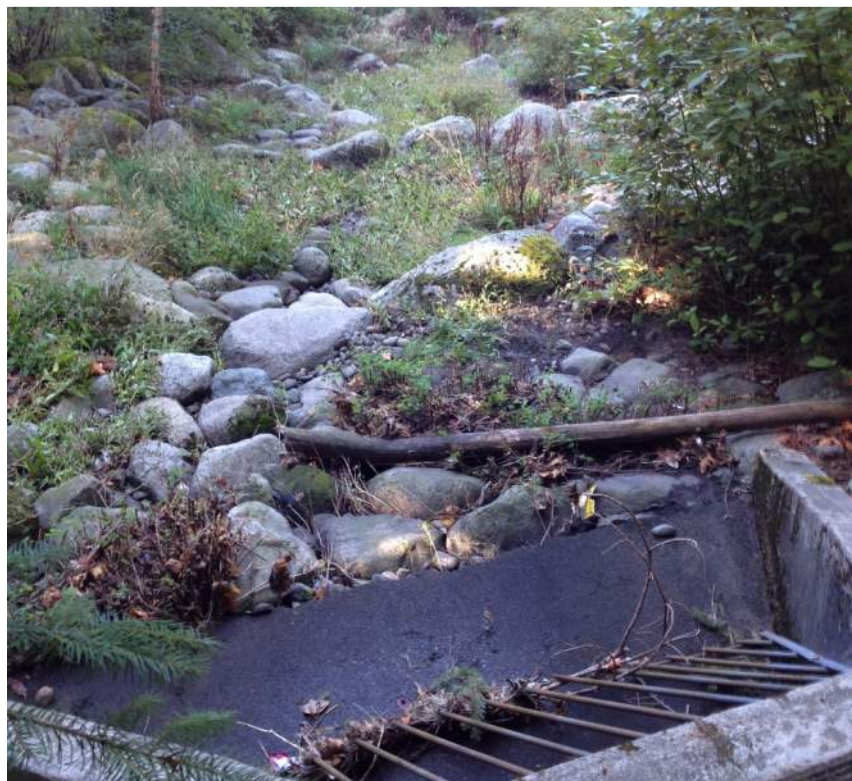
FIGURE 8 - EXAMPLE BOEING CREEK PARK OUTFALL STABILIZATION PHOTOS

Boeing Creek Park Outfall – 2008, following construction

Boeing Creek Park Outfall – 09/27/2018
