ARBORIST MEMORANDUM

To: City of Shoreline
 CC: Elizabeth Gibson, Project Landscape Architect, KPG
 From: Tristan Fields, ISA Arborist #PN-8826A & Tree Risk Assessment Qualified, KPG
 Date: October 21, 2021
 Re: N 148th Non-Motorized Bridge Project
 Project No: 19019

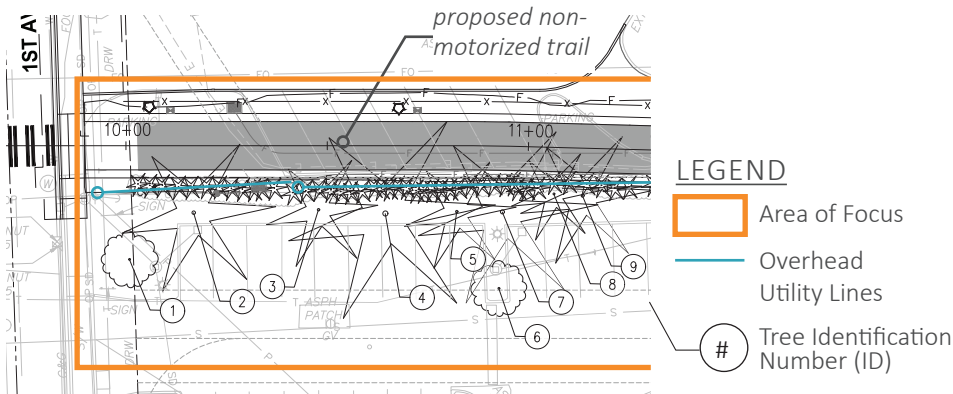
Figure 2 - West side of Area of Focus showing tree identification numbers.

Tree 2 was topped many years ago and developed 2 strong co-dominant leaders with some included bark. There are no signs of pest or disease. There is utility conflict on the north side of the tree with some pruning to reduce interference. Wounds show sap drip with strong signs of healing.

Tree 3 was also topped many years ago, is multi-stemmed with no obvious leader. About 40% of the canopy has been pruned to eliminate utility conflicts. There is evidence of mechanical damage that shows good signs of healing.

Tree 4 has been topped and had regrowth of a strong dominant leader. Tree 4 has an 8-10% lean to the south. During construction additional care to be taken to protect buttress roots extending north.

Tree 5 has one central leader with a formerly co-dominant leader that has been broken, however Tree 5 is showing good vigor.

Tree 6 shows low vigor; suggest replacing with a hardier parking lot species. Refer to Shoreline ROW Street Tree List.

Tree 7 has one strong central leader. During construction additional care to be taken to protect buttress roots extending north.

Tree 8 has two co-dominant leaders with included bark. Like Tree 7 above, during construction additional care to be taken to protect buttress roots extending north.

Recommend arborist be on-site and monitor excavation around tree roots of trees 1-15.

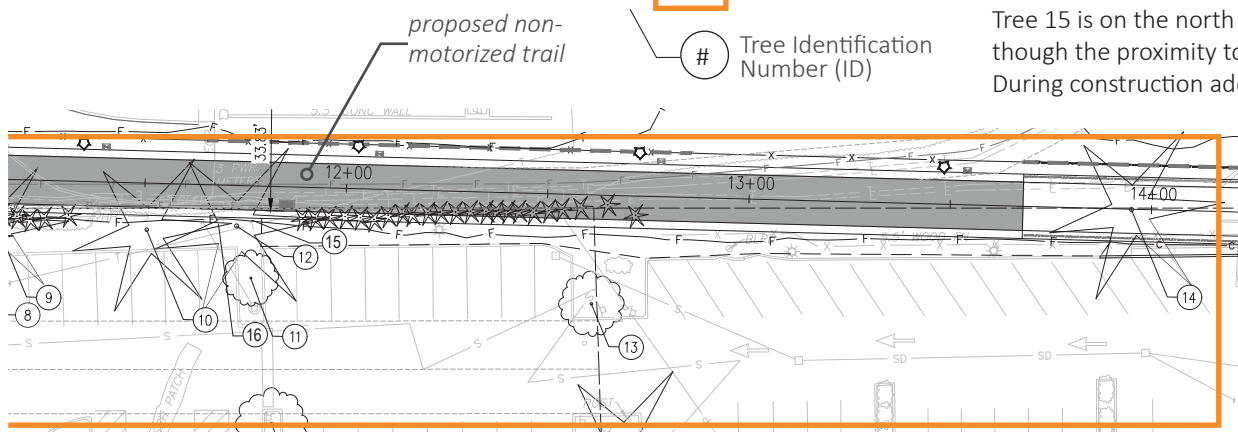
Figure 3 - East side of Area of Focus showing tree identification numbers.

Tree 9 has two co-dominant leaders from a previous topping. The north side of the tree was pruned due to utility conflicts.

Tree 10 has two buttress root to the north. During construction additional care to be taken to protect buttress roots extending north.

Tree 11 shows low vigor, suckering from the base; suggest replacing with a hardier parking lot species. Refer to Shoreline ROW Street Tree List.

Tree 12 has approximately 15% canopy loss. Otherwise, showing excellent vigor and strong buttresses.

Tree 13 shows branch failure and canopy loss; it is a healthier tree, but suggest replacing with a hardier parking lot species. Refer to Shoreline ROW Street Tree List.

Tree 14 is inaccessible due to blackberry growth, however, over 4 major limbs were lost and canopy is at 55% of fullness. From a distance, vigor looks low. Tree will need to be removed due to trail alignment.

Tree 15 is on the north side of Tree 12, shows excellent vigor, suggest retaining even though the proximity to the trail, removal may be too large of an impact to Tree 12. During construction additional care to be taken.

Tree 16 is a younger Douglas Fir on the north side of Tree 12. During construction additional care to be taken. Suggest remove due to proximity to Tree 12, if supervising arborist deems removal necessary, suggest flush cutting the stump.

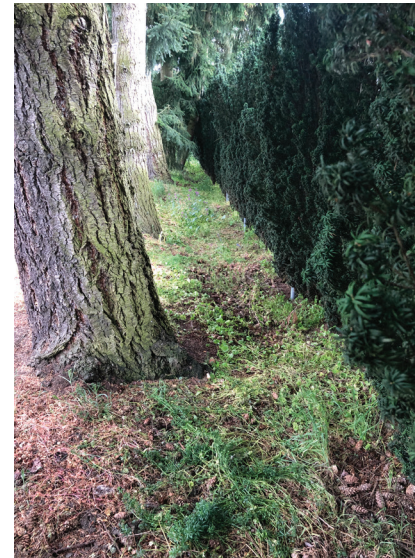
The yew hedge is located on the north side of the subject trees within Area of Focus (see Figure 4 below). The base of this hedge is within 2' to 5' of the base of the large conifer trees along this row. The hedge is slated to be removed due to site visibility and pedestrian safety along the proposed trail. The hedge's roots are integrated with the large trees. To reduce further impacts to the large trees, cut the hedges flush to the ground, but do not grind the stumps.

Image showing the proximity between the yew hedge and the row of trees.

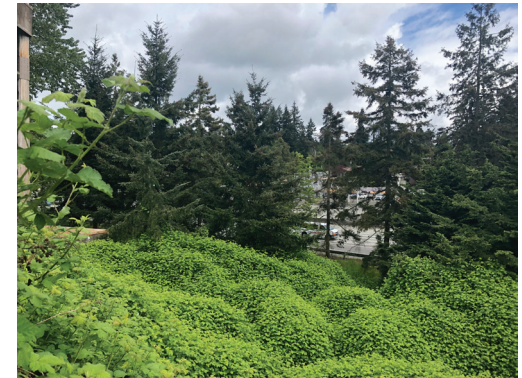
Image showing Area of Note with blackberry, buffer trees, and I-5 in the distance.

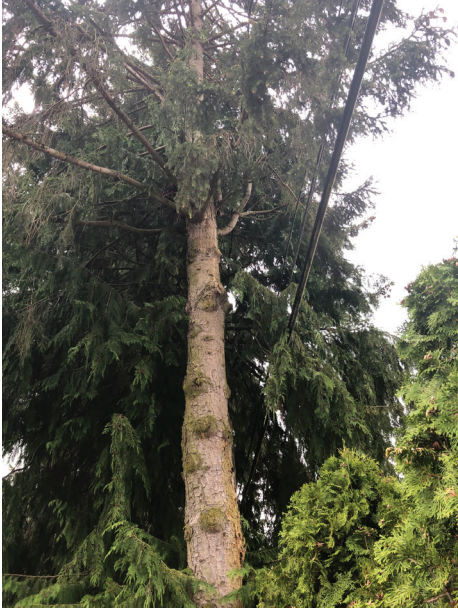
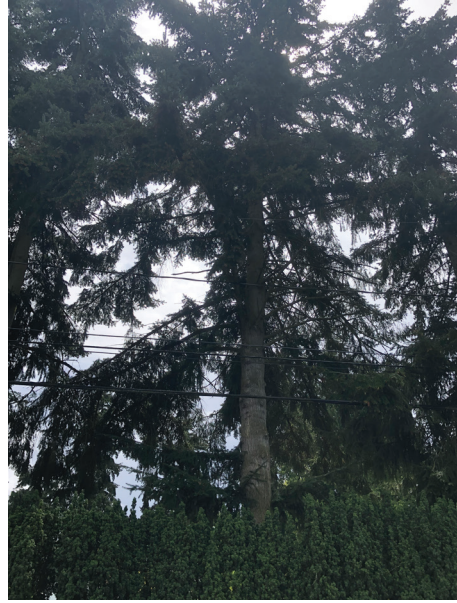
Images showing utility interaction with row of trees.

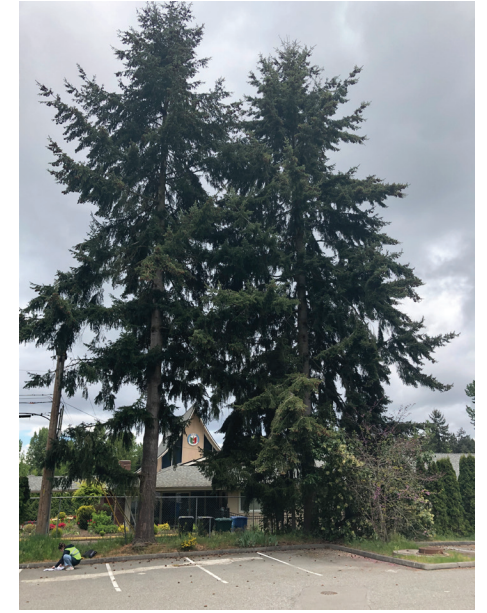
Two trees of note are Trees 10 & 12. The proposed trail will skirt within 5' of the base of Tree 12. There shall be an arborist on-site during construction to determine if the tree's root mass is too significantly impacted and should therefore be removed. Because of the proximity of Tree 12 to Tree 10, Tree 10 shall also be carefully considered for construction impacts and potential removal, particularly if Tree 12 is ultimately removed.

Image showing Trees 10 and 12 (left to right) and their proximity to Iglesia Church of Christ.
