ARBORIST MEMORANDUM

Date: October 13, 2022

Project Title: N 148th Non-Motorized Bridge - Phase 1

Project No: 16114W29

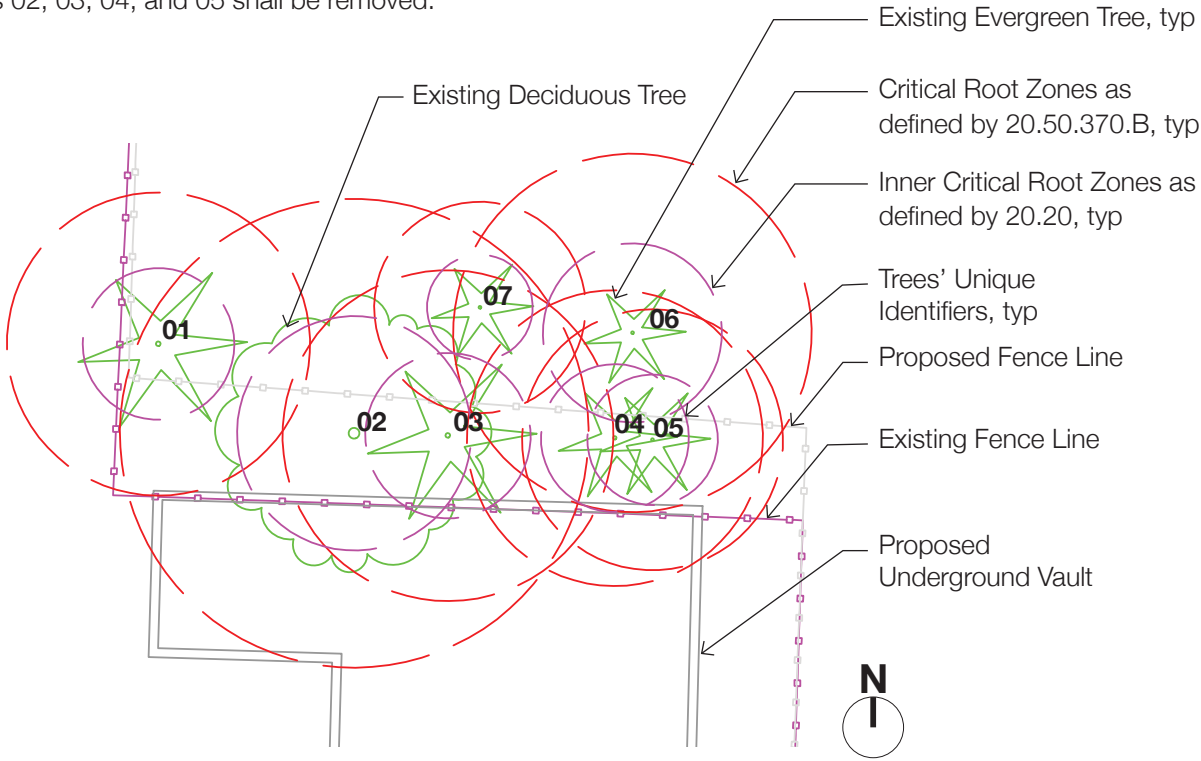
Figure 2, below, shows all the existing trees on site applying the DBH as it translates to critical root zones (red dashed line) and the inner critical root zones (magenta dashed line). The site assessment revealed a variance between the proposed drawings and the existing site conditions. Figure 2 shows the estimated existing fence line location (magenta) and the proposed fence line location (light grey). Also shown in Figure 2 is the proposed underground vault.

Figure 2 - 1:20 scale tree protection plan showing tree locations and critical root zones in relation to the underground vault.

The impacts from the excavation for the proposed vaults will be significant to Trees 02, 03, 04, and 05. Trees 02, 03, 04, and 05 shall be removed.

Trees 01, 06, and 07 can be preserved. Because of the extent of excavation happening within the critical root zone (CRZ) of Trees 01 and 06, municipal code 20.50.370.E. shall be followed by having a project arborist on site to supervise the work. Any roots found within the CRZ of three inches or greater in diameter will be cleanly cut to the edge of the trench to avoid ripping of the root.

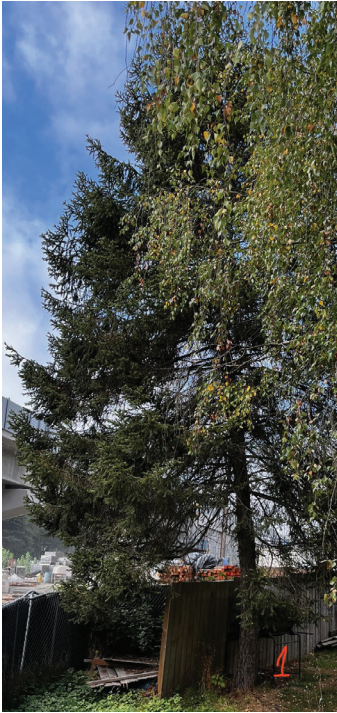
Tree 01 - showing fair health and proximity to Tree 02

Trees 01, 06, and 07 should be monitored annually for decline and wind firmness. If the trunks of Trees 02, 03, 04, and 05 can be flush cut, that is preferred to aid in the structural health of Trees 01, 06, and 07.

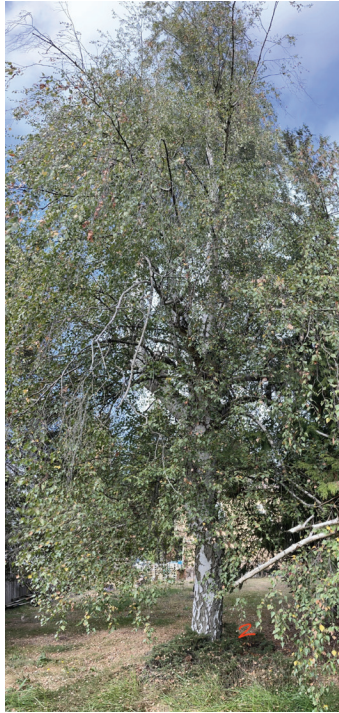
Trees 02, 03, 04, and 05 are outside of parcel ownership of 307 NE 151st St (parcel number 3222200040). The trees also have varying degrees of health (see Table 1, page 3). Tree 02 is suspected to be in slow decline due to an infection of Bronze Birch Borers. Tree 03 is in fair health, showing drought stress, and Trees 04 and 05 are in decline with top die-back.

Tree 02 - showing classic symptoms of Bronze Birch Borer disease with top die-back

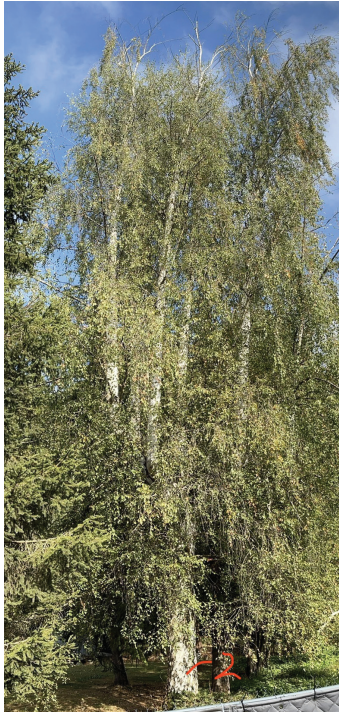
Tree 02 - looking south east

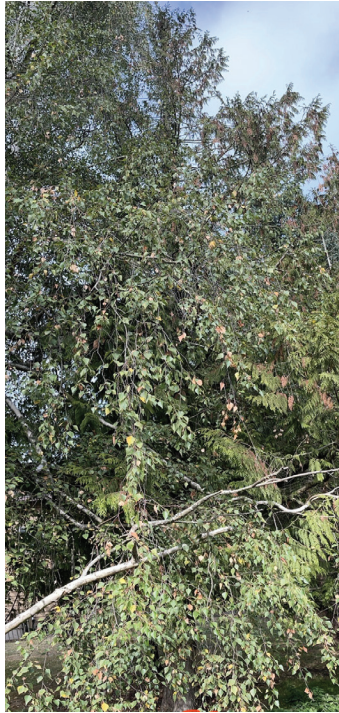
Tree 03 - hidden in the foliage of Tree 02

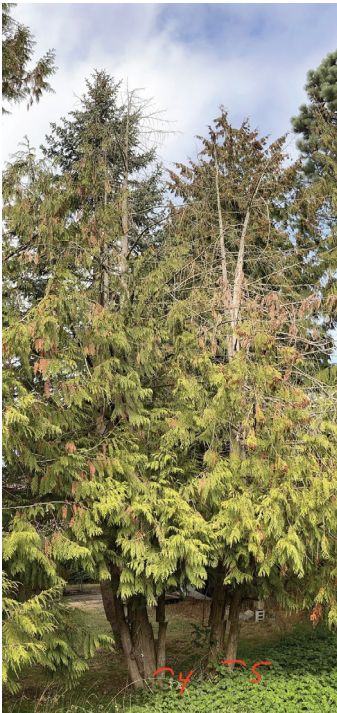
Trees 04 & 05 - showing top die-back, stress, and decline

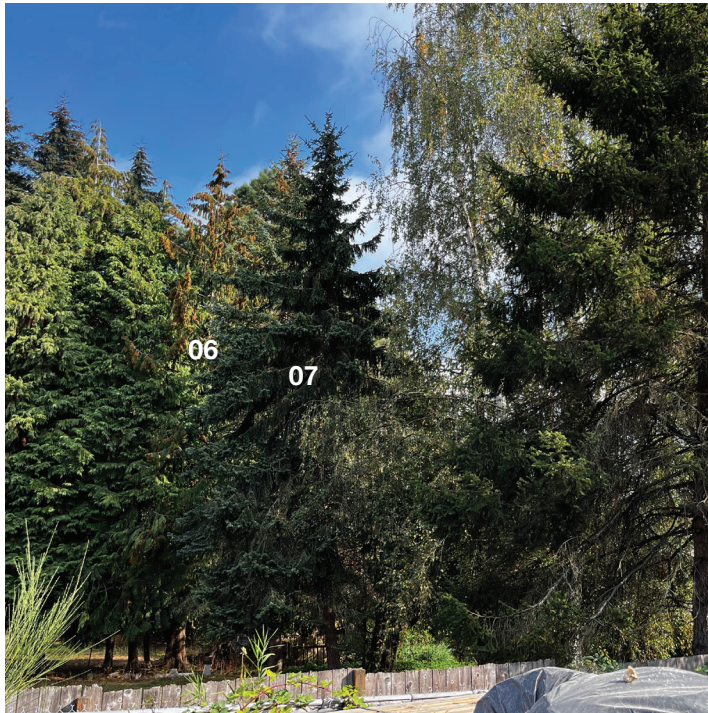
Trees 06, 07, and 01 - looking south east, showing the fair health of Trees 06 & 07
