Re: Pump Station 30 – Arborist Report

DCG/Watershed Reference Number: 181216.11

PUMP STATION 30 TREE PROTECTION PLAN

PROJECT:
 NE 170TH ST & 15TH AVE NE
 SHORELINE, WA

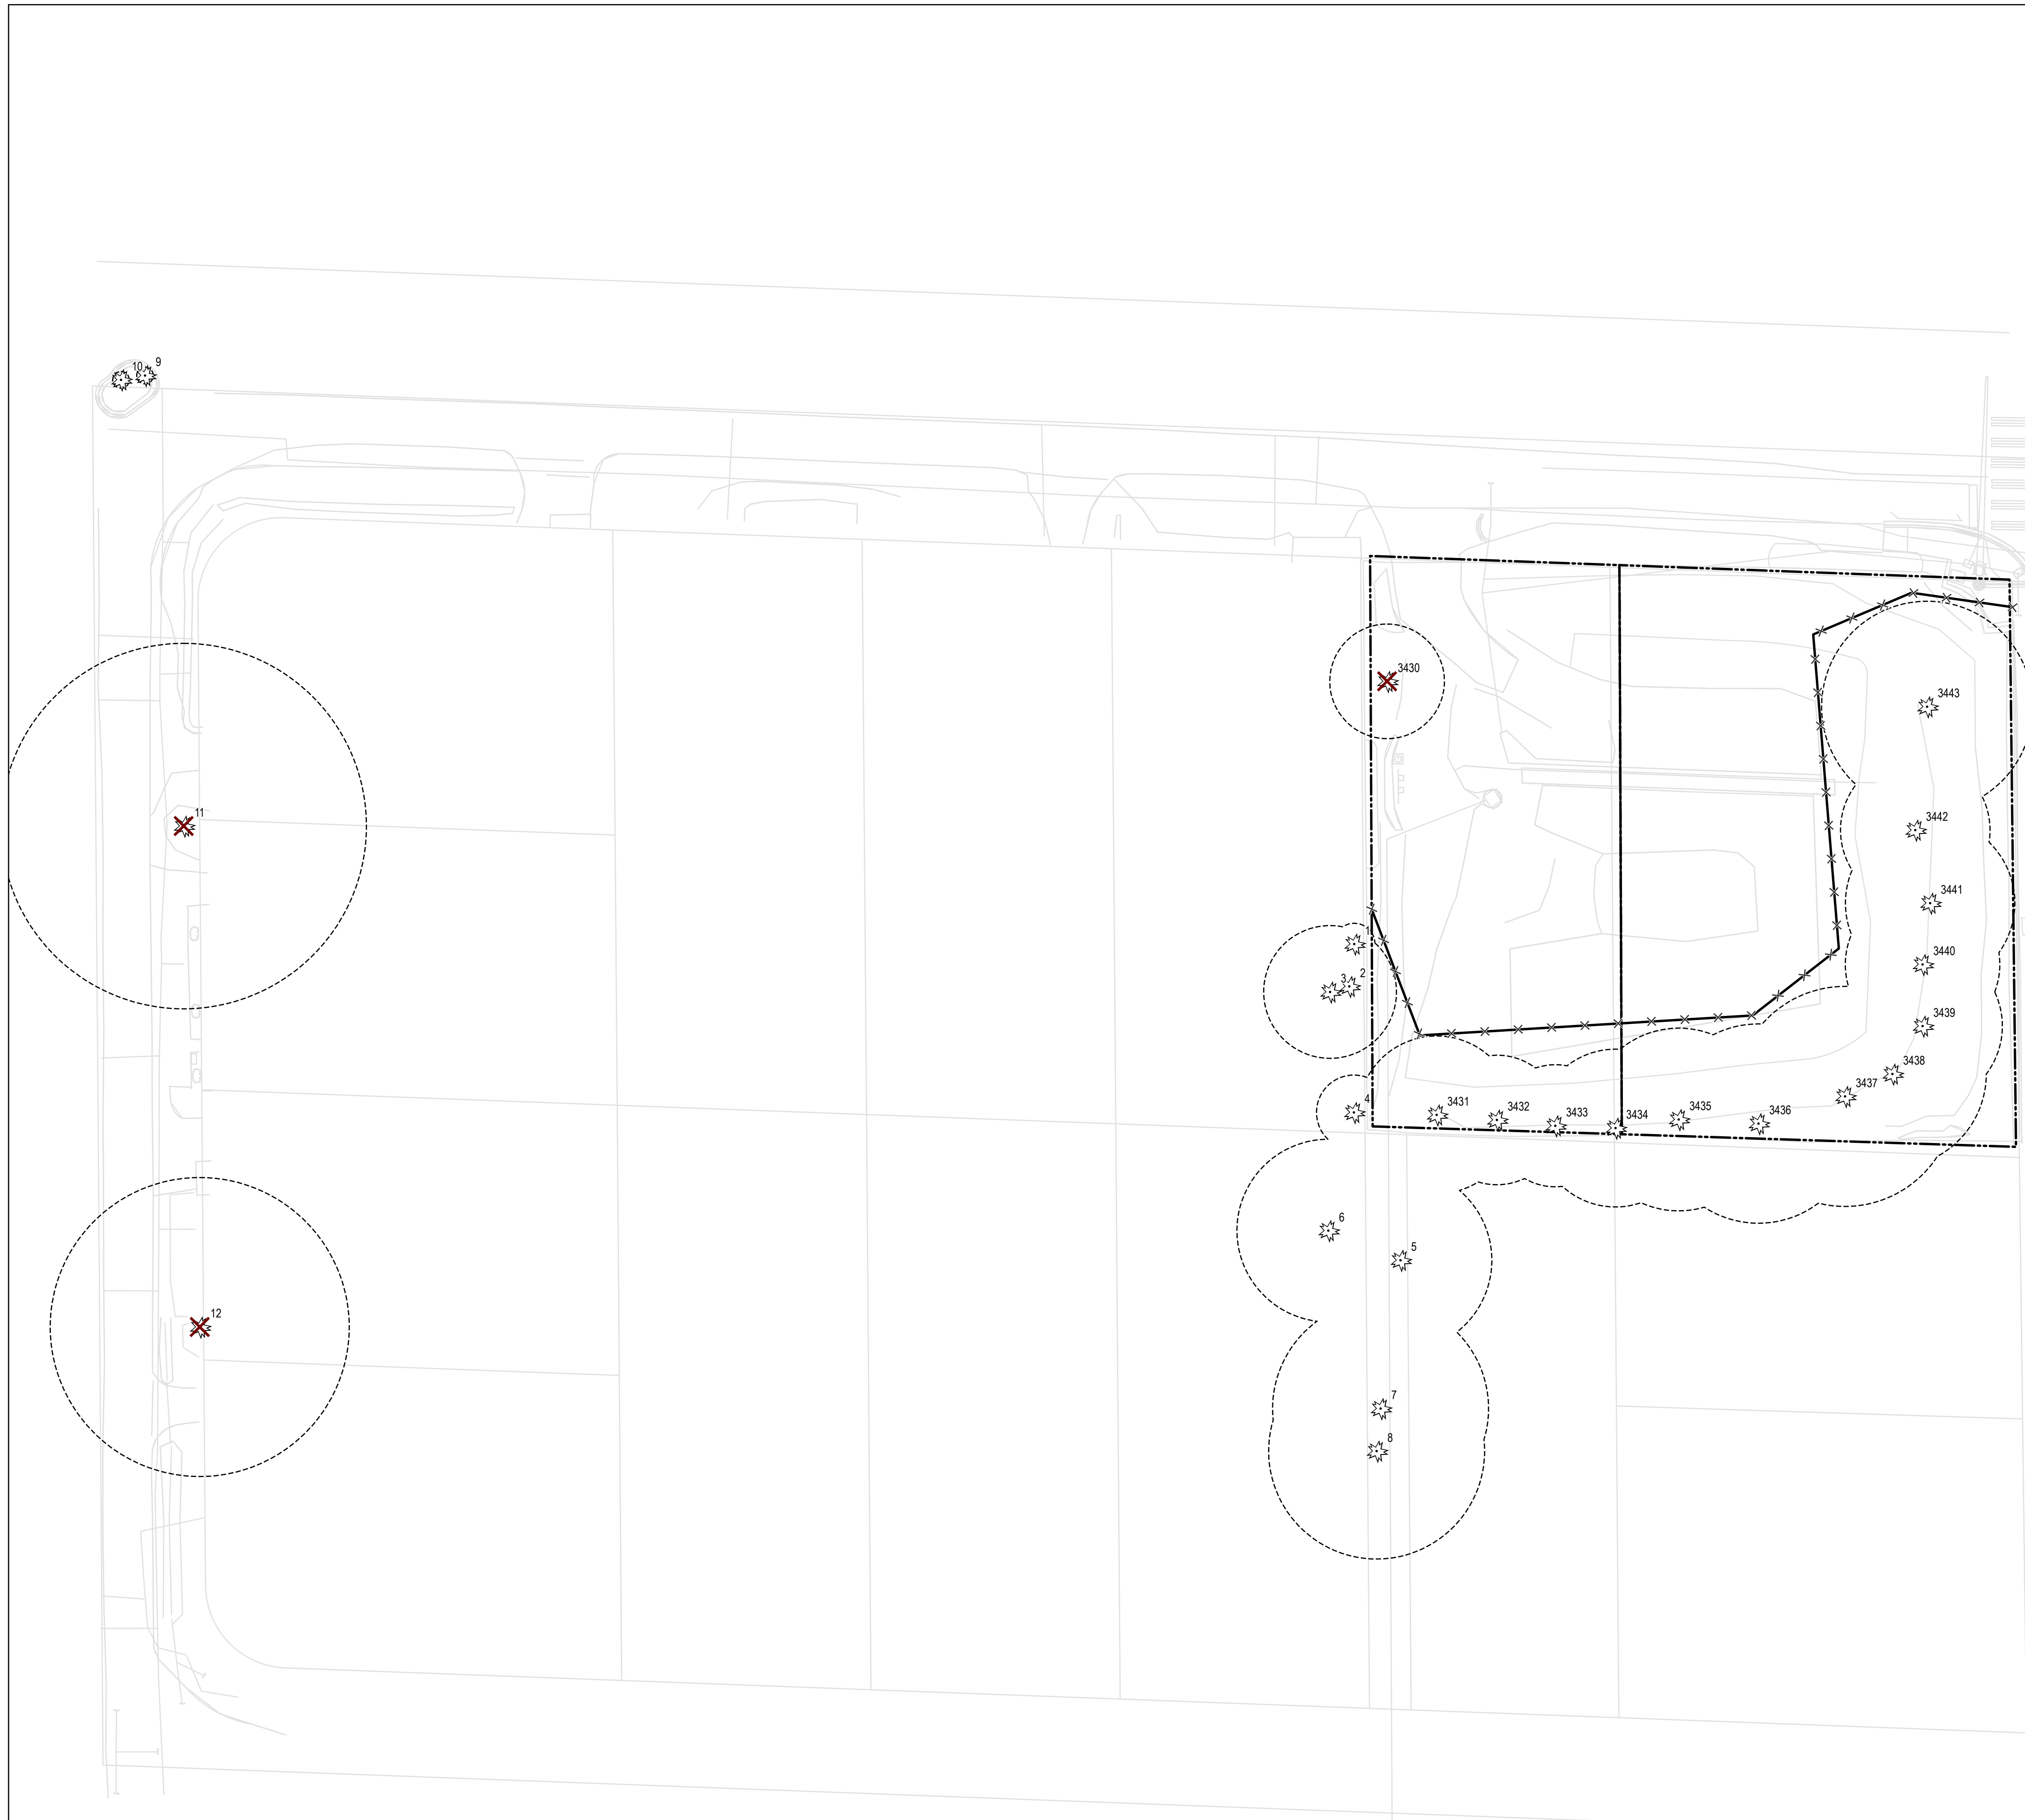
TREE PROTECTION PLAN

Tree #3430 will need to be removed to accommodate the construction of the valve vault and wet well. If the project proposes to run the forced main along NE 170th St and 12th Pl NE, ROW Trees #11 and 12 will also need to be removed. If an alternative path for the forced main along the west property line can be utilized, ROW Trees #11 and 12 would not require removal.

In addition to the inventoried significant trees, there are several non-significant arborvitae (*Thuja occidentalis*) along NE 170th St that are in *Good* condition and can be retained. There are also several arborvitae within the property along the west fence line that are in *Poor* or *Dead* condition and should be removed.

All retained trees, including those on-site, in the ROW, and on adjacent properties will require protection measures during construction. Trees can be damaged quickly and irreversibly by construction activities, especially by heavy machinery and exposure to chemicals. The following best management practices follow the industry standards for tree protection (ANSI A300 Part 5, 2019), and should be adhered to whenever work is being performed.

- Fencing should be placed at the outer edges of the tree protection zone.
- Fencing should be four to six feet high, and constructed of chain link, wire-mesh, or high-visibility plastic fencing.
- Fencing should include visible warning signs, such as “Tree Protection Area – Keep Out”, spaced no further than 15 feet apart.
- Fencing and signage should be installed prior to the start of construction and remain in place for the duration of the project.
