Re: Pump Station 30 – Arborist Report

DCG/Watershed Reference Number: 181216.11

PUMP STATION 30 TREE PROTECTION PLAN

NE 170TH ST & 15TH AVE NE
 SHORELINE, WA

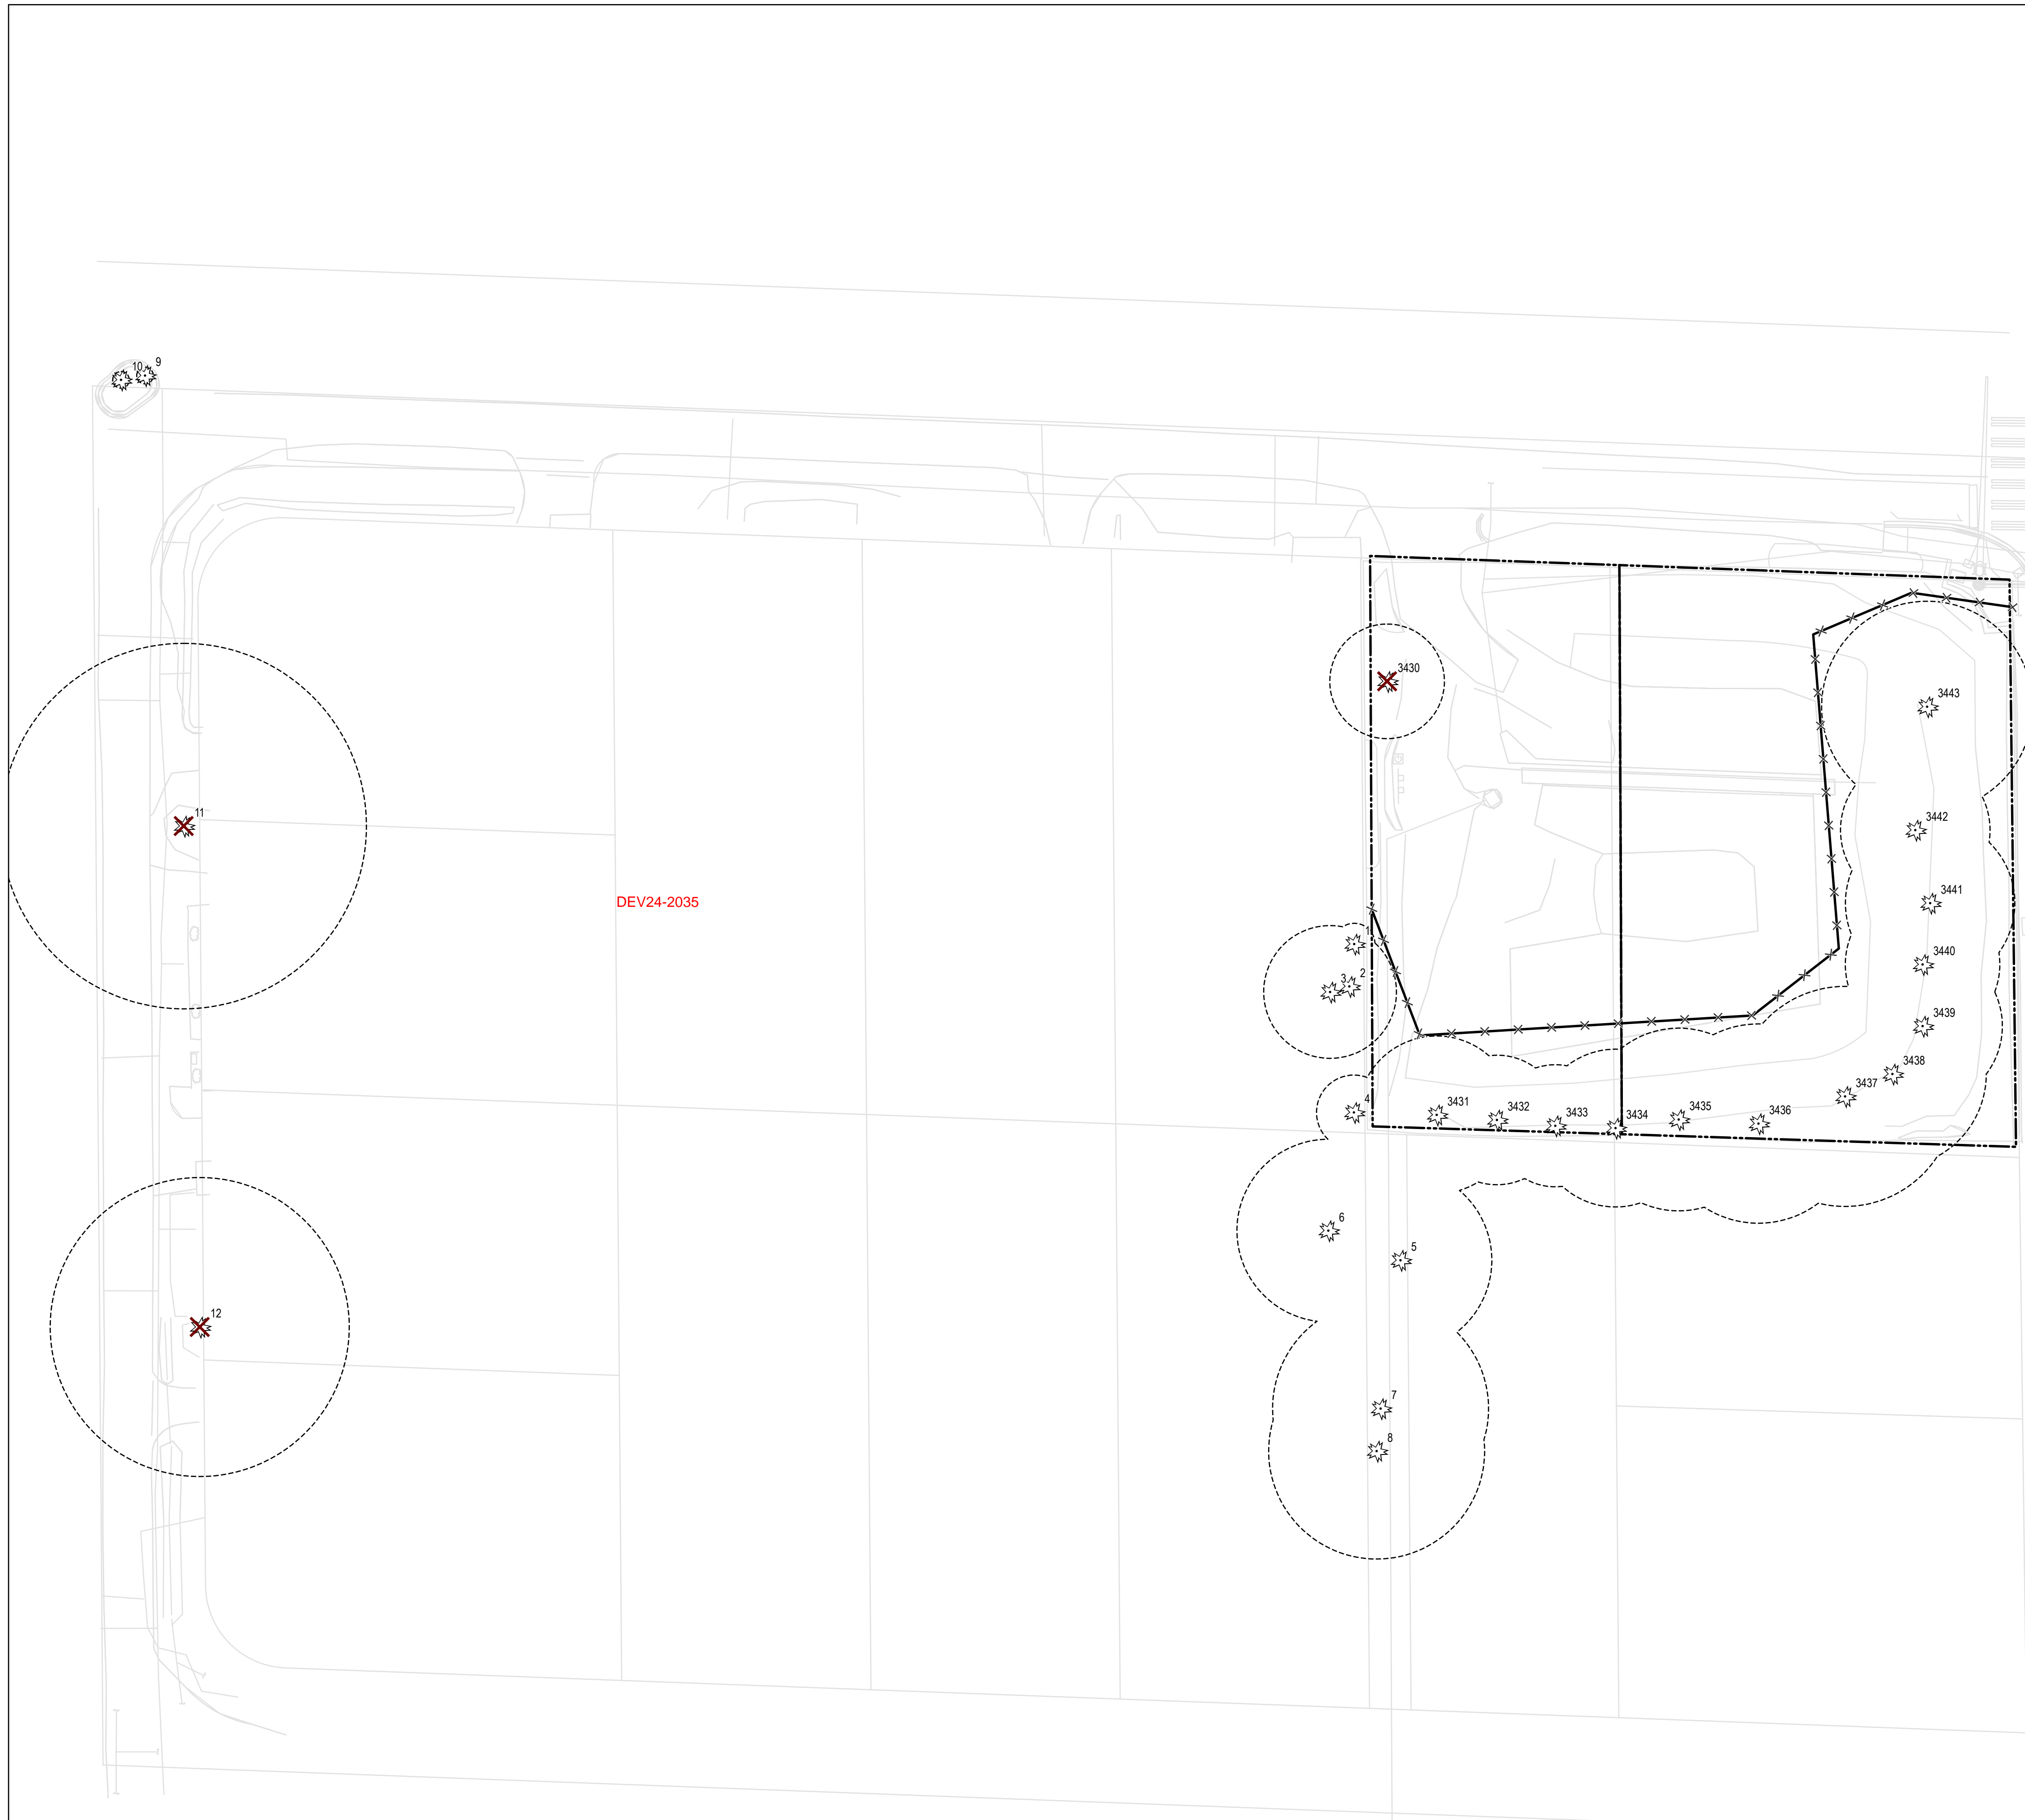
TREE PROTECTION PLAN

The majority of the significant trees can be retained, both on and off-site or in the ROW, as they are in *Good* condition and won't be negatively impacted. Specific exceptions for removal are

Tree #3430 will need to be removed to accommodate the construction of the valve vault and wet well. If the project proposes to run the forced main along NE 170th St and 12th Pl NE, ROW Trees #11 and 12 will also need to be removed. If an alternative path for the forced main along the west property line can be utilized, ROW Trees #11 and 12 would not require removal.

The removal of Tree #3430 would require three replacement trees to be planted. The removal of Trees #11 and 12 would require three replacement trees each.

All retained trees, including those on-site, in the ROW, and on adjacent properties will require protection measures during construction. Trees can be damaged quickly and irreversibly by construction activities, especially by heavy machinery and exposure to chemicals. The following best management practices follow the industry standards for tree protection (ANSI A300 Part 5, 2019), and should be adhered to whenever work is being performed.

- Fencing should be placed at the outer edges of the tree protection zone.
- Fencing should be four to six feet high, and constructed of chain link, wire-mesh, or high-visibility plastic fencing.
- Fencing should include visible warning signs, such as “Tree Protection Area – Keep Out”, spaced no further than 15 feet apart.
- Fencing and signage should be installed prior to the start of construction and remain in place for the duration of the project.
