REFERENCE: Tree Inventory & Arborist Report

SITE ADDRESS: 14731 Wallingford Ave N, Shoreline, WA 98133 (Parcel #: 7655900185)

DATE: 6/13/2024

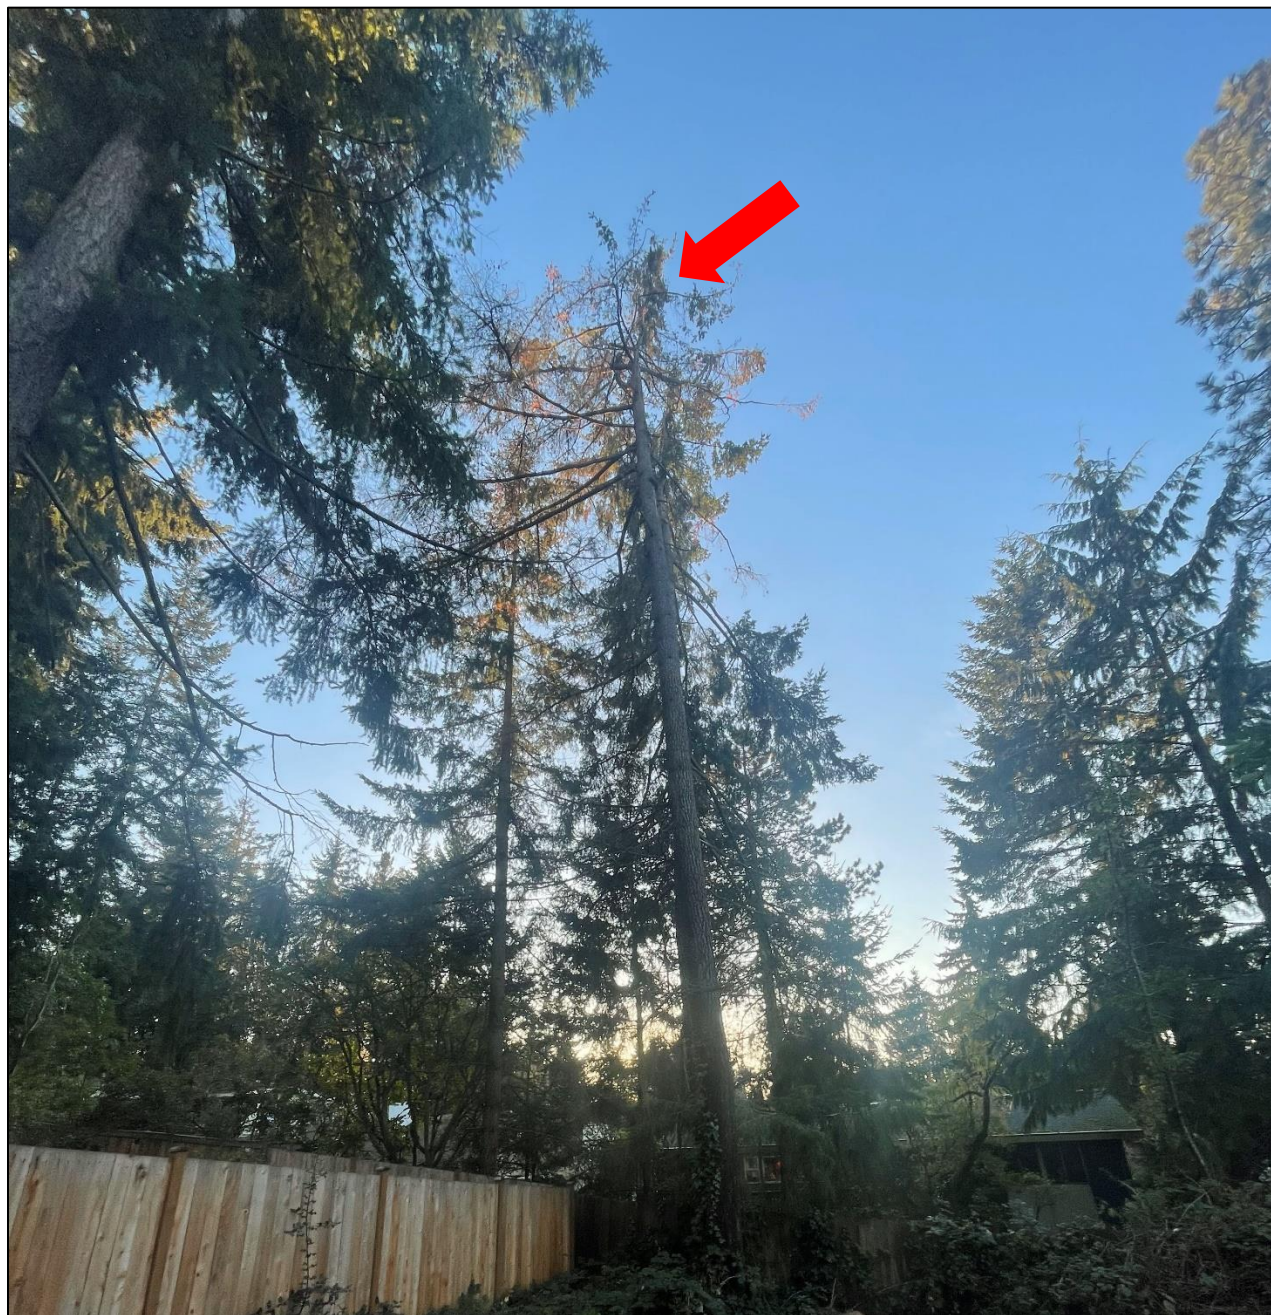
*Photo 1. Tree #463, non-viable tree.*

463	On-site	<i>Pseudotsuga menziesii</i>	Douglas-fir	16.0	Poor	Poor	No	0	Remove	-	Yes - not viable	0	Nearly 100% dead; only small amount of foliage and remaining
464	On-site	<i>Pseudotsuga menziesii</i>	Douglas-fir	17.0	Fair	Fair	Yes	15	Retain	11	-	0	Canopy one-sided to the west; suppressed top; in contact with existing fence
465	On-site	<i>Chamaecyparis lawsoniana</i>	Lawson's cypress	22.0	Good	Good	Yes	12	Retain	15	-	0	High live crown ratio
466	On-site	<i>Thuja plicata</i>	Western redcedar	47.0	Fair	Poor	No	25	Remove	-	Yes - not viable	0	Codominant at about 10 feet with a very narrow angle of attachment; pitching from seem - likely an active crack; likely substantial decay at union; obstructed by ivy; topped at about 40 feet with multiple trunks emerging
467	On-site	<i>Thuja plicata</i>	Western redcedar	26.0	Good	Poor	No	20	Remove	-	Yes - not viable	0	Shares canopy with adjacent cedar tree; topped at about 70 feet; canopy one-sided to the northeast

The additional three trees proposed for removal are non-viable as discussed above (tree #s 463, 466, 467) and are also exempt from replacement standards.

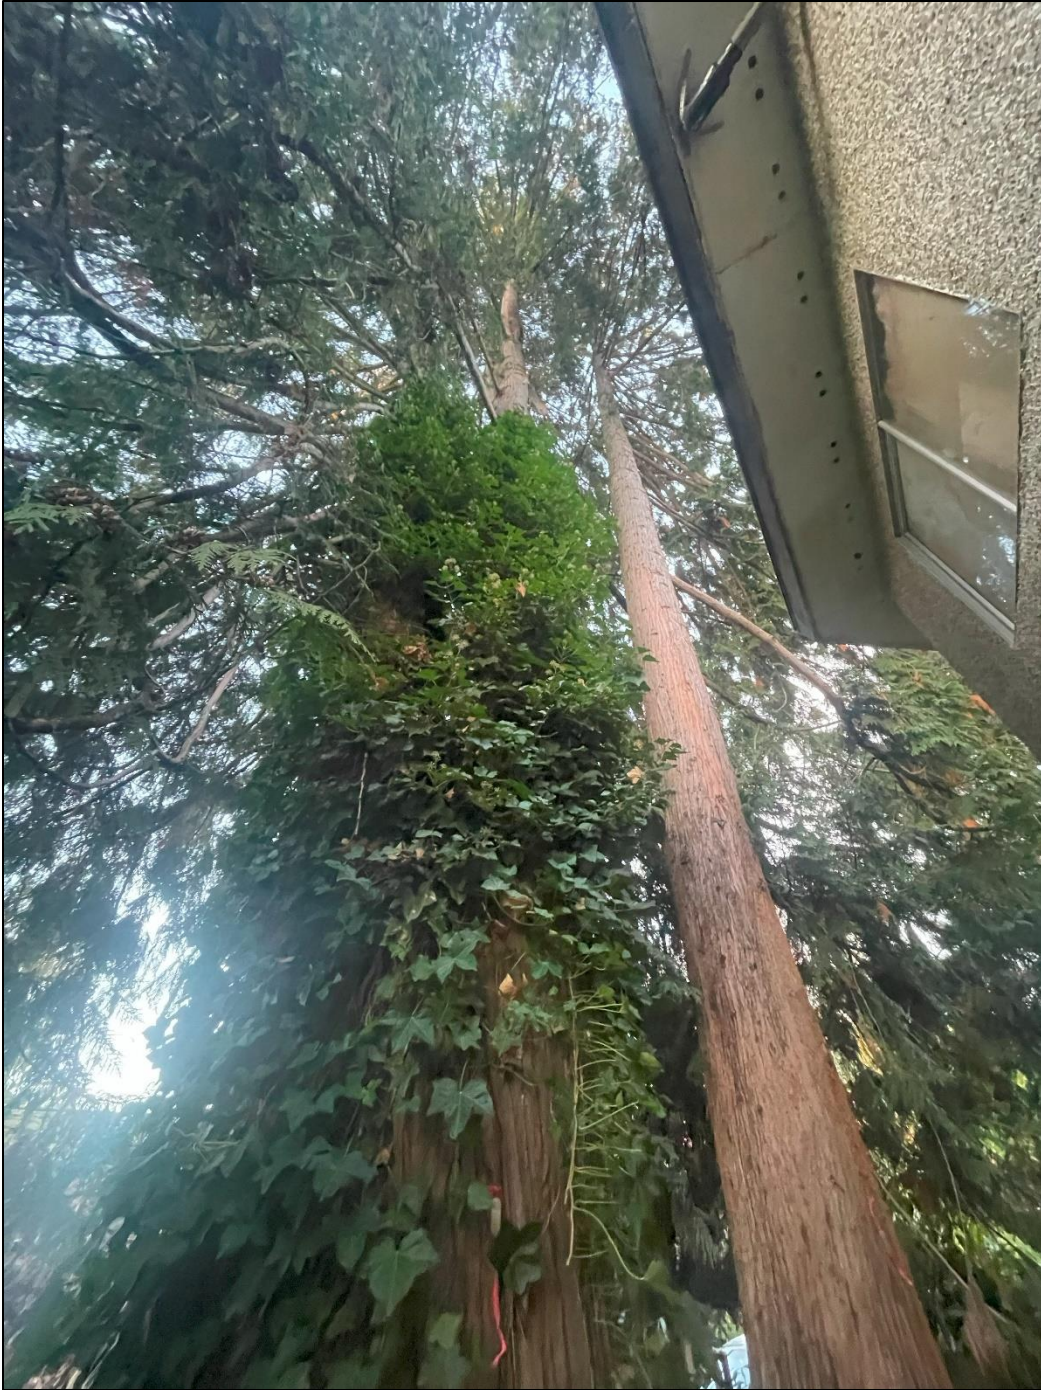
*Photo 2. Tree #s 466 and 467, non-viable.*

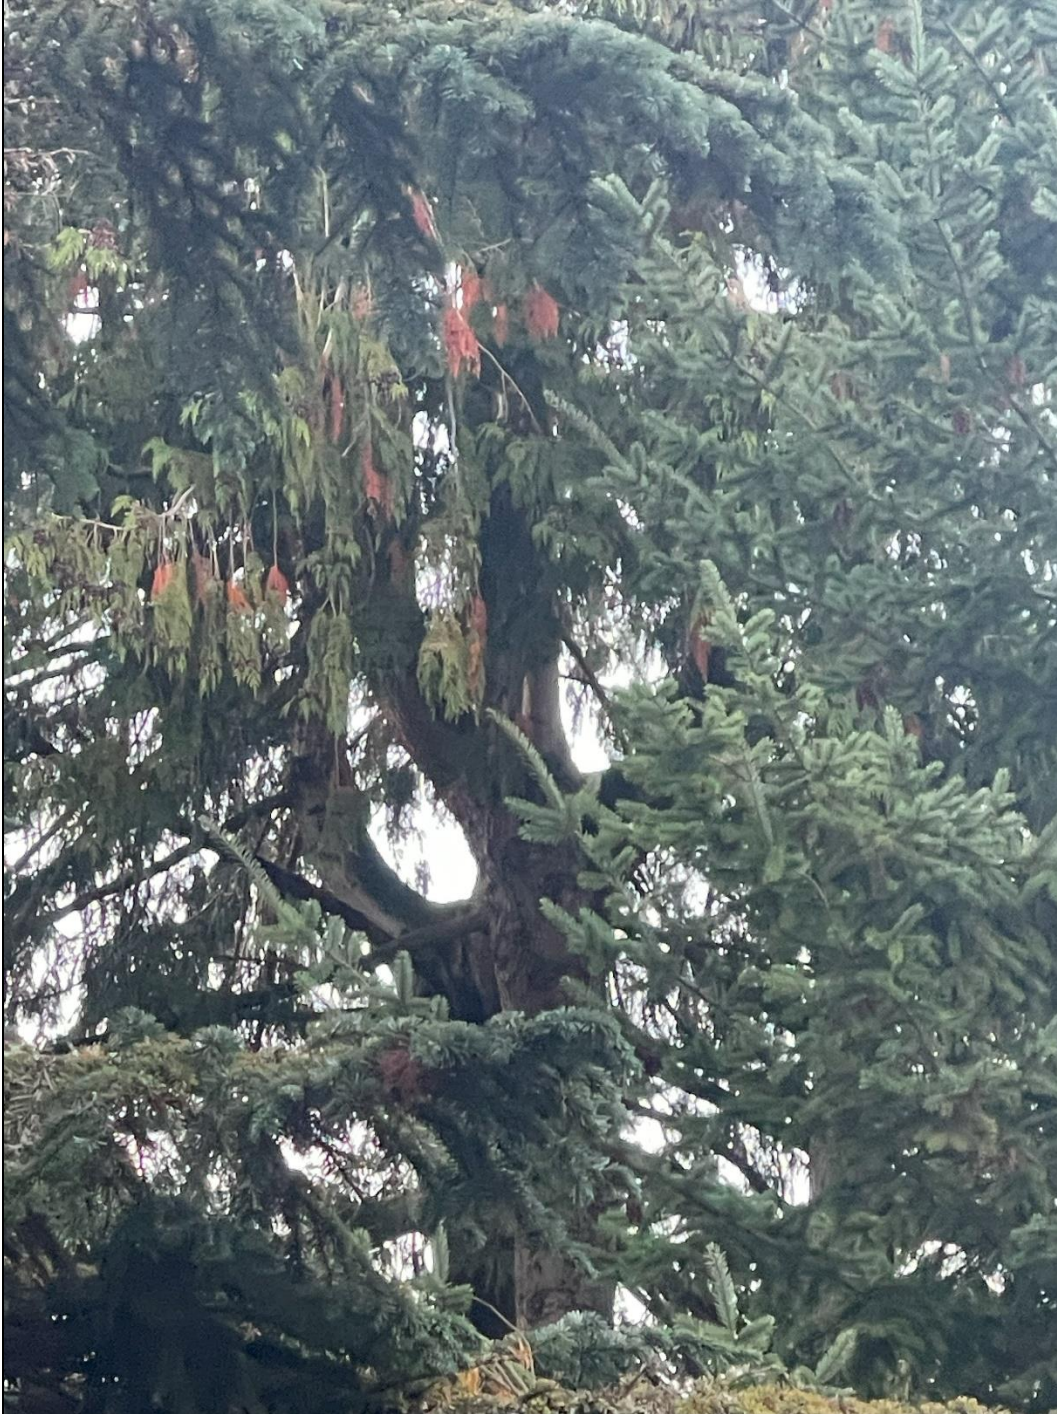
*Photo 3. Top of Tree #467, non-viable tree with multiple tops and weak attachments.*
