December 22, 2021

Re: Arborist Assessment – 15th Avenue NE Sidewalk Project

The Watershed Company Reference Number: 181216.7

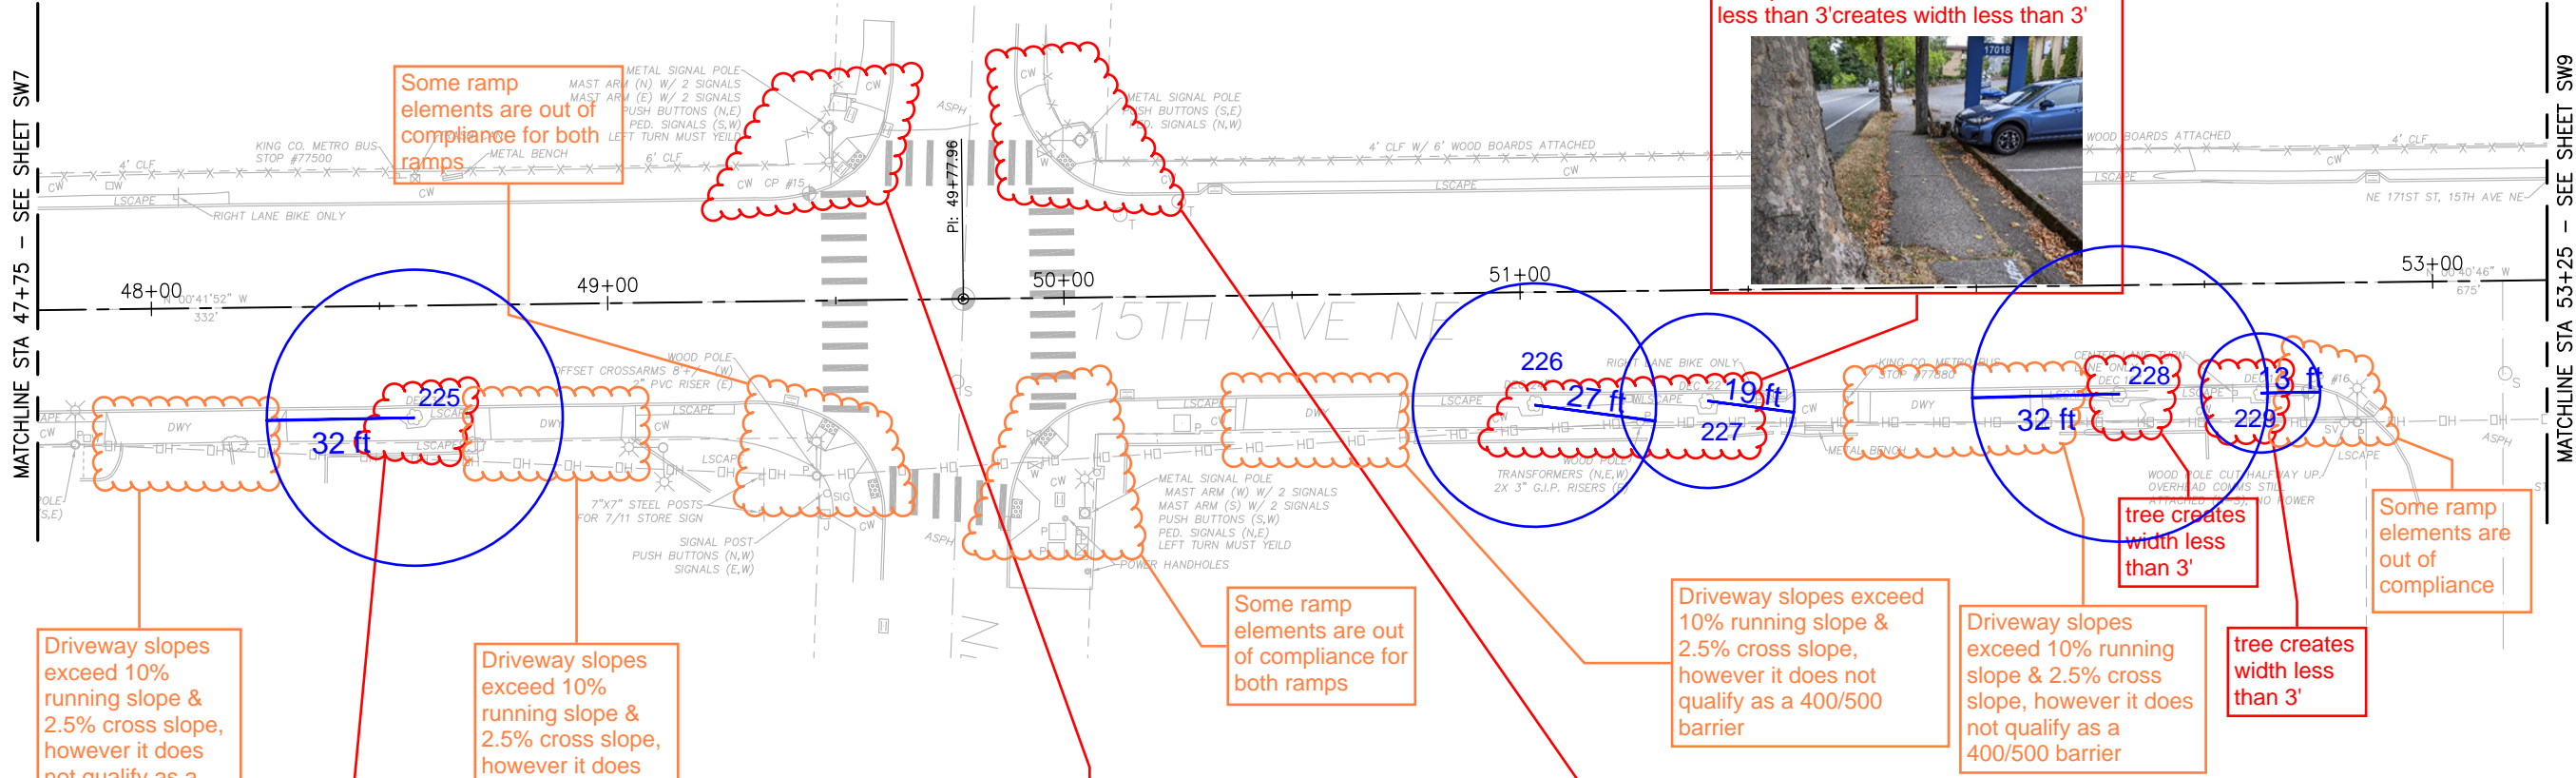
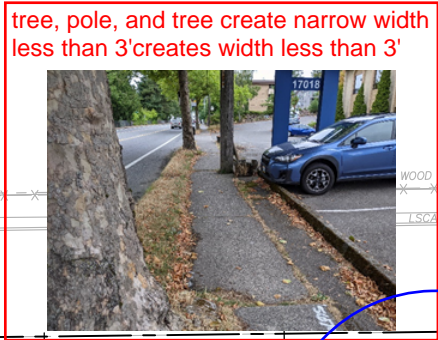
DRAWING NO. SW8
SHEET X OF SHEETS

tree, pole, and tree create narrow width less than 3' creates width less than 3'

Driveway slopes exceed 10% running slope & 2.5% cross slope, however it does not qualify as a 400/500 barrier

Some ramp elements are out of compliance for both ramps

tree creates width less than 3'

Some ramp elements are out of compliance

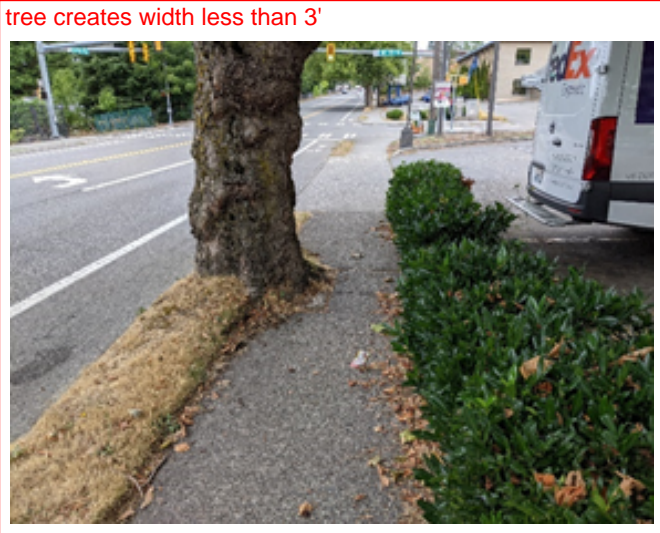
tree creates width less than 3'

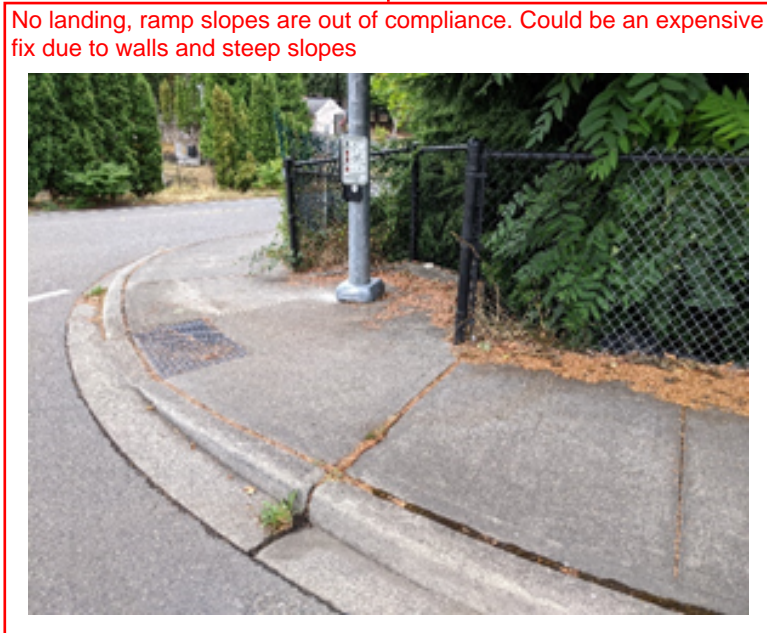
No landing, ramp slopes are out of compliance. Could be an expensive fix due to walls and steep slopes

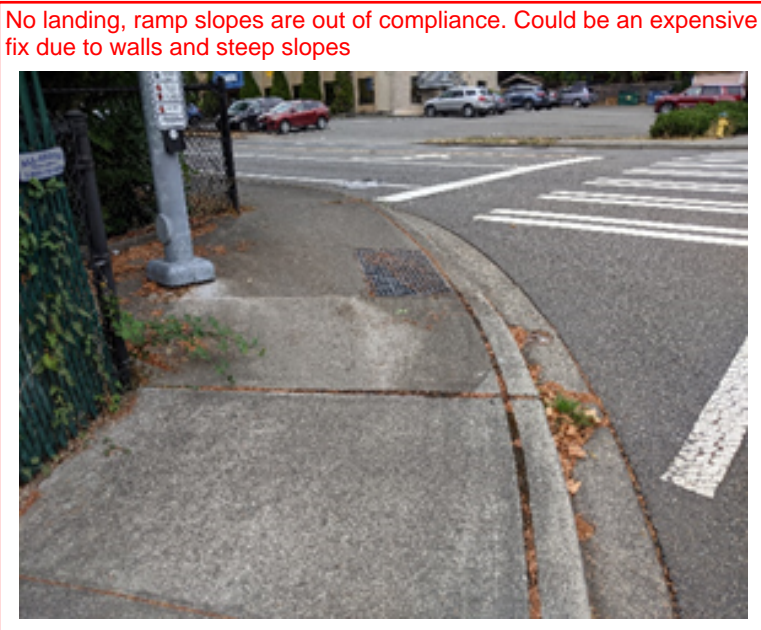
No landing, ramp slopes are out of compliance. Could be an expensive fix due to walls and steep slopes
