# SEDIMENT MONITORING PLAN

## HIDDEN LAKE

Prepared by  
Herrera Environmental Consultants, Inc.

**December 7, 2016**

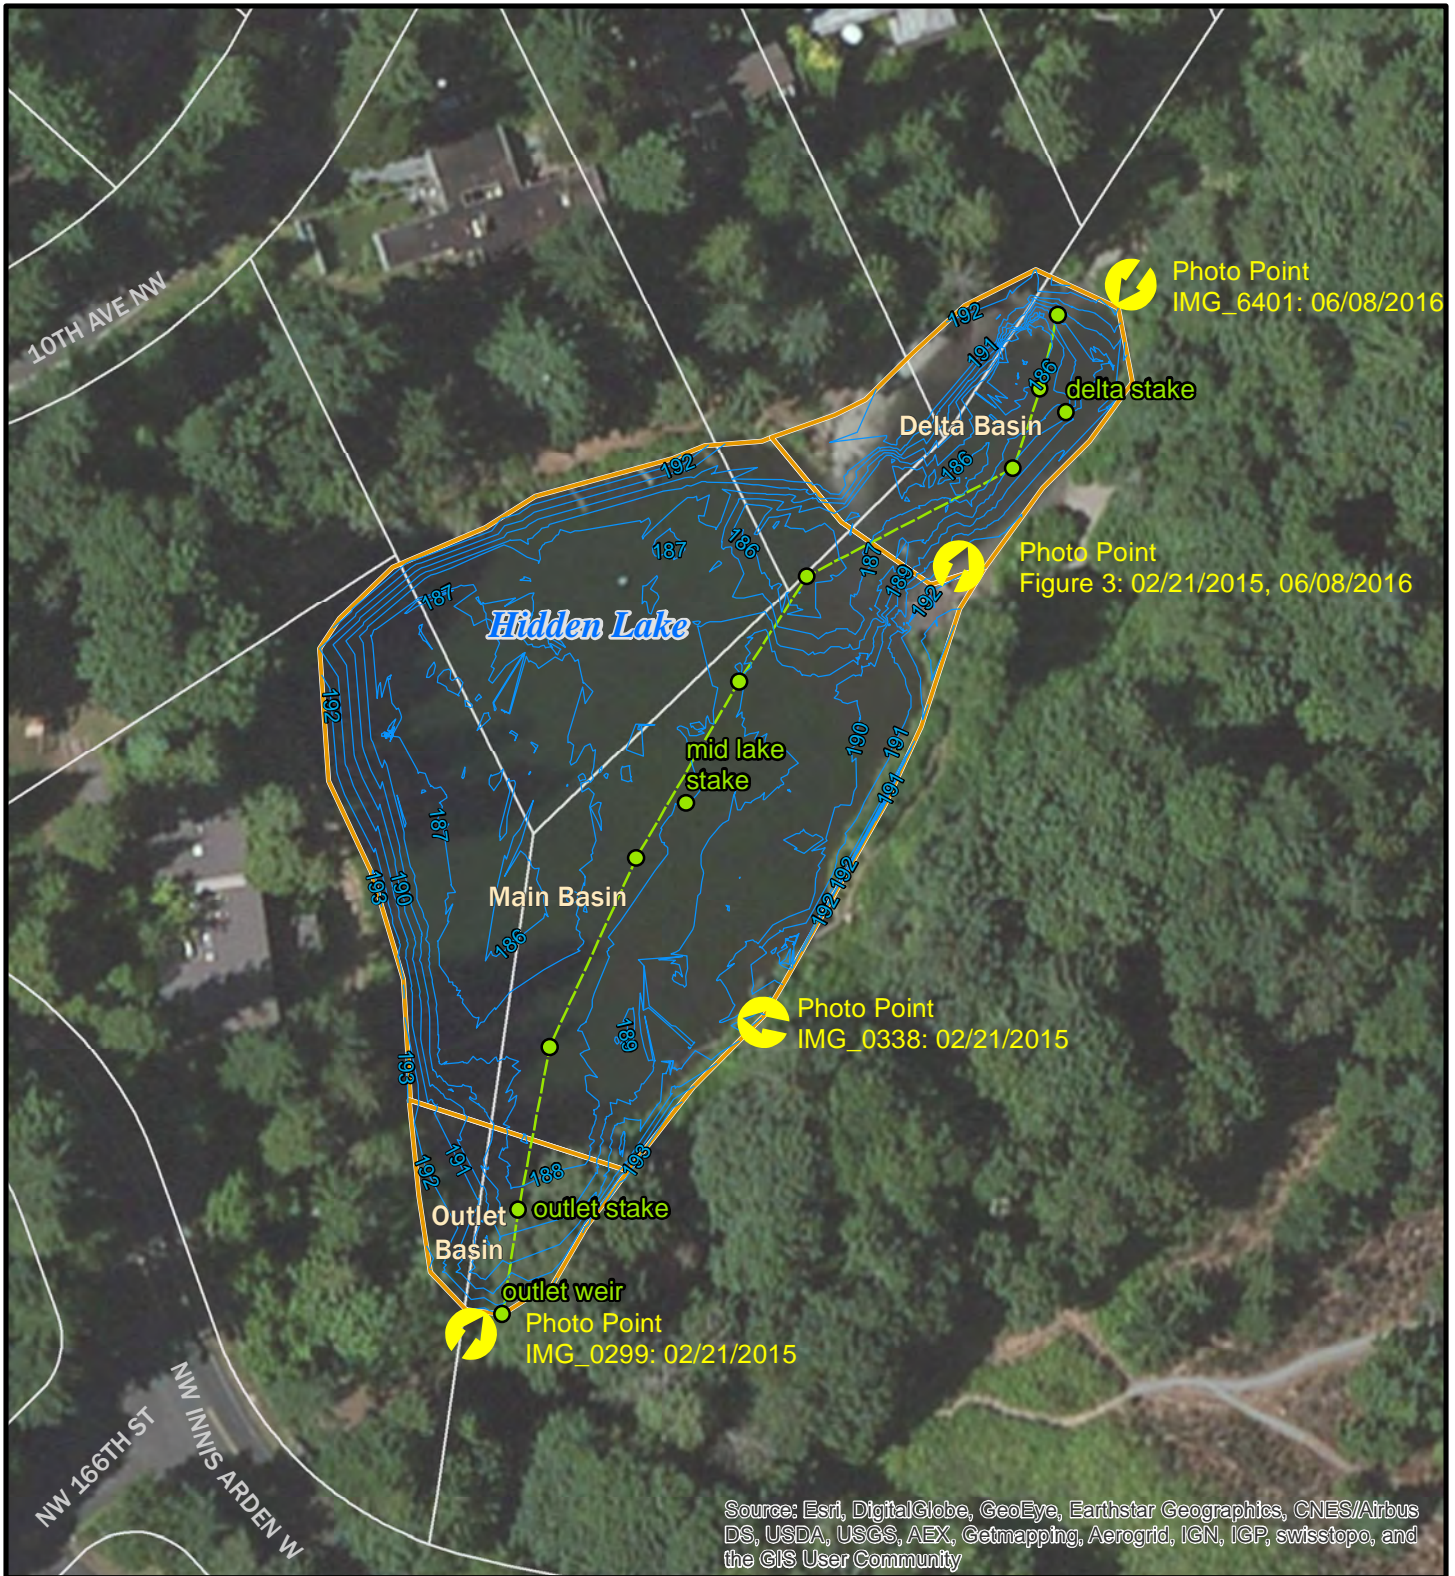
**Figure 2.**  
Sediment Monitoring Points and Profile,  
Hidden Lake, Shoreline, Washington..

The lake can be divided broadly into three areas: a creek delta at the upstream (north) end, the main body of the lake, and the outlet area at the downstream (south) end (Figure 2). Each of these parts of the lake should be monitored as the physical conditions within each are distinct.

As of October 2015, the delta area had a water (and sediment) storage capacity of approximately 1,500 cubic yards below the lake outlet structure elevation with an average depth of 6 feet at the center and about 3 feet on the edges (based upon bathymetric survey data collected for project analysis and preliminary design purposes). The main part of the lake had a total water storage capacity of approximately 7,000 cubic yards in October 2015 with an average depth of 6 feet in the center of the lake and 3 feet on the edges. The lake outlet area is quite small at fewer than 200 cubic yards of water storage capacity, but the bathymetry here is more complicated due to the presence of the outlet structure.

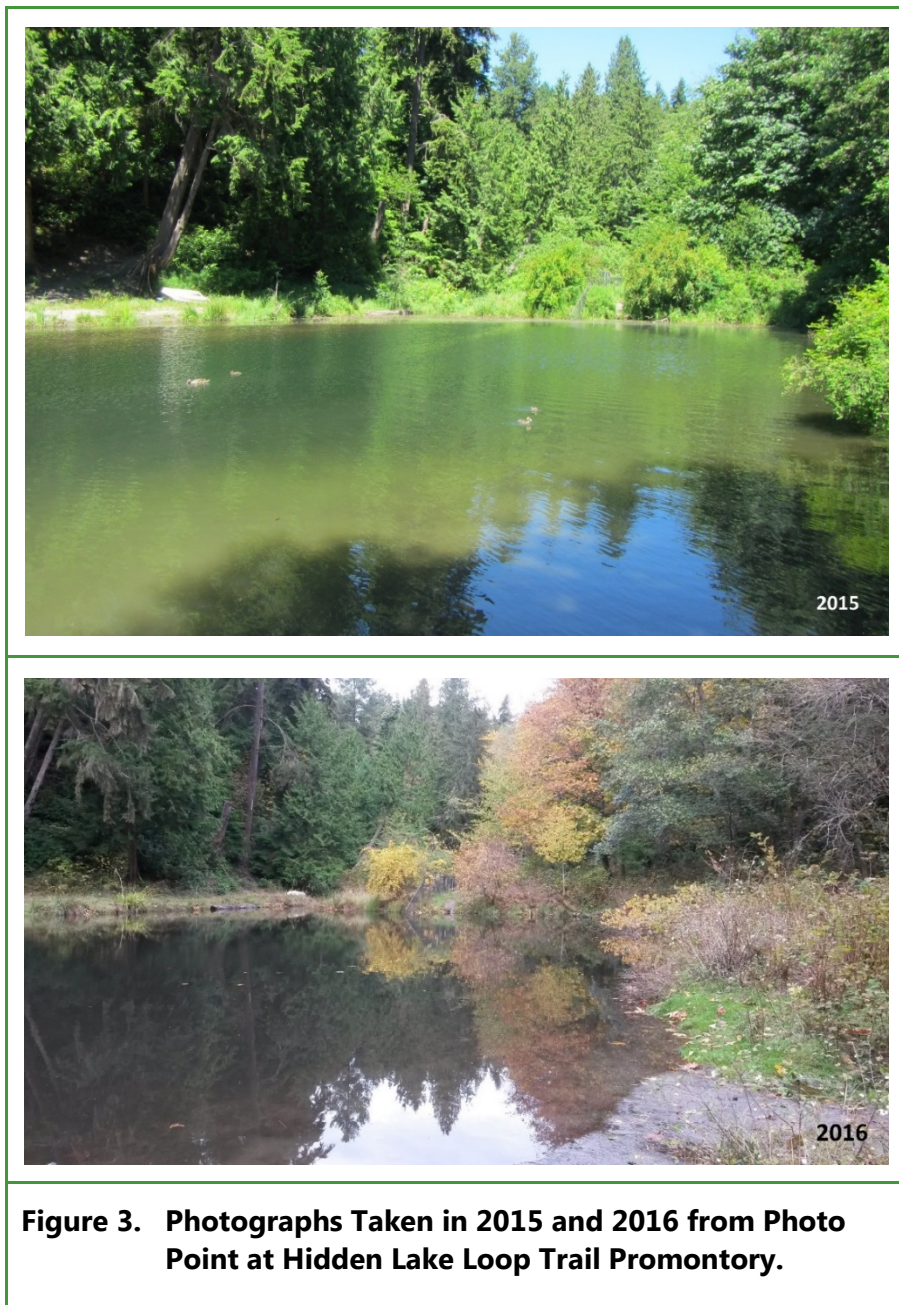
**Figure 3. Photographs Taken in 2015 and 2016 from Photo Point at Hidden Lake Loop Trail Promontory.**

To complement the numerical data obtained via water depth measurements at the monitoring stakes, photographs should be obtained at key locations to monitor overall changes in the lake. "Photo points" with the same direction of view in each photograph, taken over time, should be established. One key photo point location is on the dam at the lake outlet structure. Another is at a distinct promontory looking at the fence near the boundary between the delta and main areas of the lake along the Hidden Lake Loop Trail in Shoreview Park. A time series has already begun to be collected by Herrera at the loop trail promontory and is shown in Figure 3. As can

be seen in these photos, the shoreline advanced several feet between June 2015 and October 2016. Herrera has photographs of other locations, including the City maintenance access point near the outlet structure, and those photographs are available upon request.

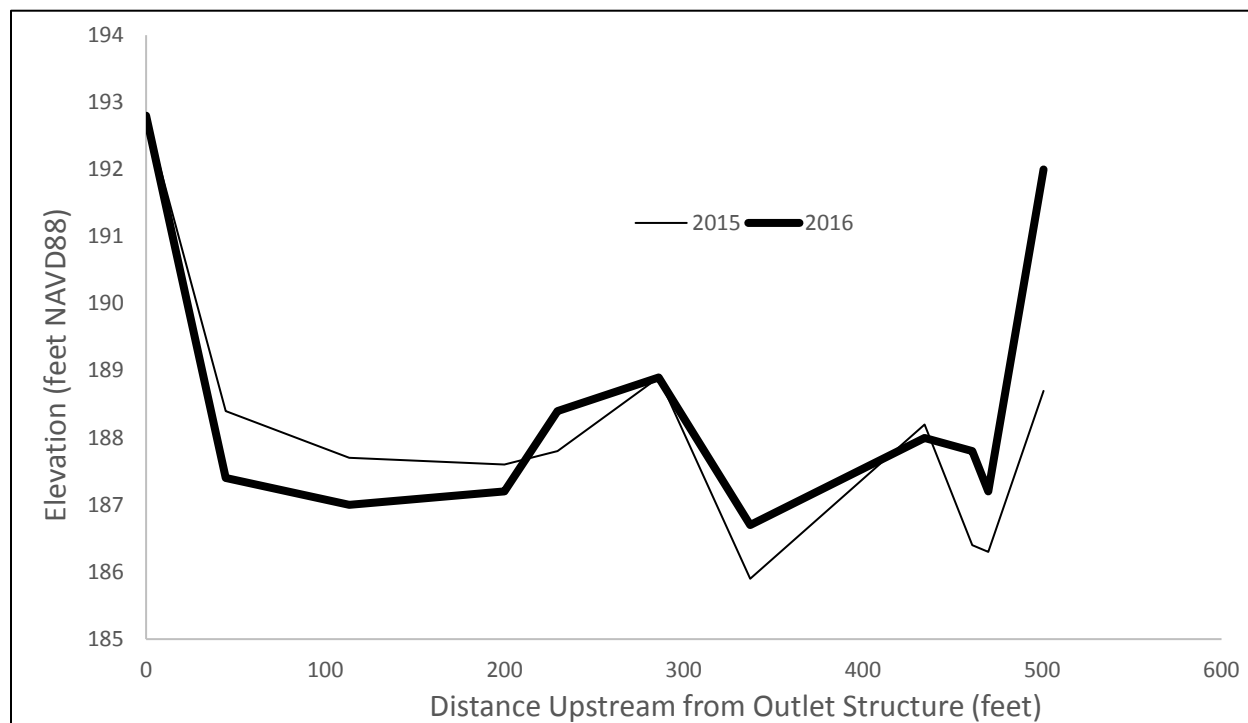
**Figure 4. Lake Bed Elevation Profile Comparison between 2015 and 2016.**

Following installation of monitoring stakes in the lake on October 21, 2016, it was possible to compare the lake bed elevation at each of the stake locations with lake bed bathymetric survey collected in June 2015. To complement the measurements at the stakes, depth measurements were taken approximately 50 feet apart between the stakes and at the outlet structure. The resultant comparison of lake bed elevation changes between summer 2015 and fall 2016 is shown in Figure 4. Care should be taken in direct comparisons of the data because the topographic survey measurements taken in 2015 were made with sonar (acoustic) equipment, while the sediment monitoring protocol involves penetration of a stadia rod to refusal in the lake bed. Near the lake outlet, where considerable silt and clay is deposited, the soft bed likely triggered higher bed elevation readings in the sonic measurements than those defined by pushing a stadia rod gently to refusal. However, as can be seen in the data plotted in Figure 4, up to several feet of sediment deposited near the delta front at the upstream end of the lake in the 16 months from June 2015 to October 2016. Given the remaining storage volume in the lake, and evidence of sediment accumulation since summer 2015, it appears that forecasting complete filling of the lake with sediment in the time frame of 2020 to 2025 remains accurate.

**Note: The outlet elevation is 192.6, with a water surface elevation on of 193.0 on the stake installation and initial monitoring visit.**
