## **ADMINISTRATIVE ORDER#000110-081909**

### **SITE SPECIFIC CODE INTERPRETATION TC 16, TC 17 AND TC18**

#### **CODE SECTION: 20.80.460 and 20.80.470 Streams**

Hamlin Park Drainages Investigation  
February 15 and 22, 2009

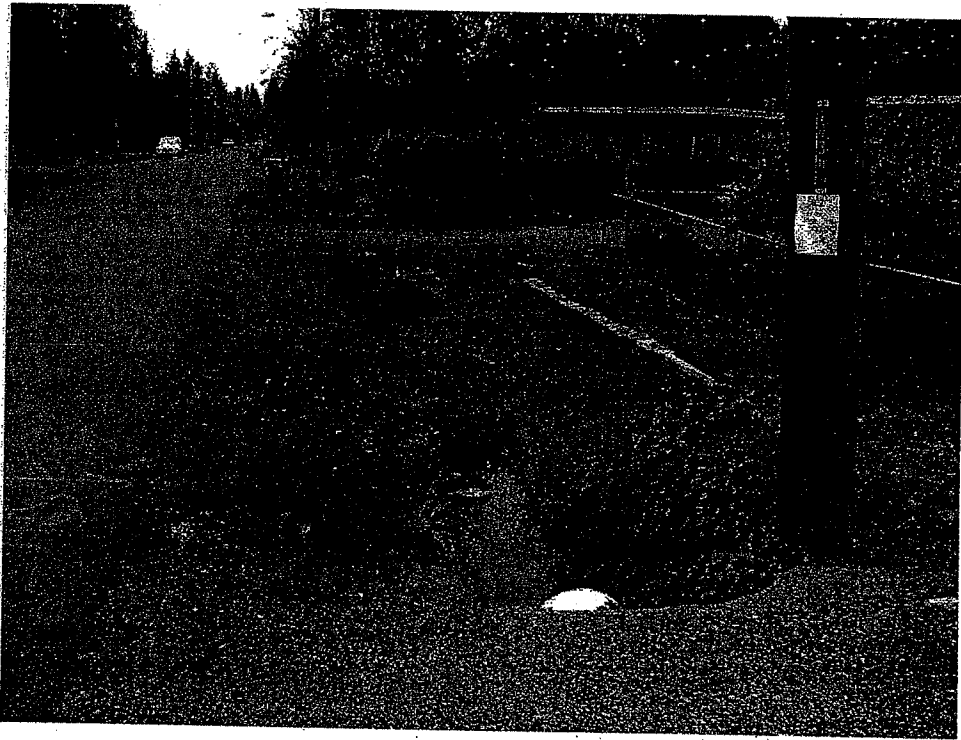
Figure 4. Ditched Hamlin Creek channel along the west side of 20th Avenue NE, downstream of the Fircrest Campus (Taken on 9/17/08).

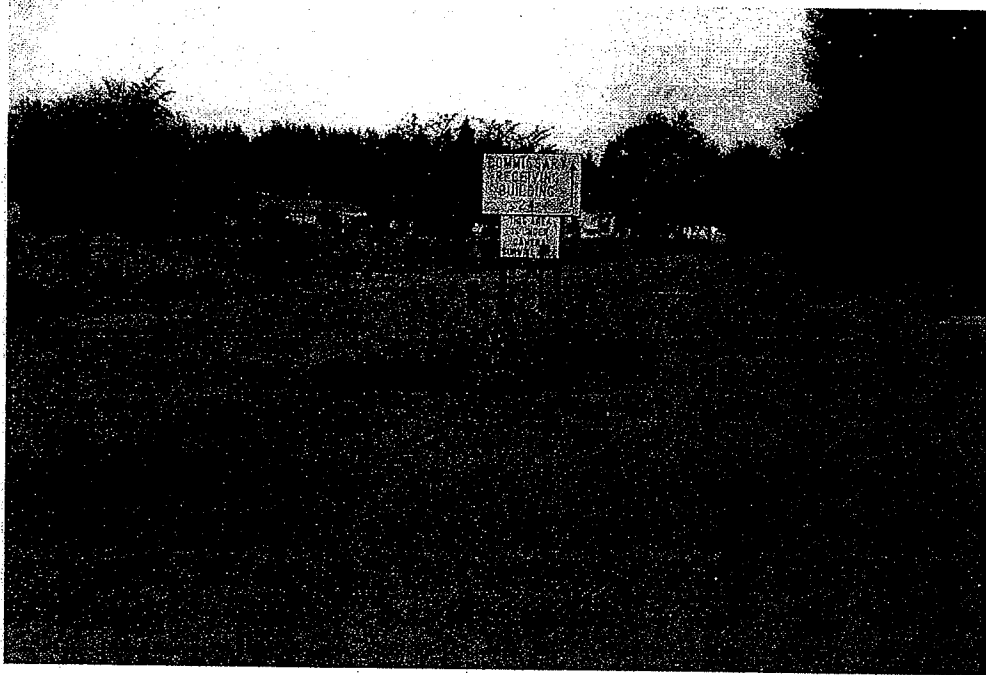
Figure 7. Hamlin Creek Area A stream daylighting area, facing North from near NE 150th Street. Catch basin in foreground locates the confluence of the east and west forks, both of which are currently piped at this location (taken on 9/17/08).

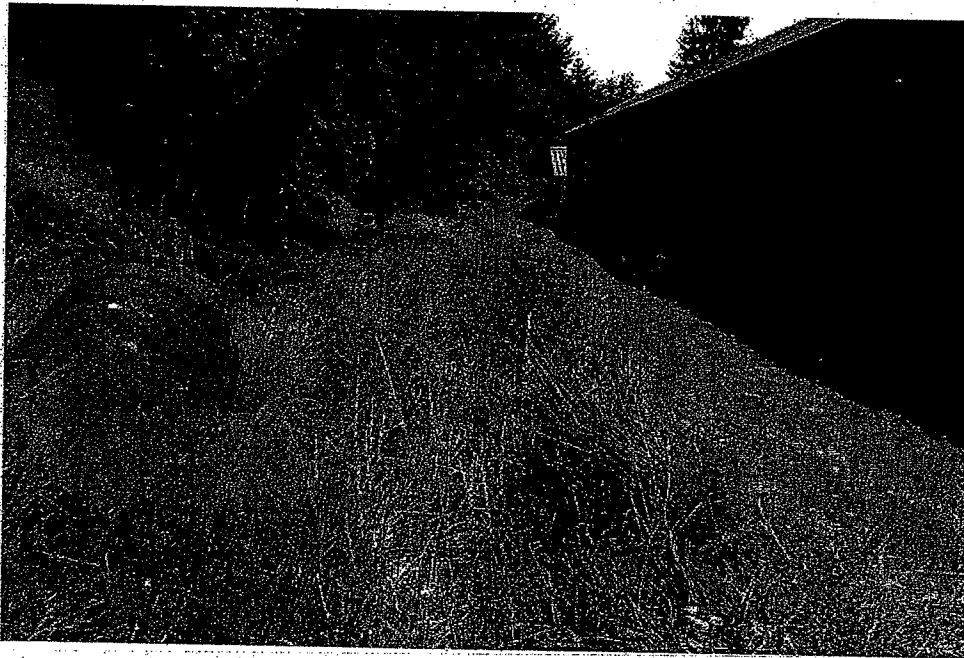
Figure 13. Area B facing downstream. Notice former pipe sections, now removed, and the close proximity of the existing buildings (taken on 8/4/08).

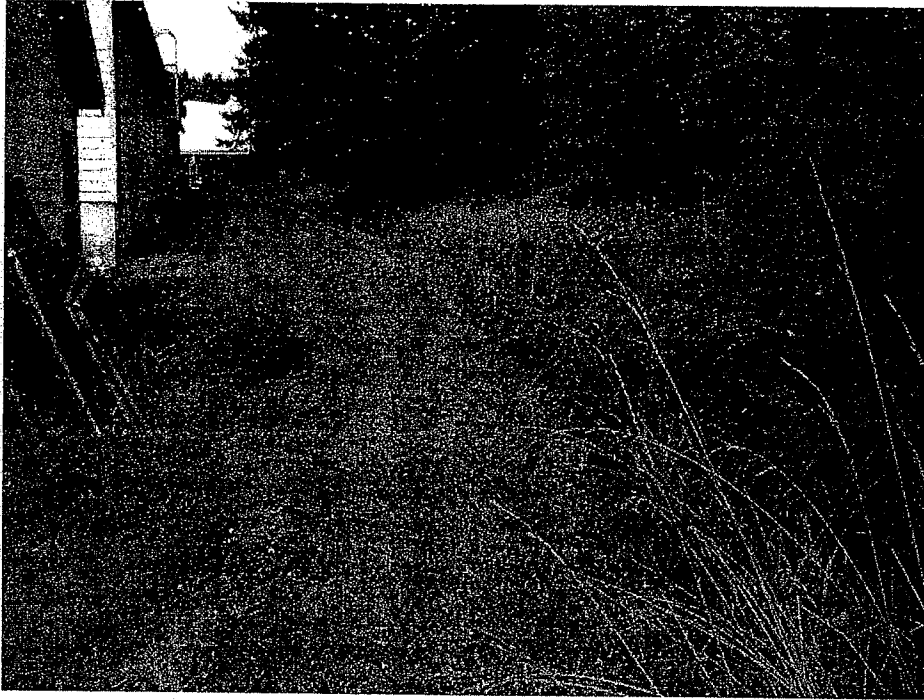
Figure 14. Area B facing upstream. The existing channel is an abrupt, grass-lined ditch. Again, notice the close proximity of the existing buildings (taken on 9/17/08).

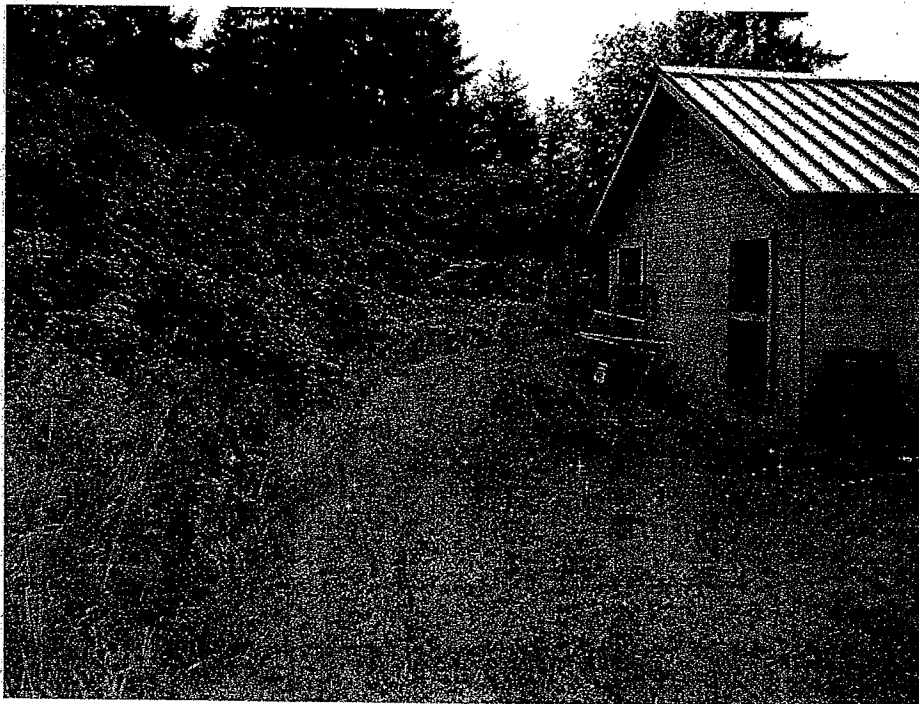
Figure 15. Area B facing downstream near lower end. Note slope vegetated with invasive Himalayan blackberry and morning glory (taken on 9/17/08).

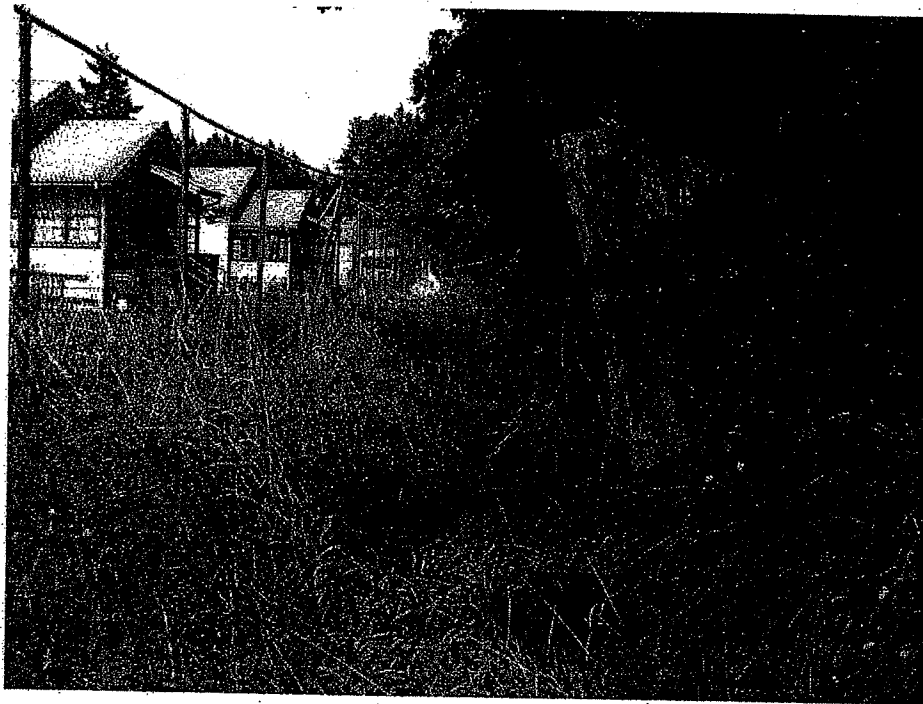
Figure 16. Area C facing upstream from near lower end. Little space is available for enhancement between the forested slope to the east (right) and the road and buildings to the west (taken on 9/17/08).

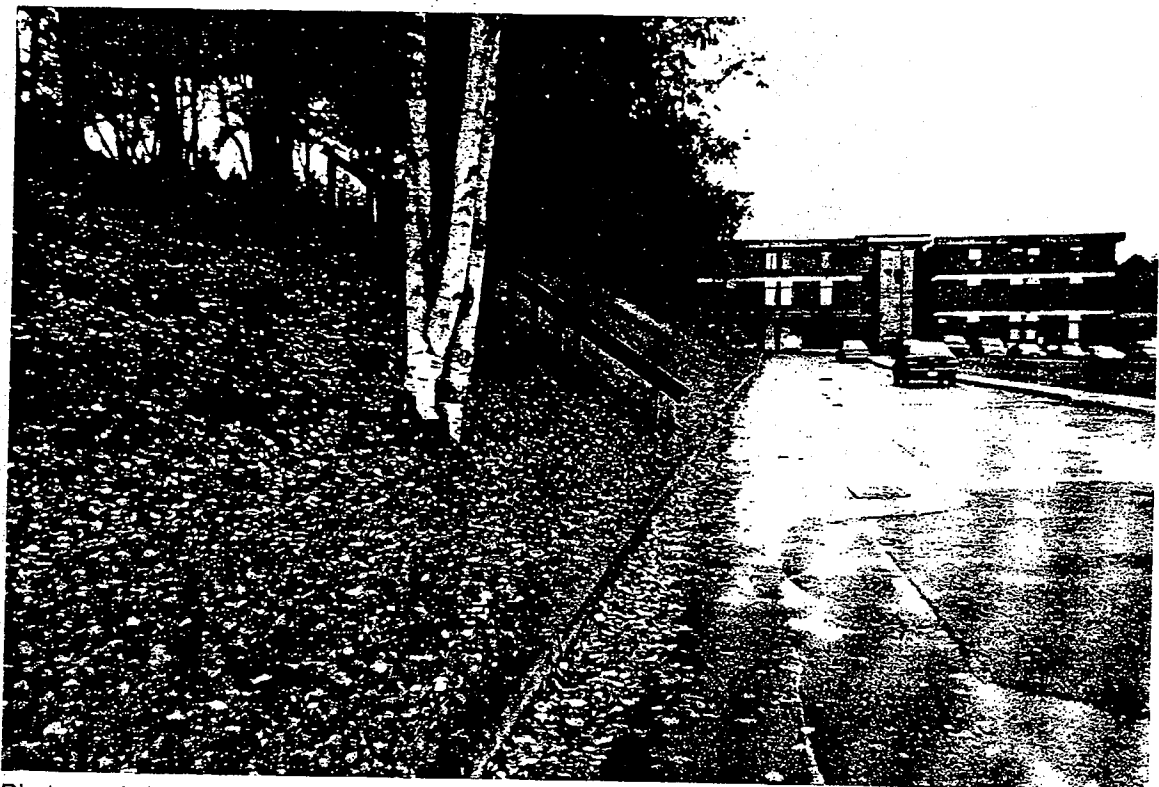
Photograph 2. Steep slope along the eastern side of the ridge at the western side of the site. The view is northeast toward Building 200 from the southern end of the ridge. The slope is up to 40 percent and ranges up to 20 feet, north of Building 200 in the mid-ground. The slope was cut during site development.

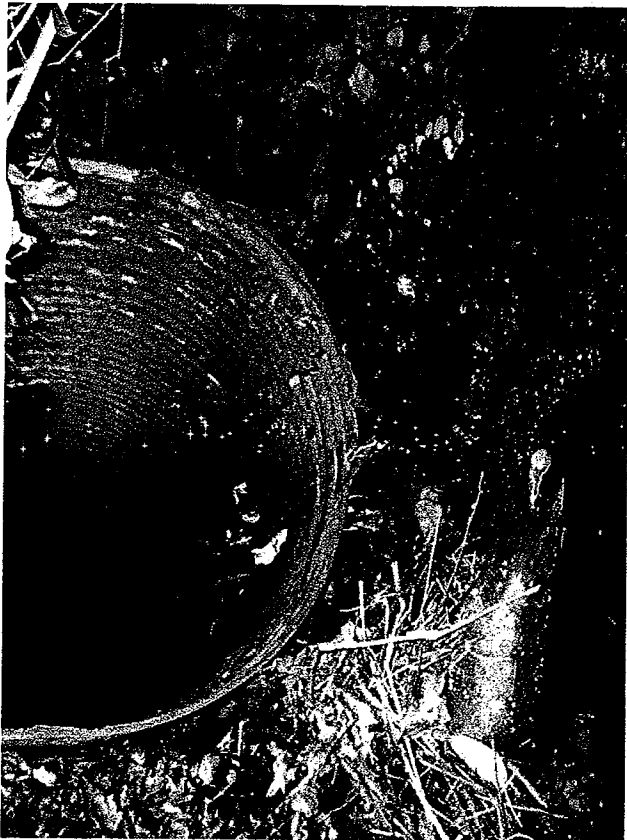
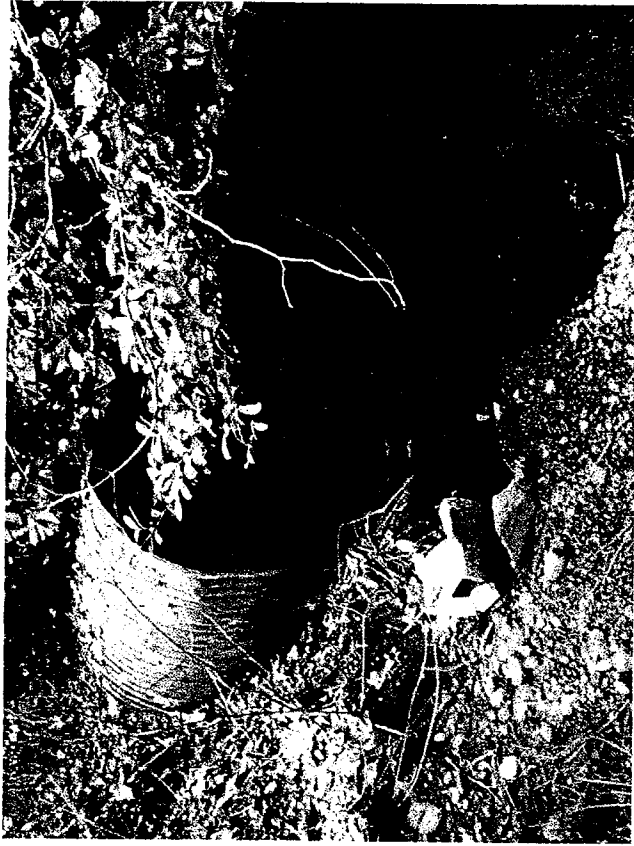
Hamlin Park drainages outfall into Thornton Creek (2-15-09)
