LAYTON TREE CONSULTING, LLC

**TREE INVENTORY & ASSESSMENT
NE 145th Street and 1st Avenue NE Project
Shoreline, WA**

**Report Prepared for:
Shea Properties Management Company, Inc**

October 6, 2020

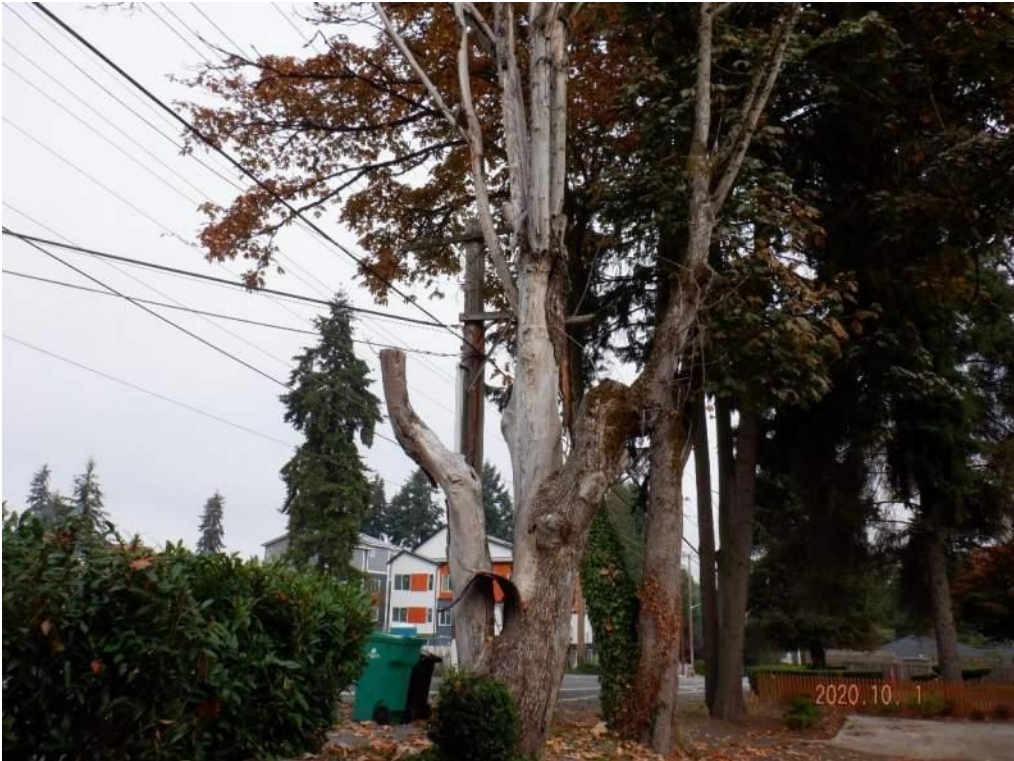
Seven dead trees were identified in the study area, as well as the survey dead birch snag (see Map 2). These include Trees #21, #47, #48, #51, #53, #60 and #63. Tree #21 was a semi-mature bigleaf maple. It has had significant issues for quite some time now, evidenced by the condition of the lower trunk. See picture below. This dead tree poses a risk to surrounding targets.

The removal of all of the identified dead trees (#21, #47, #48, #51, #53, #60 and #63) is recommended to abate any potentially hazardous conditions. Trees #21 and #51 pose an elevated risk and should be prioritized for removal. The owners of these properties should be made aware of these conditions.

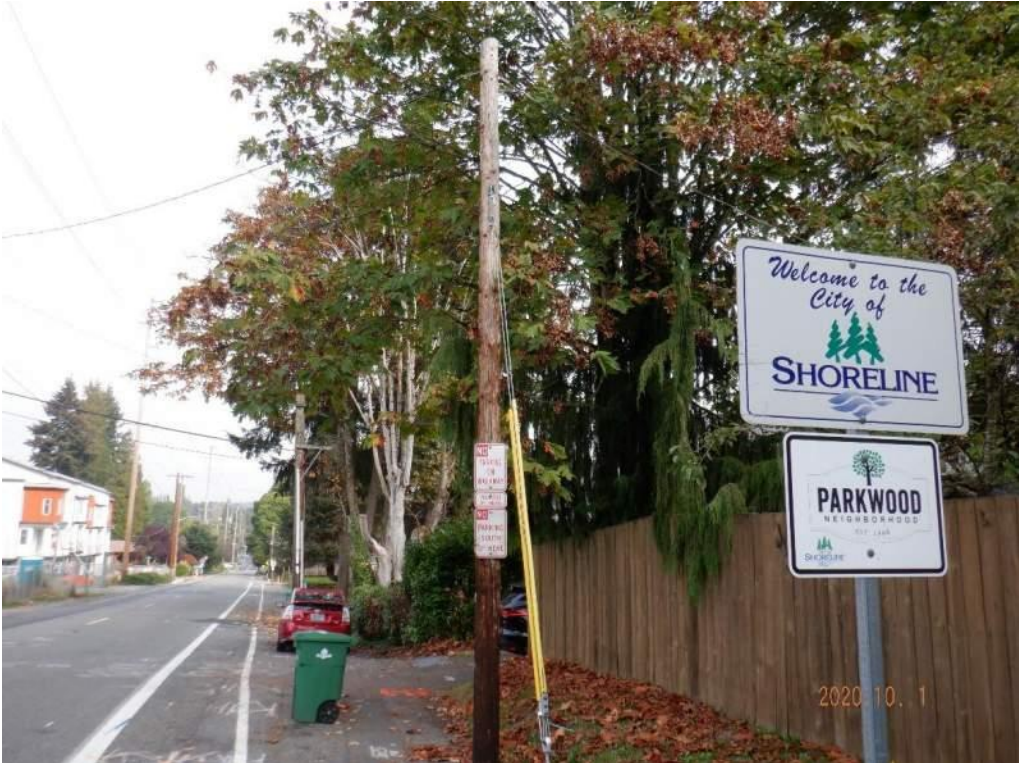
1st Ave NE looking north, Tree #21 in background

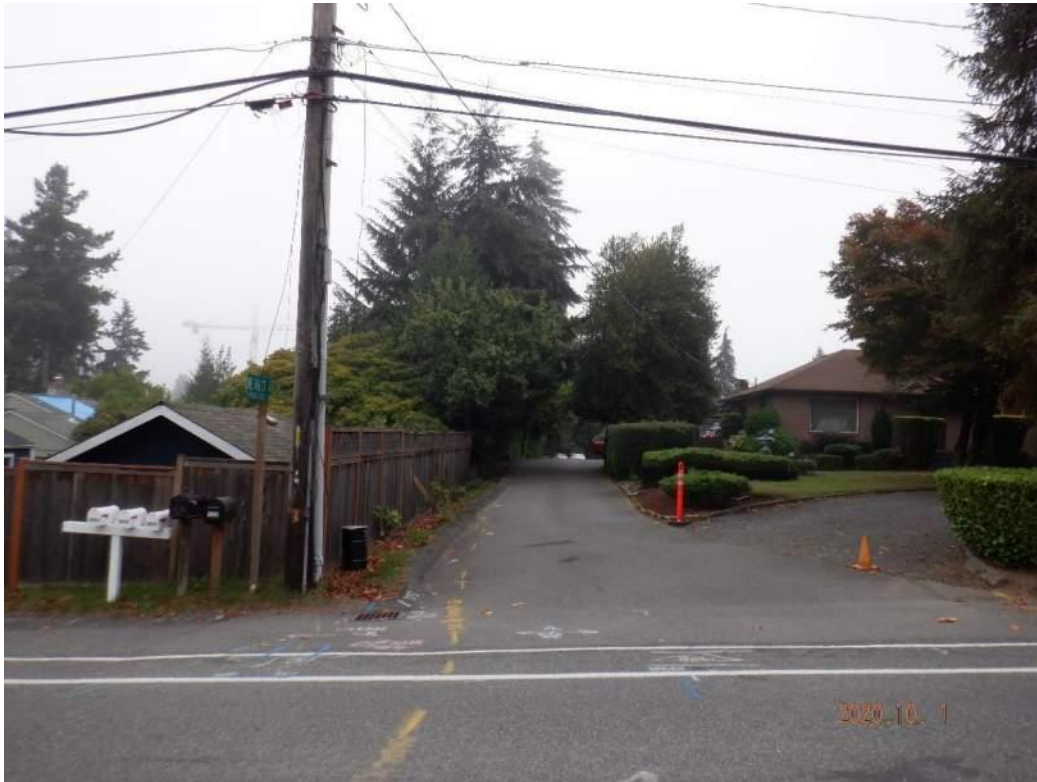
NE 146th CT, looking east from 1st AVE NE, Trees #5 > #12 in background

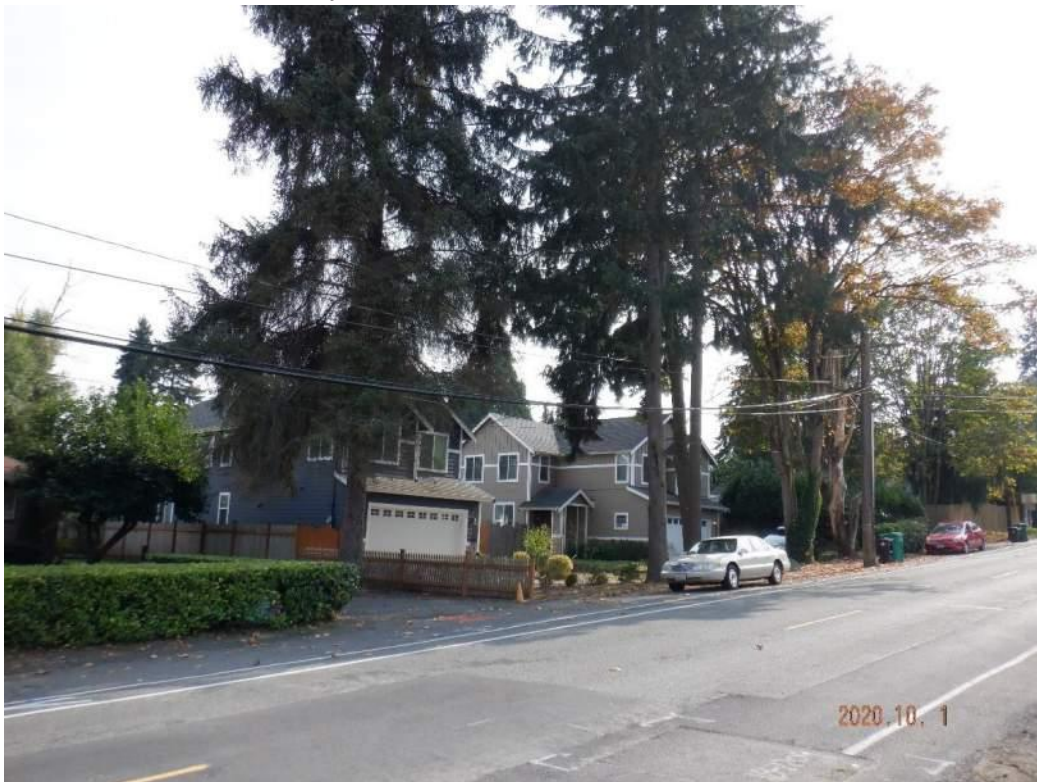
Trees #2 and #14 are semi-mature to mature Colorado spruce trees adjacent to 1st Avenue NE. Both have a major infestation of the Cooley spruce gall adelgid. This is evident by the numerous cone-like growths at the branch tips. Both trees are of good vigor despite the infestation. The damage caused by this pest is mostly aesthetic and not life-threatening. Tree #14 has large exposed surface roots within its dripline.

Trees #14 and #17 > #20 adjacent to 1st AVE NE

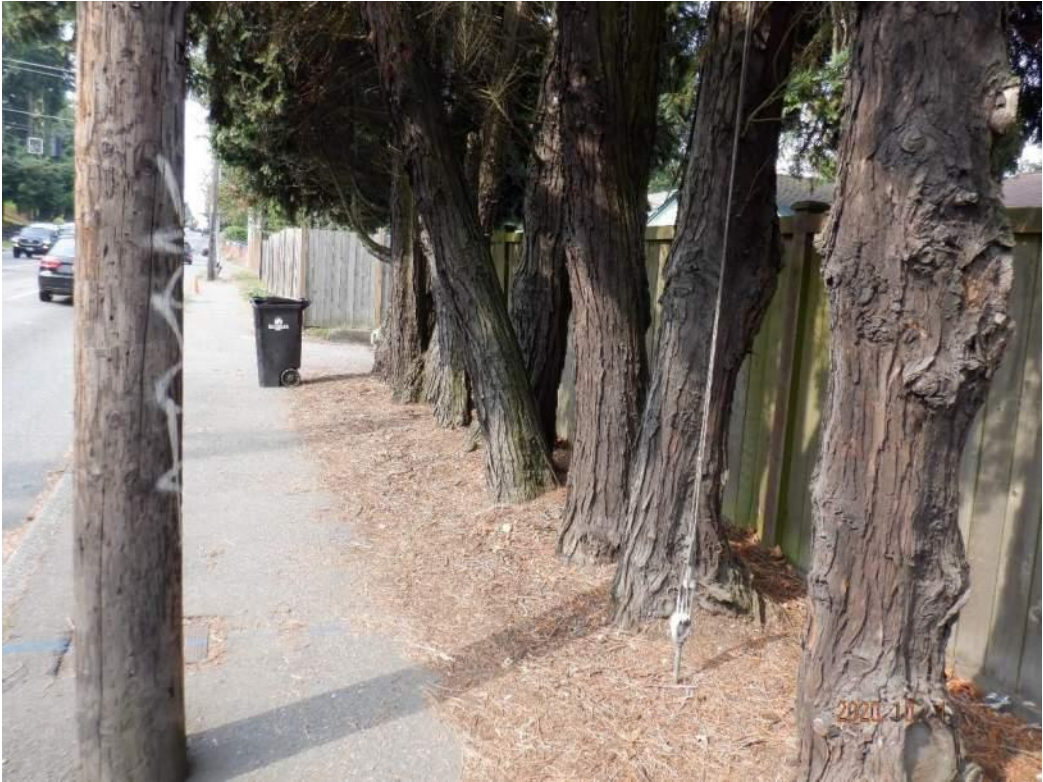
The semi-mature row of Lawson cypress in front of 114 – NE 145th Street is also showing signs of decline. Top foliage has recently died back. There is a good chance these trees will continue to gradually decline.

Row of Lawson cypress (Trees #35 > #42) in front of 114-NE 145th ST

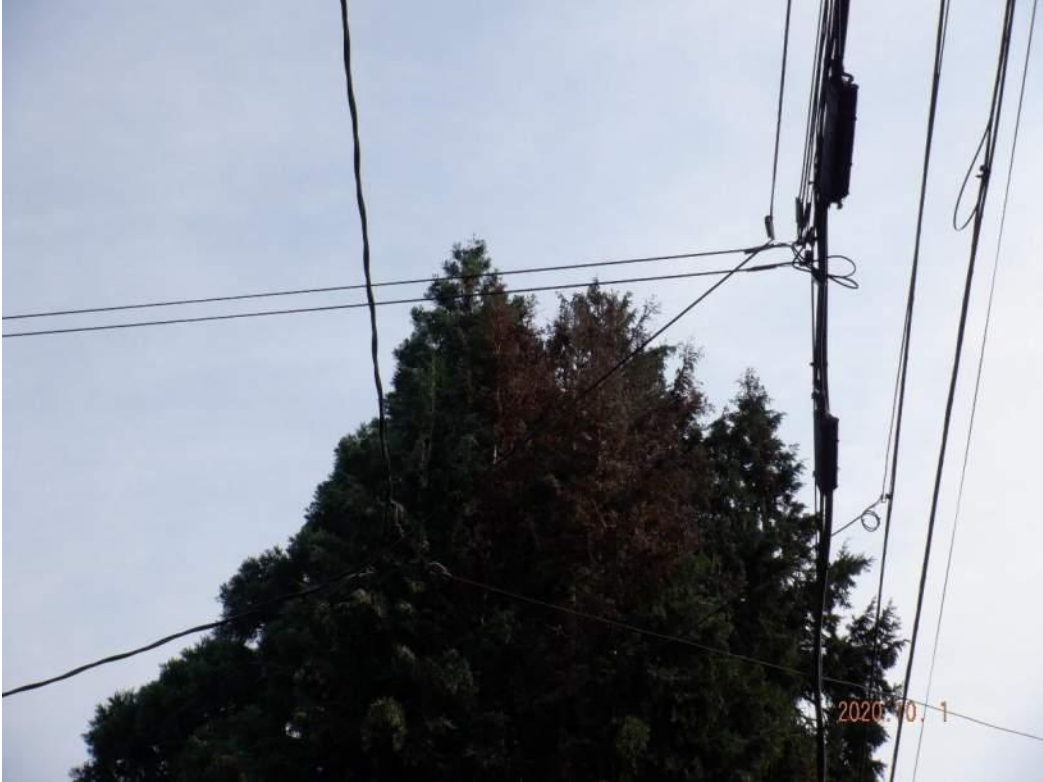
Top dieback/decline of trees pictured above

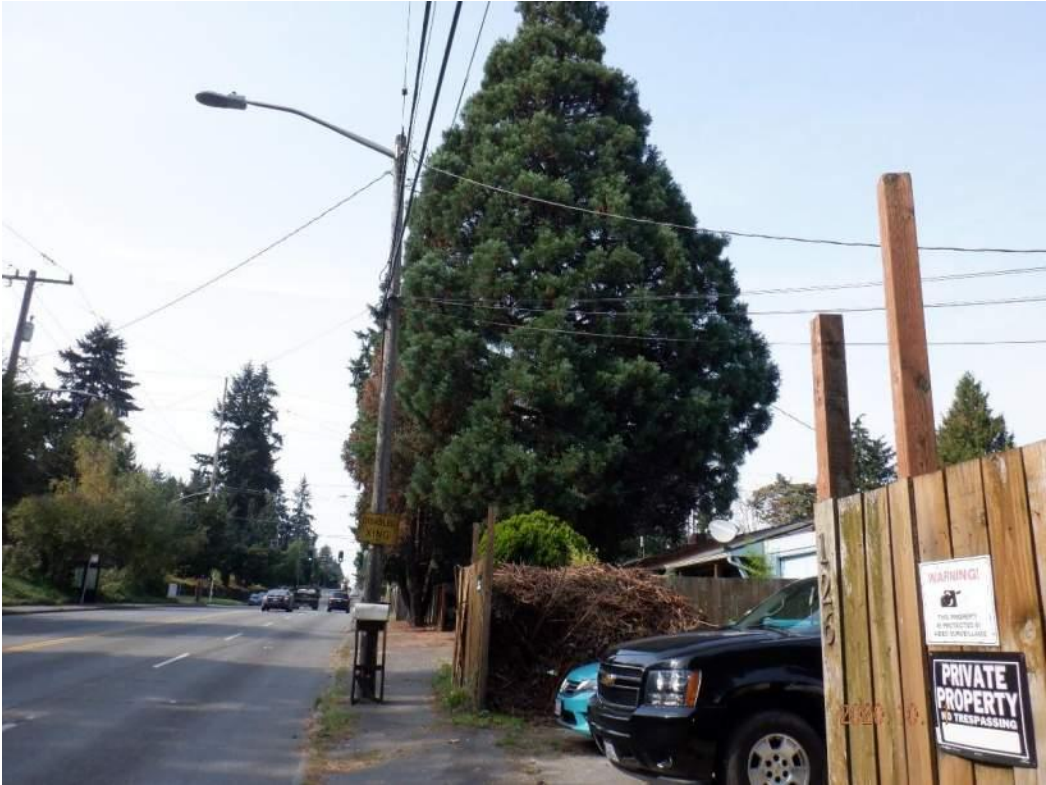
Tree #43 is a semi-mature to mature giant sequoia located in front of 122 - NE 145th Street. It has a massive root system that is lifting the adjacent concrete and asphalt. It is of good vigor and has sound structural form. Condition is rated as 'good'.

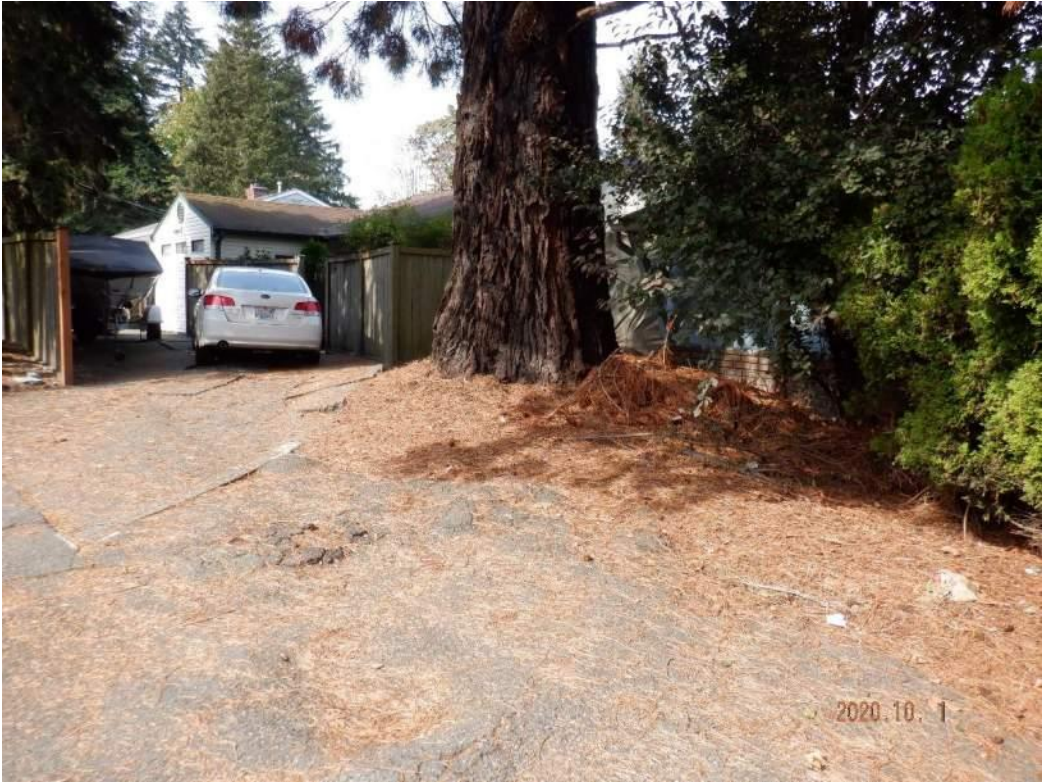
Tree #43 – lower trunk

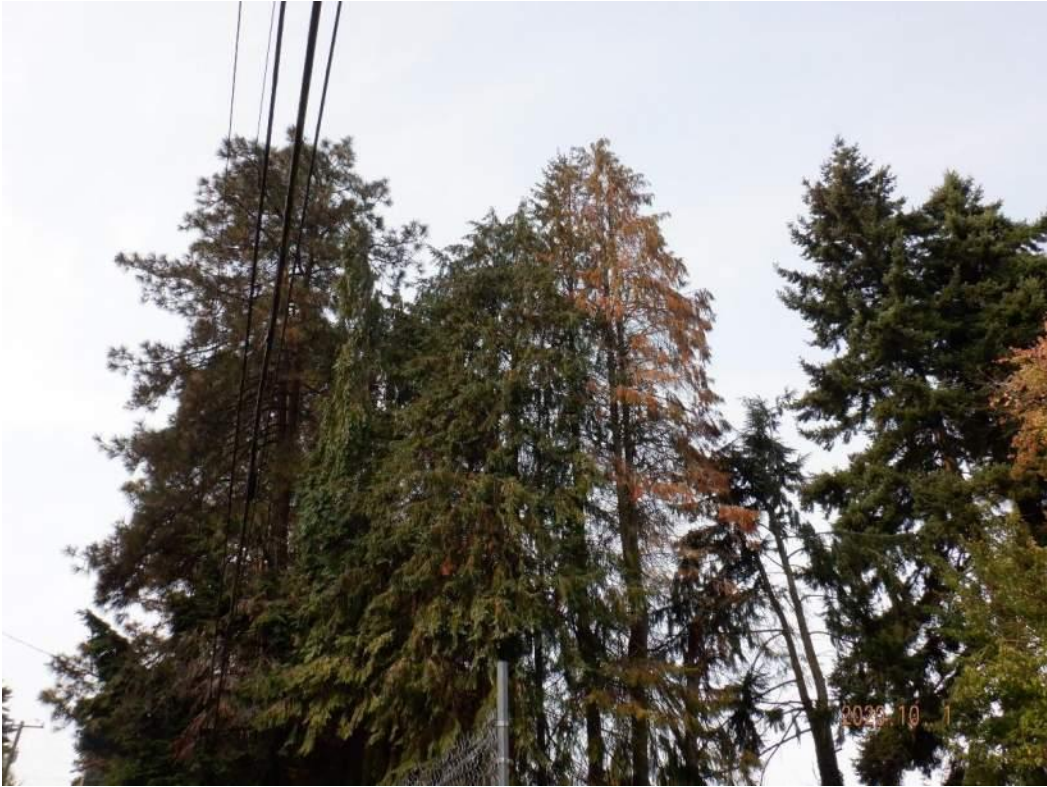
The other dead trees (#47, #48, #51, #53, #60 and #63) are all Lawson cypress. All are located in front of the property at 132 - NE 145th Street. Some have been dead for a year or more and others have recently

succumbed to mortality. The cause of decline and mortality is likely associated with a root disease and drought-stress.

Trees in front of 132 – NE 145th ST, declining Lawson cypress (center)

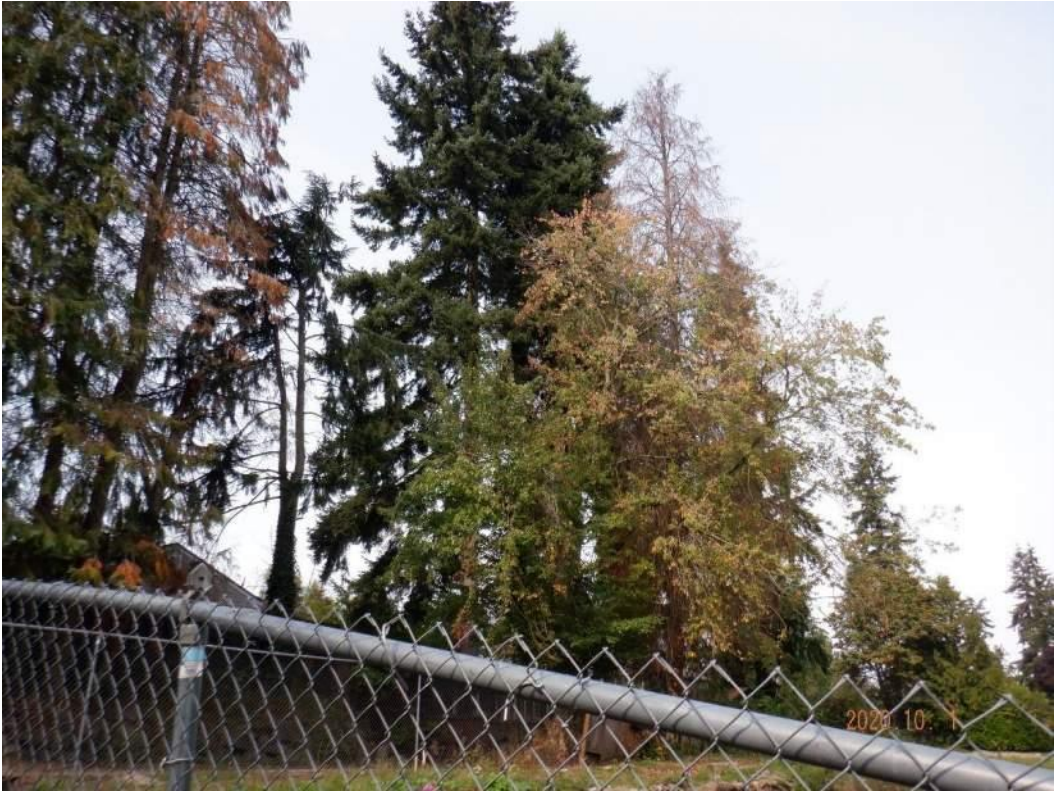
Recent dead Tree #63 (center-right)
