Storm Creek *Basin Plan*

March 2013

OSBORN
CONSULTING
INCORPORATED

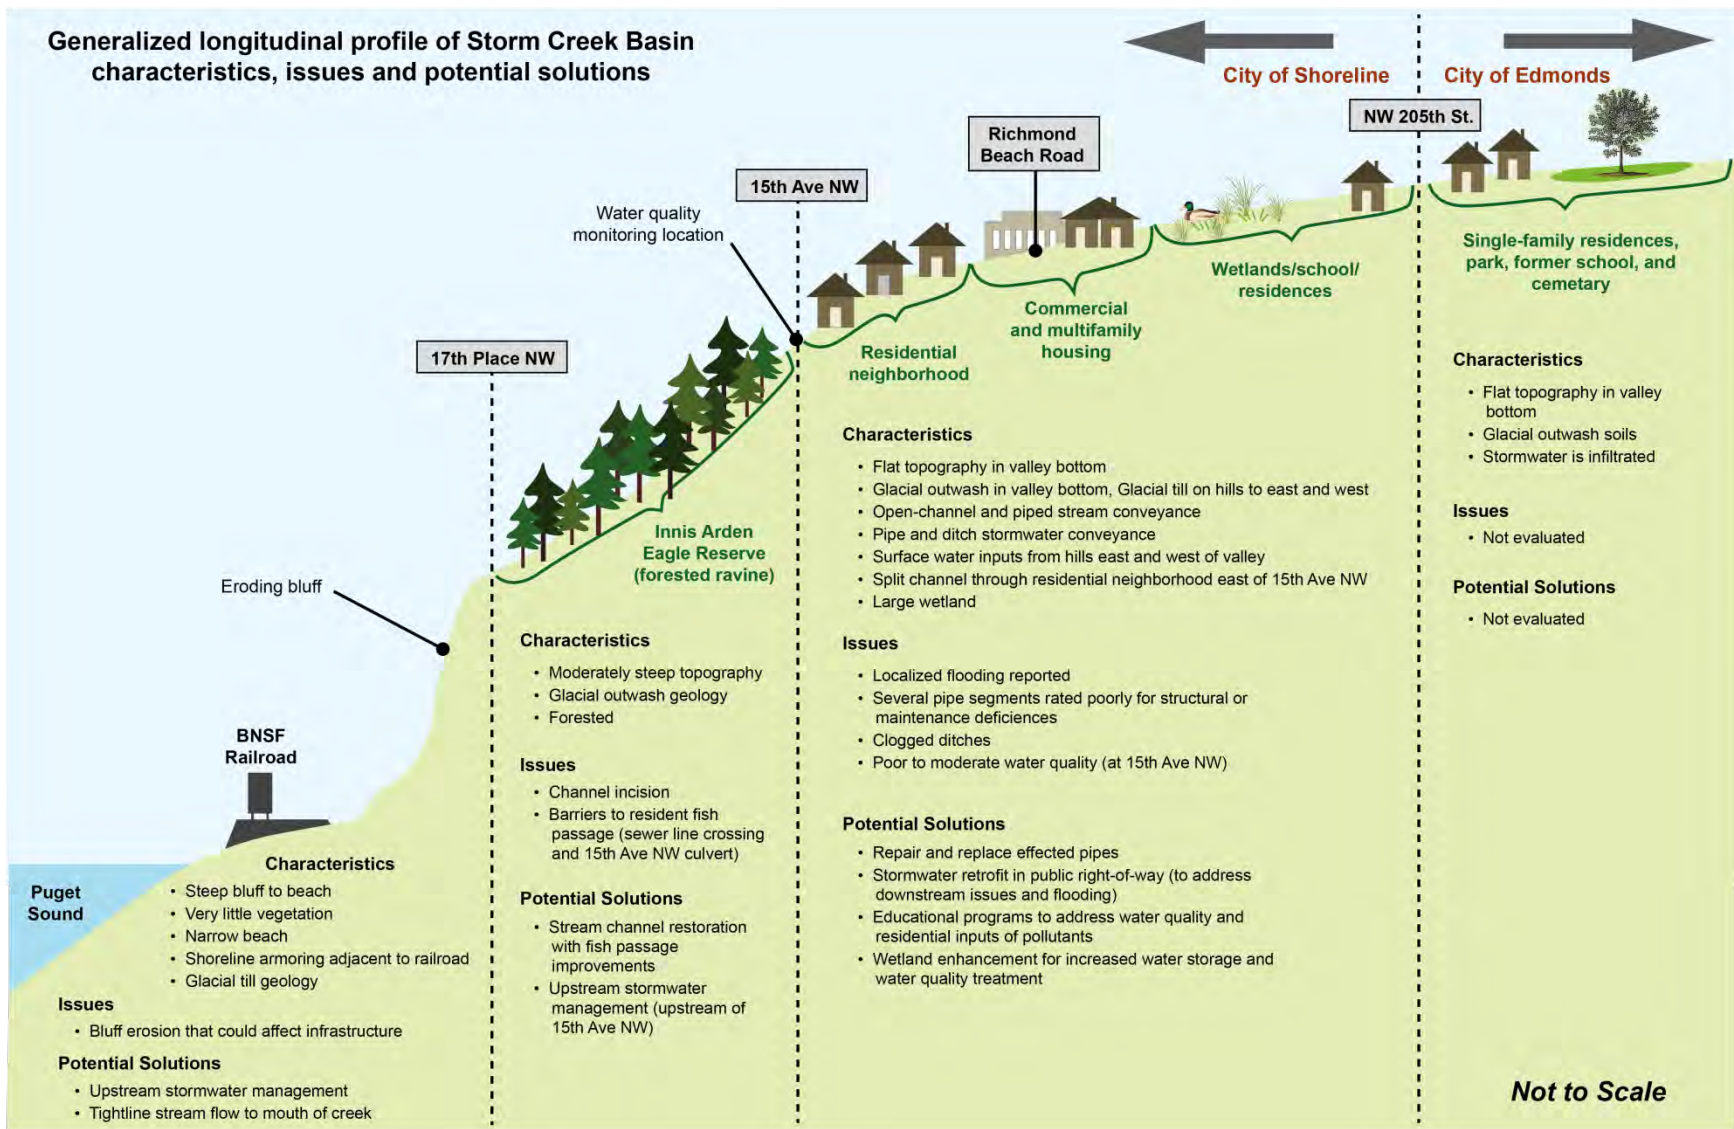
Figure ES-2. Schematic of Storm Creek basin characteristics, issues, and potential solutions

Figure 17. Schematic of Storm Creek basin characteristics, issues, and potential solutions

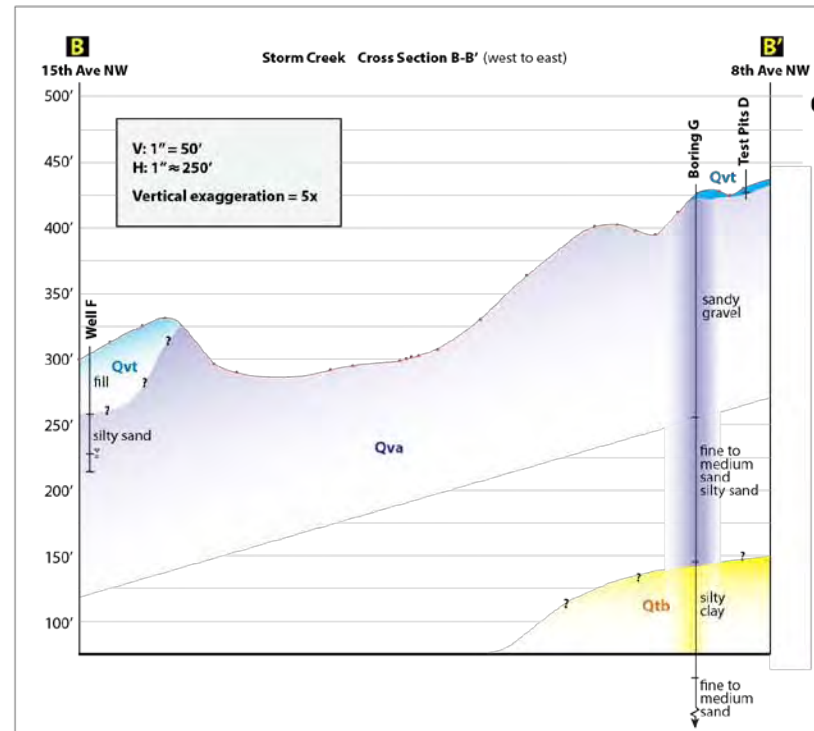
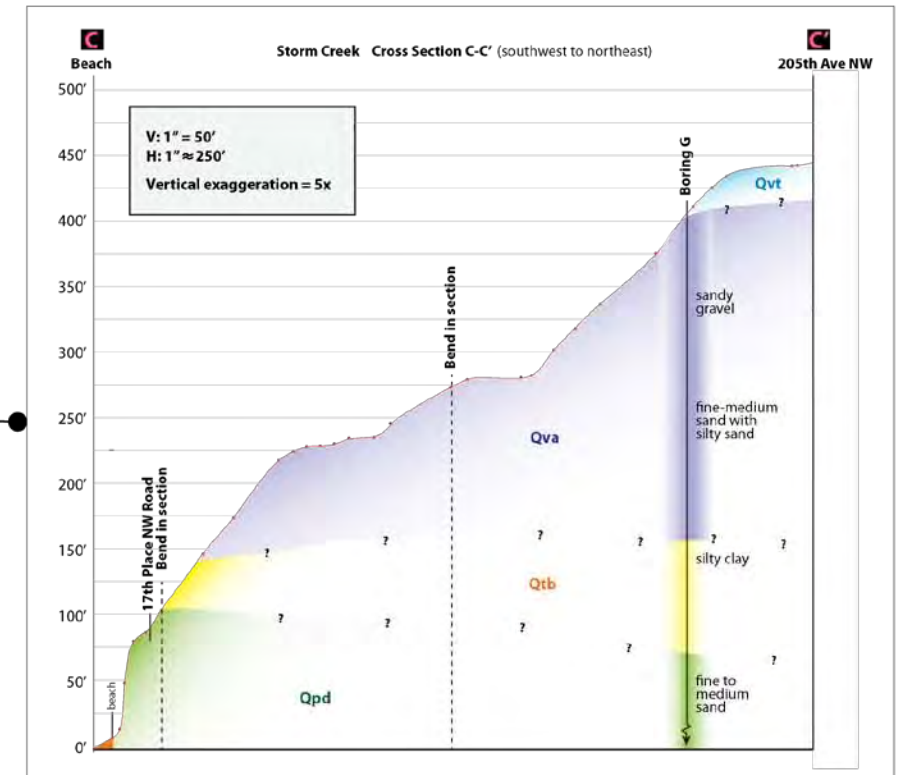
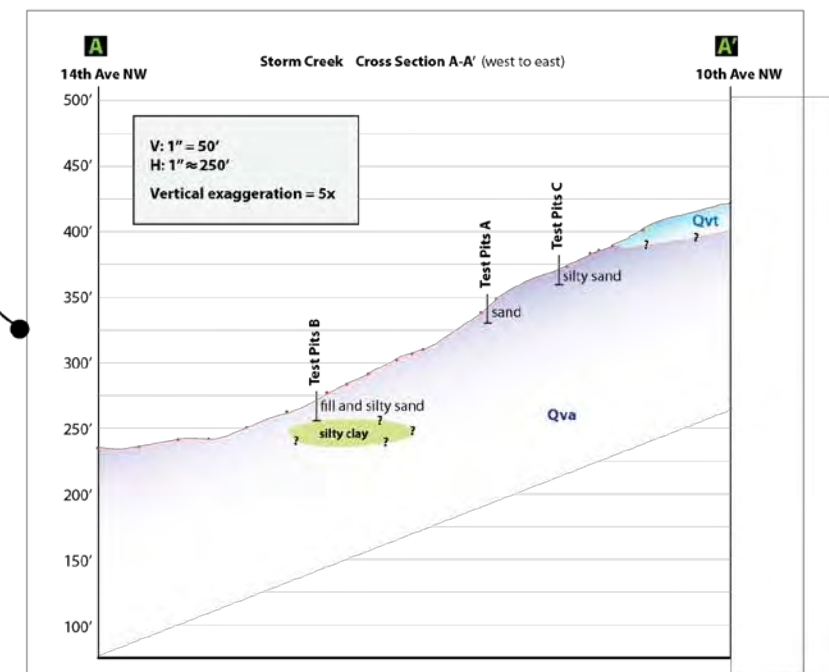
Figure 5. Geologic cross sections

Windward reviewed geologic boring logs and test pit data available through Geomap Northwest (Booth et al. 2004) to correlate surface geologic conditions to subsurface conditions, and to get an understanding of the thicknesses of the materials mapped. The cross sections in Figure 5 show the potential thicknesses of geologic materials in the basin. This information is important in order to identify potential stormwater management options, including infiltrative low-impact development (LID) techniques.

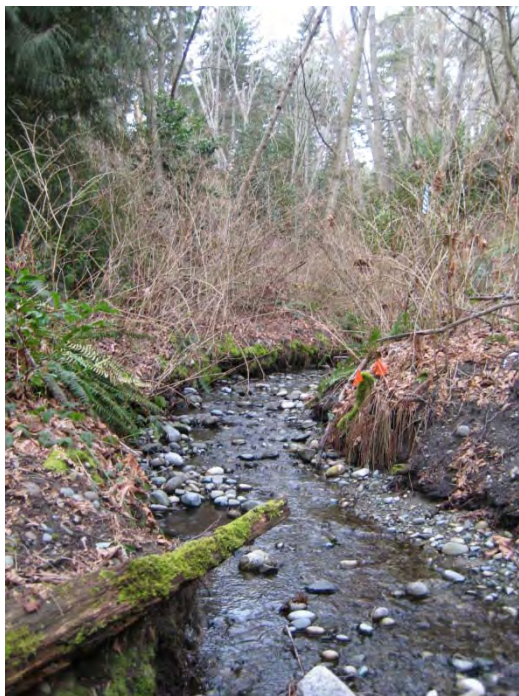
Photo 1. Example of channel incision in Storm Creek within Eagle Reserve

Eagle Reserve is formed within glacial advance outwash, which is very sandy and easily eroded. Surface water flow resulting from impervious surfaces created as part of development in the basin likely caused the stream channel to enlarge in order to accommodate greater, more frequent flow events. Without monitoring data showing how the channel has changed over time, it is difficult to know

whether the channel has largely adjusted to its current flow regime or whether it is continuing to incise. There are two structures in Eagle Reserve that act as grade control, limiting the amount of incision that occurs: the 17th Place culvert and stormwater structure on the downstream end of Eagle Reserve, and the sewer line crossing in the middle of Eagle Reserve. Both of these are discussed in Section 3.7.2. Downstream of the 17th Place culvert, several rock gabion structures have been installed over the years by both the Ronald Wastewater District (to protect its sanitary sewer pipe) and King County (to protect the road). These structures provide some channel stability in the immediate vicinity of the road. However, a knick point has developed downstream of the structures, at which point the channel drops rapidly and active erosion is occurring. The channel conditions through all reaches of Storm Creek are similar to those described by Tetra Tech in 2004 (Tetra Tech/KCM 2004), indicating minimal channel changes in the intervening 8 years.

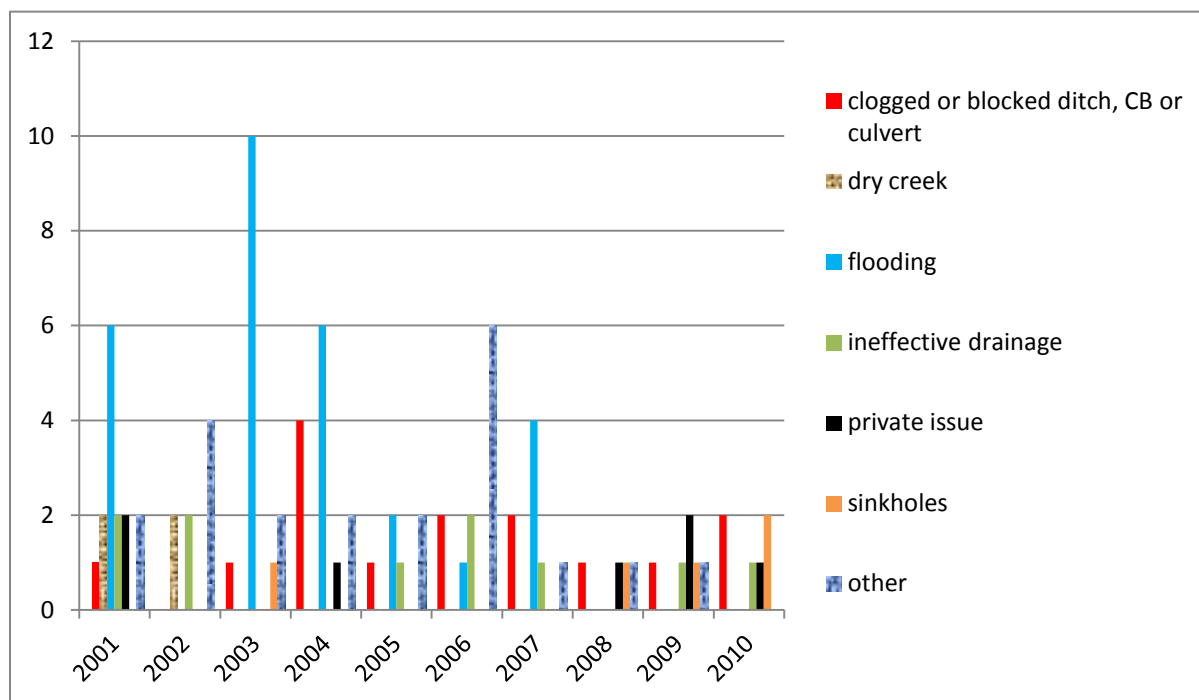
Figure 10. Number of service calls in Storm Creek basin by year and type

Windward reviewed City service requests received between April 2001 and November 2011 to identify problematic areas in the basin and potential causes. As shown in Figure 10, 91 calls were received for locations in the Storm Creek basin during this time period. Major precipitation events occurred in the Seattle and Shoreline area during October 2003, November 2006, and December 2007.

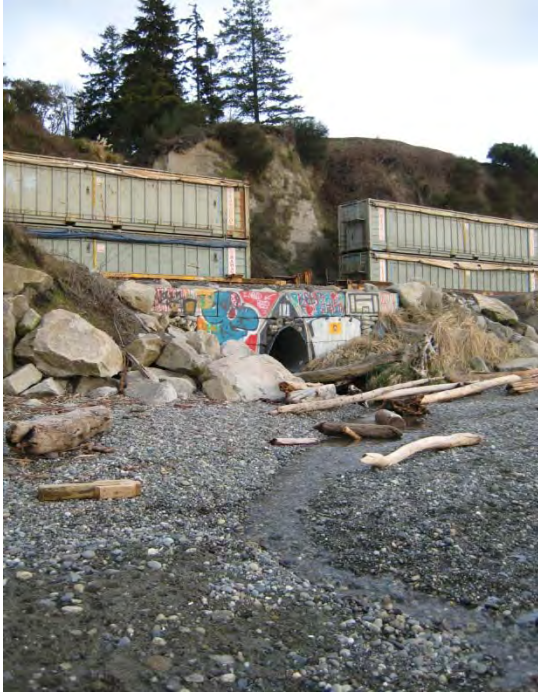
Photo 2. Culvert under BNSF railroad, mouth of Storm Creek

The existing railroad crossing culvert is a 42-in.-long corrugated metal pipe (CMP), which is steep inside with a 6-in. plunge at the outfall. The galvanizing has worn off the bottom, which is now corroded. High tides reach the downstream end of the culvert, and may push backwater most or all of the way through it. The culvert may be passable for fish under certain high-tide conditions, but the steep, chasm-like barrier described above lies immediately upstream (Photo 2).

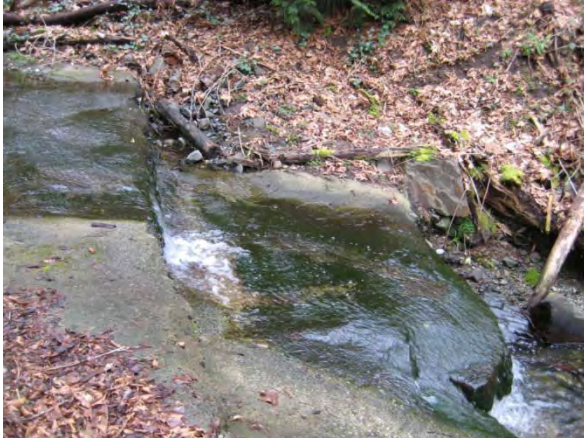
Photo 3. Concrete poured over sanitary sewer line in Storm Creek – likely fish passage barrier

Upstream of 17th Place Northwest, within the Eagle Reserve, is a sewer line crossing that has been grouted extensively with concrete to protect it from exposure and damage resulting from streambed erosion (Figure 13). As a result, several plunges of up to 3 ft have formed as the stream flows across the resulting grade control (Photo 3). These plunges are impassable to upstream-bound fish, primarily due to stream size and channel geometry; normally, a pool somewhat deeper than the height of a corresponding plunge is required immediately below to allow passage (Reiser and Bjornn 1979). In addition, larger fish can generally leap higher than smaller fish, and any resident cutthroat trout in the stream would be fairly small. The channel continues to incise downstream of the grade control, but is prevented from doing so immediately upstream of the grade control.

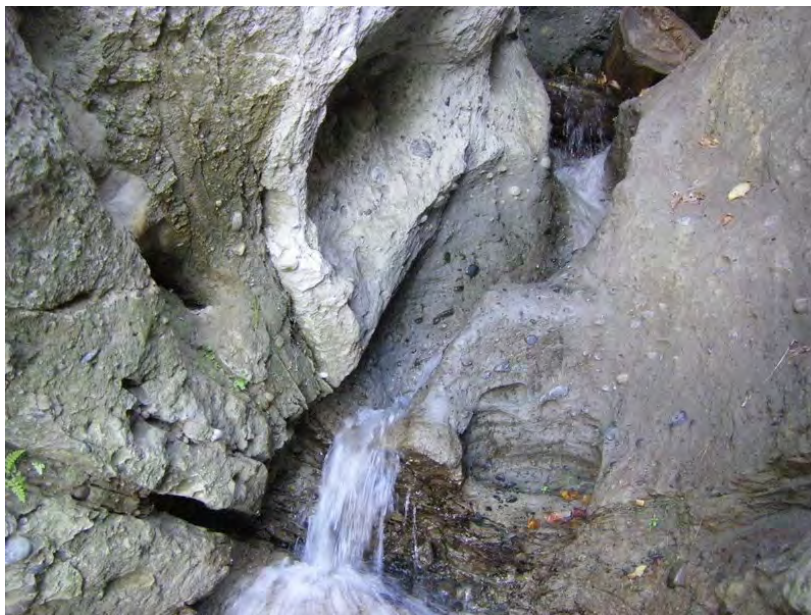
Figure 2. View of lower Storm Creek in the canyon reach, showing a portion of the steep reach about 100 ft upstream of the railroad tracks

The longitudinal profile of Storm Creek has a natural break in slope, approximately at the location of the 17th Place NW crossing. Above this point, the stream flows in a moderately confined upland channel at an average gradient of about 3 to 4%, which is typical for lowland streams in this general topography. Below the road crossing, the bed steepens abruptly, with an average gradient of almost 30%, and includes short reaches of near-vertical falls interspersed with short, relatively flat reaches (Figure 2). In general, such a slope is not stable over the long term and will continue to seek a lower course with a flatter gradient. This process is now occurring on an annual basis along the lower reach of Storm Creek. As the bottom of the channel has lowered, the canyon sidewalls have become progressively higher and steeper, and they, in turn, have begun to fail by landsliding, which serves to flatten their angle and regain a stable slope. This can only be accomplished through a widening of the canyon across its top, with attendant risk to developed upland properties on both sides of the canyon.

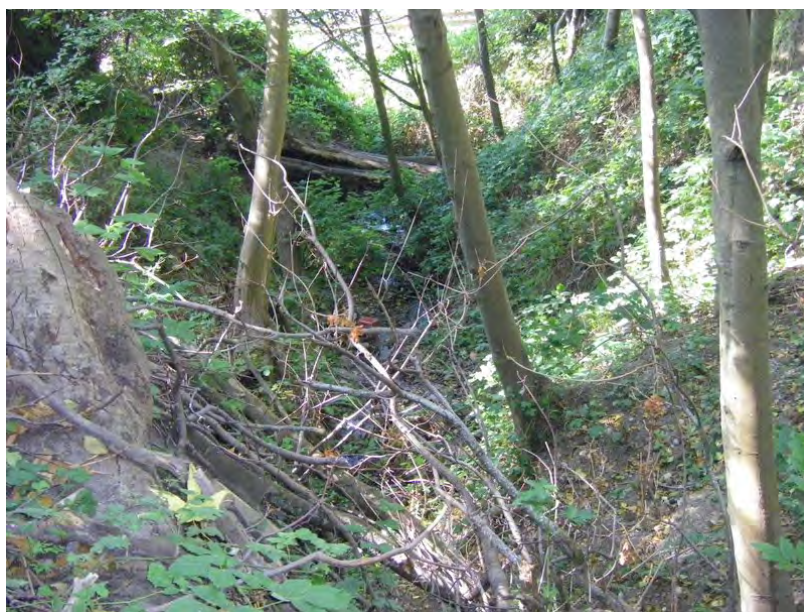
Figure 3. View of lower Heron Creek, showing trees of sufficient maturity to suggest that the broader, deeper canyon here has existed in its present form for at least several decades (and possibly much longer)

most immediately at Heron Creek just south but also at nearby Boeing Creek and Pipers Creek, indicate that Storm Creek is anomalous – every other channel in the region has already created a relatively smooth grade down to Puget Sound, over a sufficient amount of time for mature trees to have become well-established in their valley bottoms (Figure 3). Such a differential cannot be obviously explained by “human” factors, such as the age of development (which is roughly the same throughout this portion of the coast) or direct channel modification, and so other explanations must be explored.

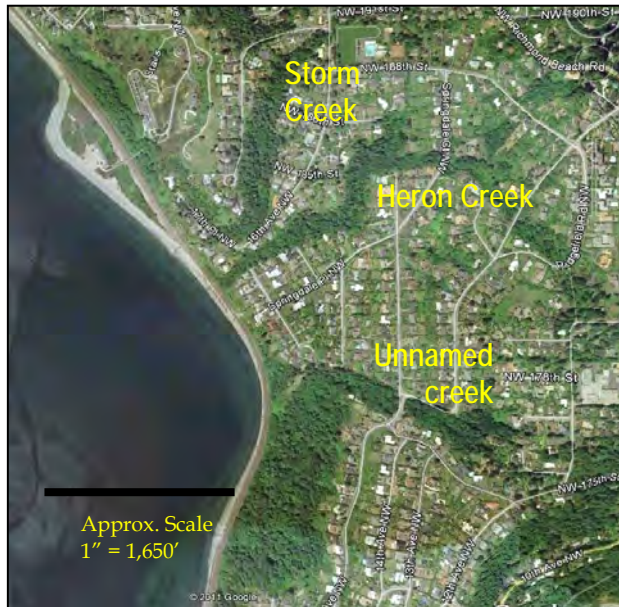
Figure 4. Aerial photograph and preliminary geologic map of the Shoreline coastal area in the vicinity of Storm and Heron Creeks

The geologic materials that underlie this part of the lowland are, in part, quite uncommon (Figure 4). They include a sedimentary deposit from a regional ice advance about 60,000 years ago, which was named the “Possession Drift” (its deposits are denoted as “Qpd” on geologic maps of the region). In the exposed ravines of both Storm and Heron Creeks, the deposit is primarily till, a very compact, heterogeneous mixture of gravel, sand, and silt reminiscent of concrete (Figure 5, Photo A). However, it has abundant zones of nearly pure sand and a variety of transecting fractures, which provide avenues of weakness for the action of stream or wave erosion (Figure 5, Photo B).

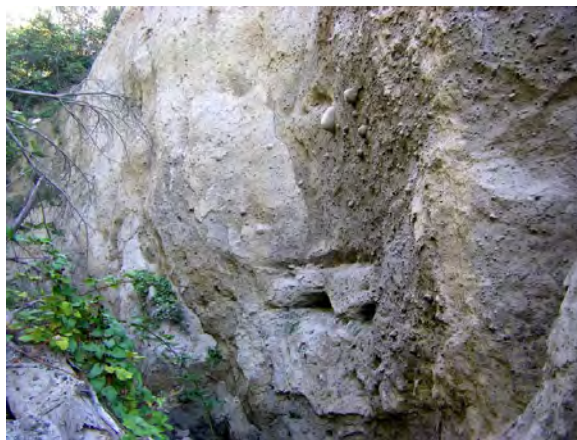
Note: Photo A is the intact coherent material, with sufficient strength to stand in vertical (and locally overhanging) walls for many years without failure. Photo B shows the same geologic deposit in an adjacent area where sandier zones have permitted rapid hollowing out by natural and human agents of erosion.

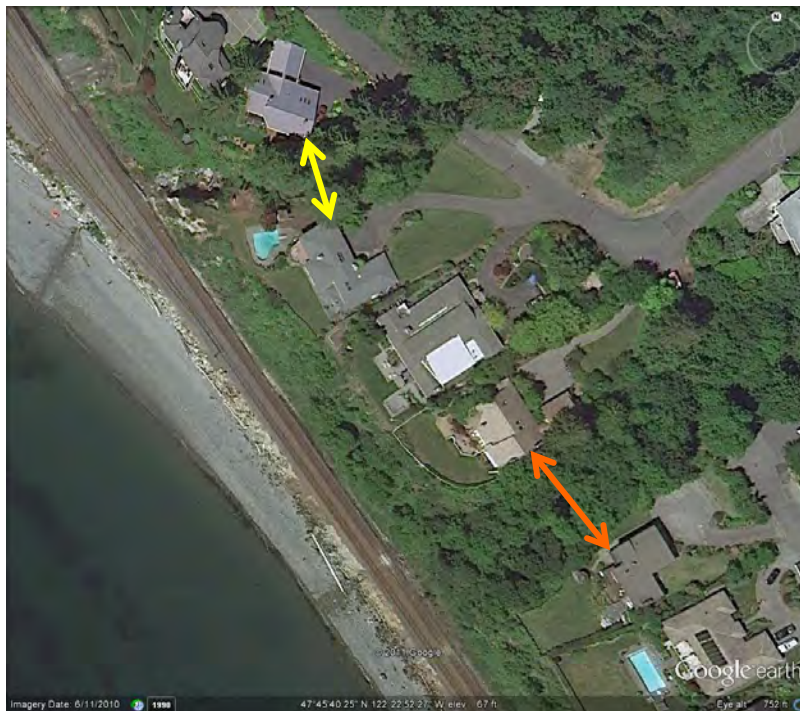
Figure 6. Aerial view of the mouths of Storm Creek (upper left) and Heron Creek (lower right)

Note: The arrows show the spacing of houses on opposite sides of the two creeks; yellow = 70 ft across Storm Creek; orange = 110 ft across Heron Creek, undoubtedly reflecting the relative depth and width of the two ravines when this area was first developed.

We have every reason to assume that a similar runoff response accompanied development in the Storm Creek watershed in the 1960s and 1970s. Stormwater management of that era was well-intentioned but, as is now widely recognized, ineffective at reducing downstream impacts such as flooding and stream erosion. Similar to the rest of the drainages in the region, Storm Creek has been receiving discharges well in excess of its “natural” rates. What is unusual here is that the canyon of Storm Creek is substantially narrower than those of its neighboring creeks, so much so that, for example, in the 1960s, the two houses that flank the mouth of Heron Creek were constructed 110 ft apart, but those that flank Storm Creek are only 70 ft apart (Figure 6; distances approximate as measured in Google® Earth). Although Storm Creek is a larger channel that drains a larger watershed, it had not incised nearly as deeply when the residential structures were built, and so it required (at the time) significantly less setback of structures from a significantly shallower ravine.

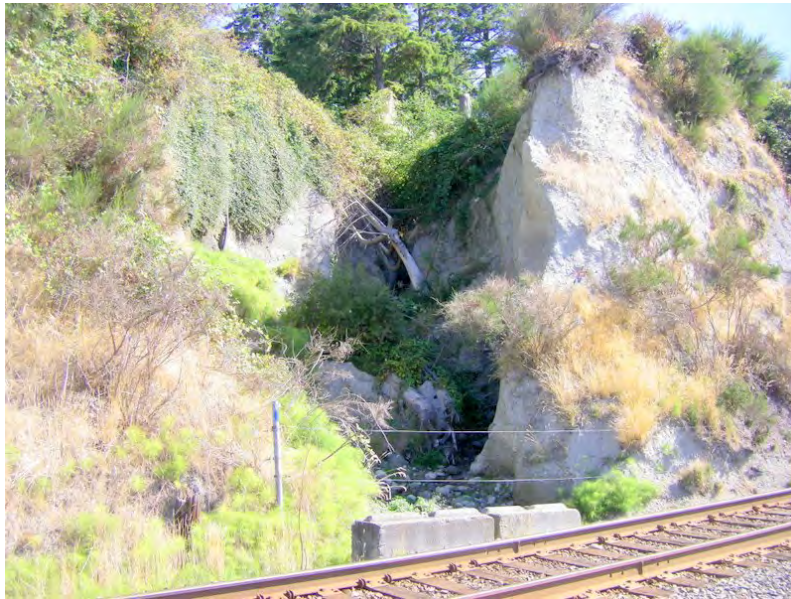
Figure 7. View of the mouth of Storm Creek, from the railroad embankment just above the southern extent of the beach at Richmond Beach Park

pace of headward expansion. Of much greater potential public concern is the health and safety of visitors to Richmond Beach Park who are inclined to explore the adjacent coastline, complete with crumbling bluffs and overhanging caverns (Figure 7). Lastly, the catastrophic collapse of a portion of the ravine sidewalls (or the rapid flushing of previously eroded sediment during a storm) could easily clog the culvert under the railroad tracks and potentially block the tracks should sufficient material become involved.
