Conservation Topic

Marine Shorelines: Geological Processes, Land Use Impacts & Conservation Practices

Prepared by: Peter Landry, P.E., L.G. May, 2006

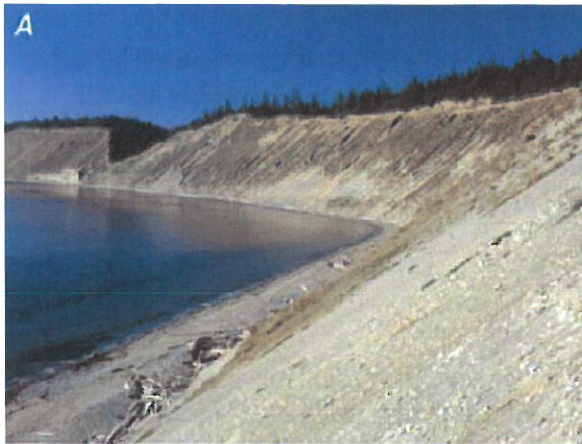
Uniform slope of sand and gravel

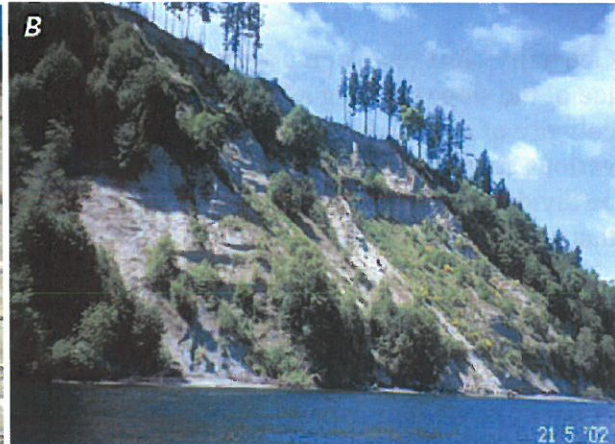
Complex bluff profile of varied composition

In contrast, bluffs consisting solely of glacial till or marine drift may form near-vertical banks. Most bluffs, however, are cut through a sequence of sedimentary units, each with distinct slope forming properties. This can lead to complex bluff profiles containing both steep and gradual segments depending on the geologic, hydrologic, and mechanical properties of individual units. Poorly consolidated sands and gravels become slope-forming units, whereas glacial till and ancient lake bed silts and clays are often cliff-forming. The presence of distinct stratigraphic elements also impacts hydrologic characteristics that influence mass-wasting mechanisms, leading to more complex profiles. For example, many high bluffs on Puget Sound are marked by a mid-slope bench that forms at the contact between permeable advance outwash deposits and underlying impermeable lakebed clays. Saturation along this contact drives upslope failures that result in more rapid retreat of the top of the slope than the base, causing the bench to widen. These benches, which can vary from a few tens of feet to hundreds of feet in width, may exhibit highly irregular topography as a result of their origin in landslides from the upper cliff.
