Inventory and Assessment Summary Report

Project: **City of Shoreline 175th Street Corridor Improvement Project
Stone Avenue North to Interstate-5
Shoreline, WA.**

Date: December 9, 2022

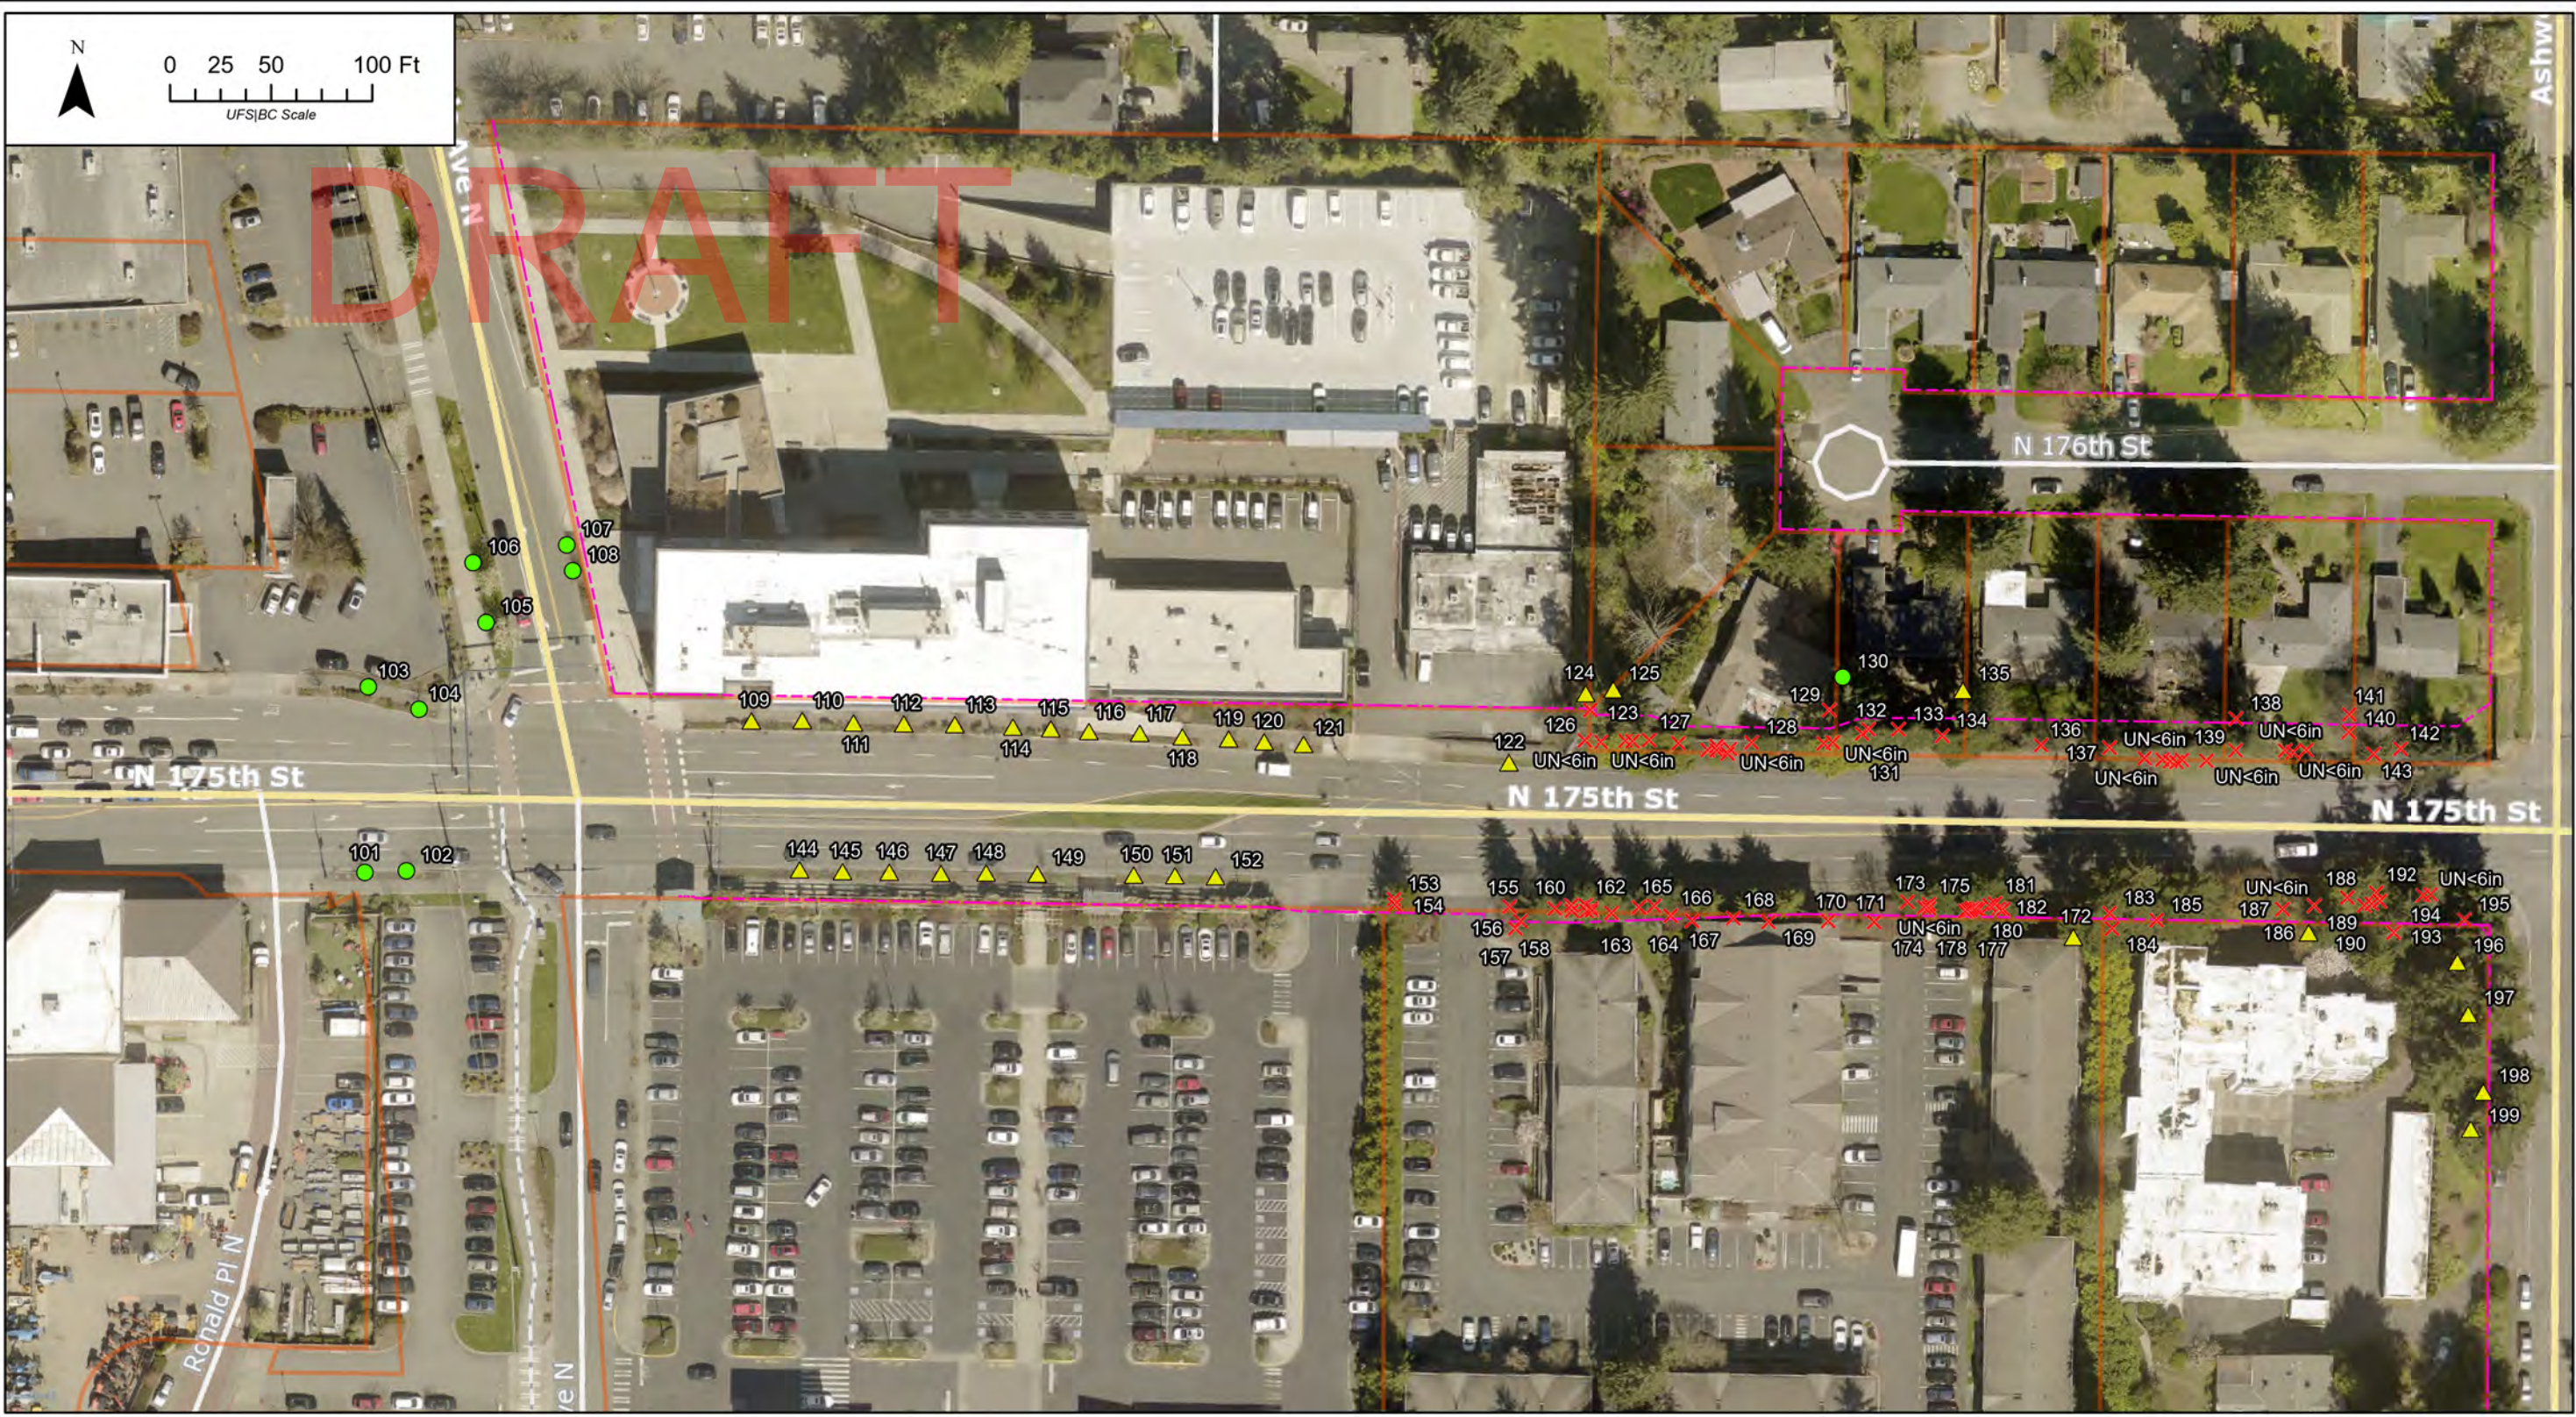
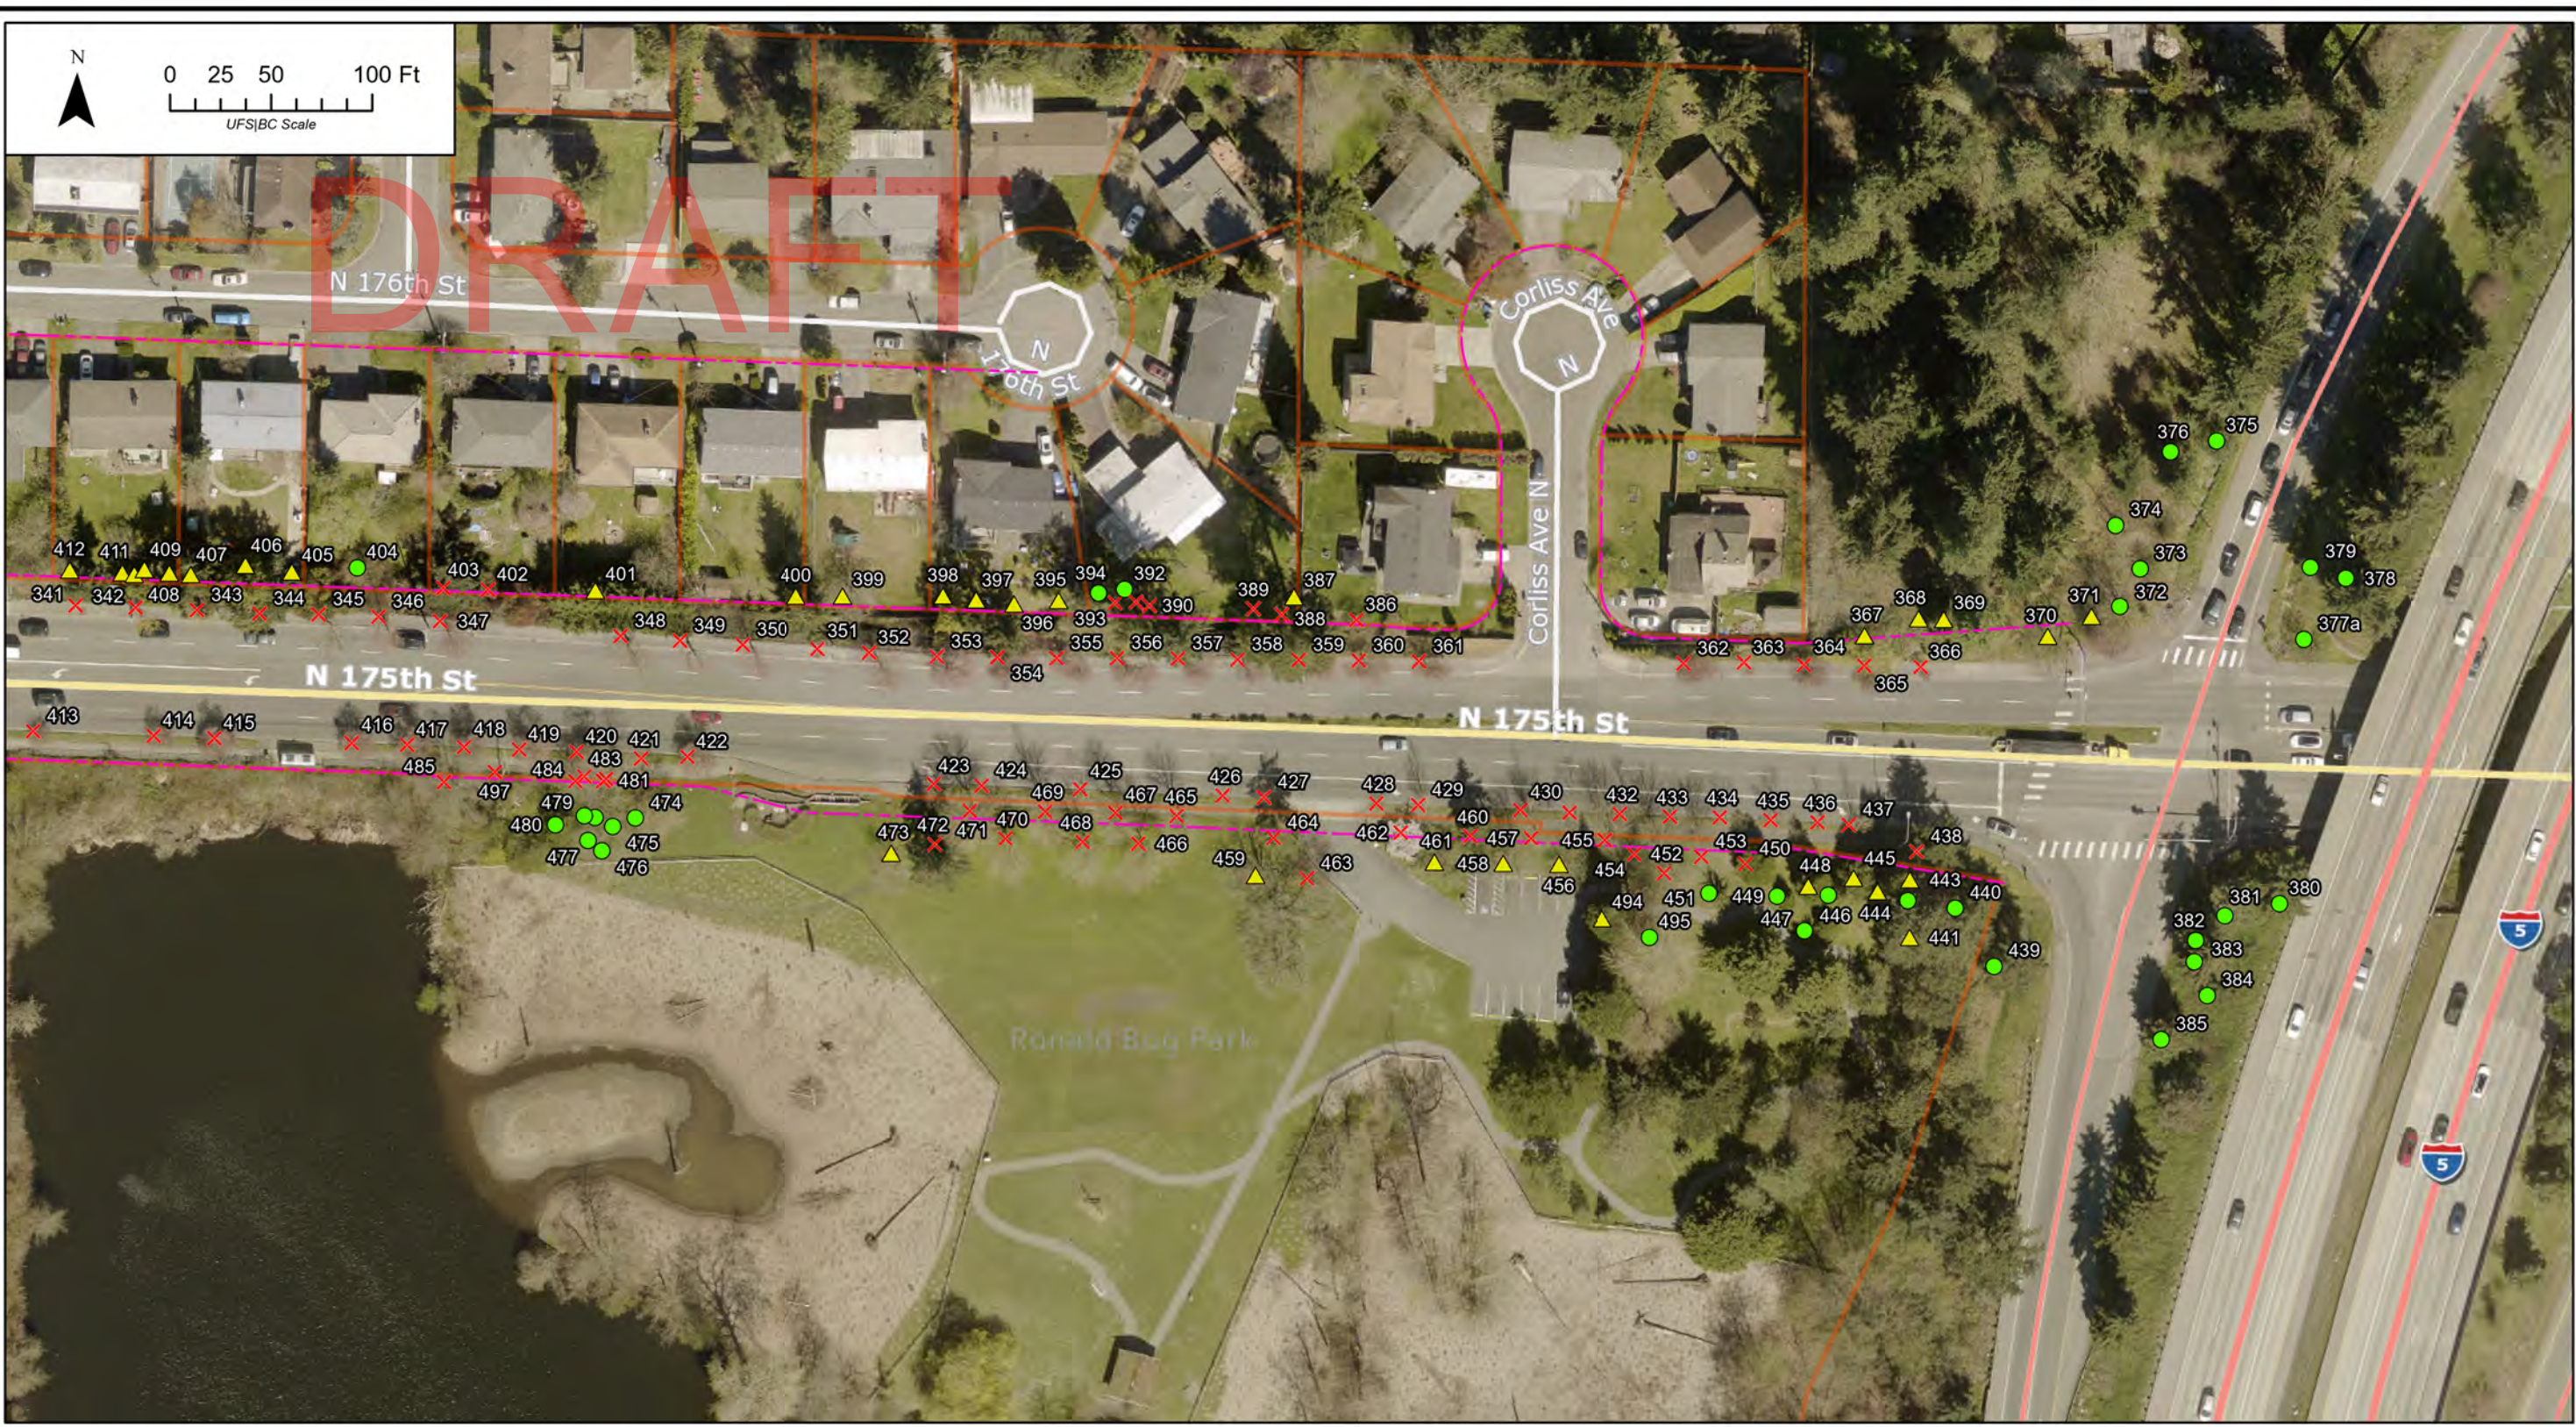
1) The determinations for classifying trees for removal, or as impacted or non-impacted, is based on the April 2022, "60% Draft, In-progress Plans developed for arborist site work" exhibit provided by HBB. This exhibit depicts the extent of proposed grade cut and fill, wall construction, and other works that may impact trees. The 60% Draft design has been compared in relation to each tree's Critical Root Zone (CRZ) to determine expected impacts and possible actions. Additional details and a review of the required work limits, construction methods, and tree locations will be required in the lead-up to final 90% phased submittals. This additional service shall provide more specific and accurate tree removal, protection, and preservation recommendations. Further adjustments to determinations for removal and protection may be required after the project arborist reviews the final placement of the work and grading limits marked in the field.

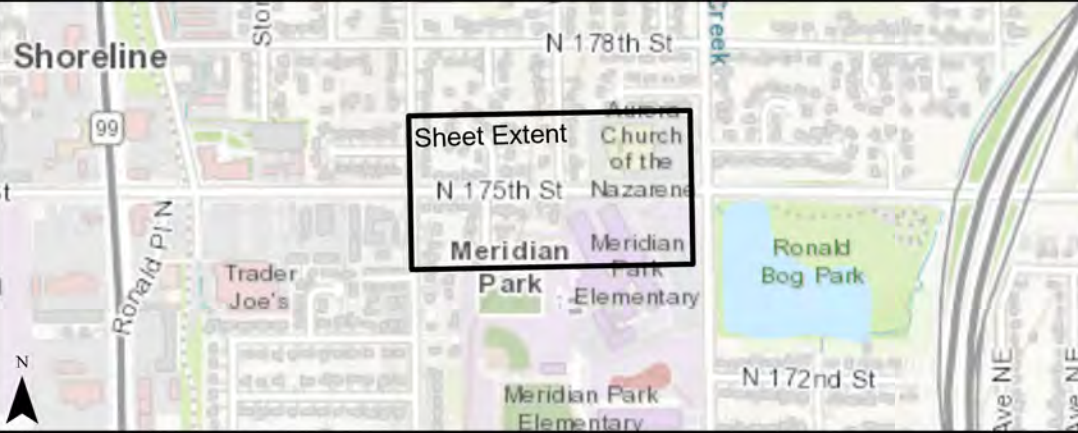
1) The determinations for classifying trees for removal, or as impacted or non-impacted, is based on the April 2022, "60% Draft, In-progress Plans developed for arborist site work" exhibit provided by HBB. This exhibit depicts the extent of proposed grade cut and fill, wall construction, and other works that may impact trees. The 60% Draft design has been compared in relation to each tree's Critical Root Zone (CRZ) to determine expected impacts and possible actions. Additional details and a review of the required work limits, construction methods, and tree locations will be required in the lead-up to final 90% phased submittals. This additional service shall provide more specific and accurate tree removal, protection, and preservation recommendations. Further adjustments to determinations for removal and protection may be required after the project arborist reviews the final placement of the work and grading limits marked in the field.

* Map labels have been simplified for reference legibility; some labels may be missing. See the Tree Assessment Matrix for individual tree details

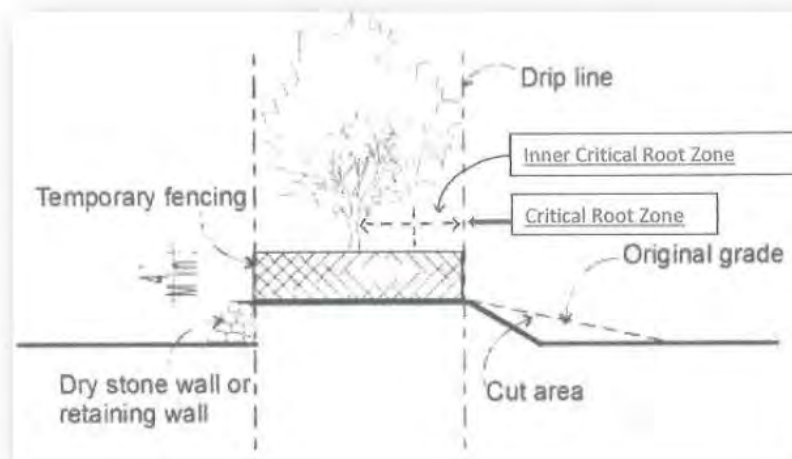
Figure 20.50.370: Illustration of standard techniques used to protect trees during construction.

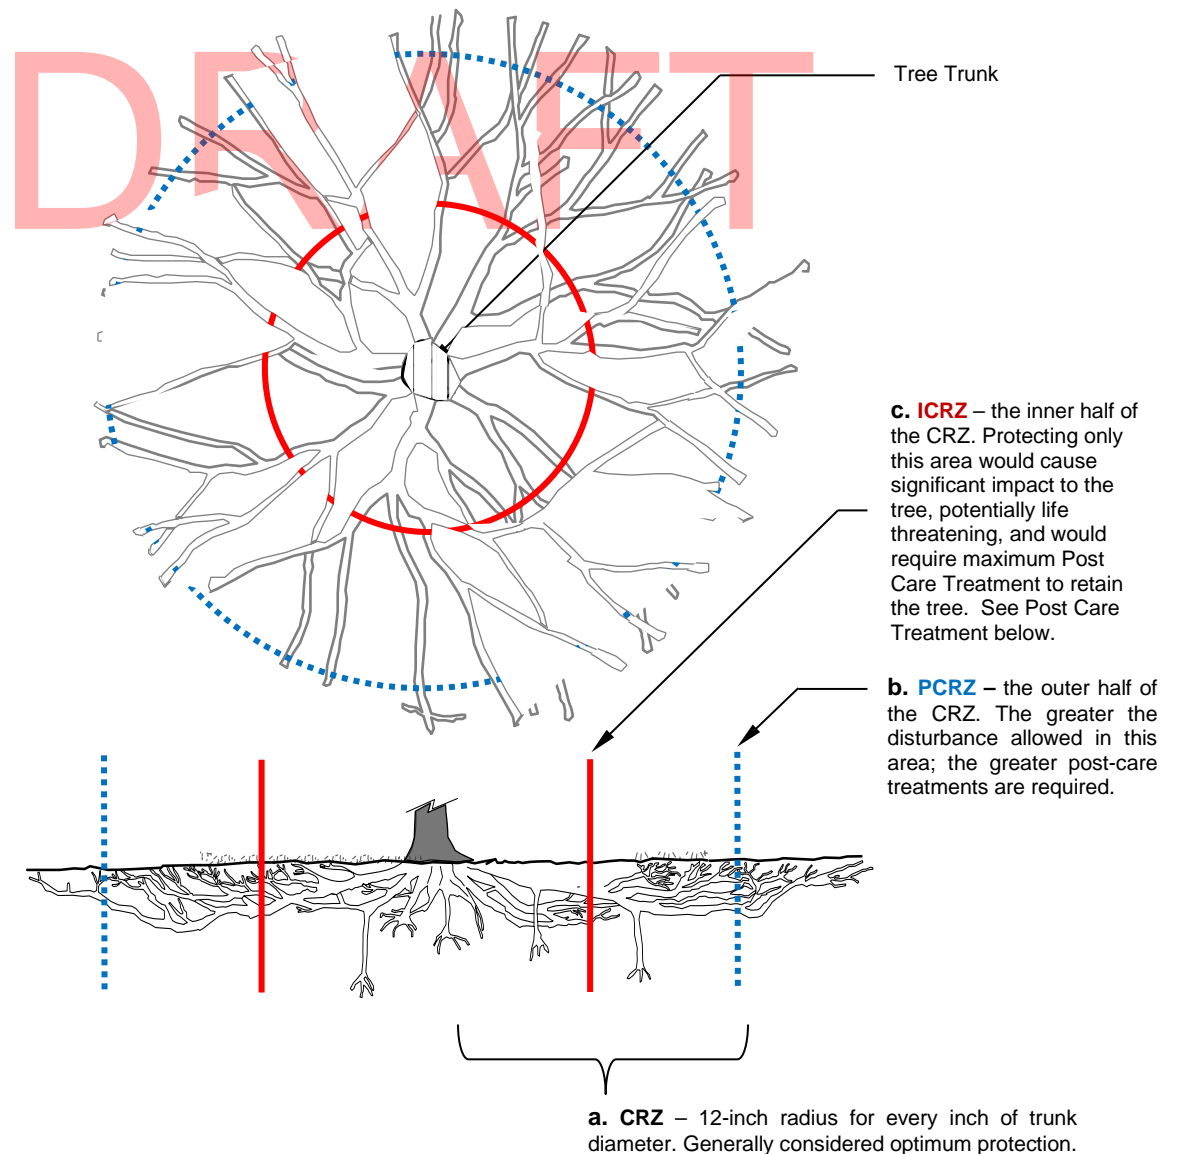
a. CRITICAL ROOT ZONE (CRZ) – The CRZ of a tree is established based on trunk diameter measured at 4.5-feet from grade (DBH). The CRZ is a generalized circular area which has a radius of 12-inches to every inch trunk diameter. Root systems will vary both in depth and spread depending on size of tree, soils, water table, species and other factors. However, this CRZ description is generally accepted in the tree industry. Protecting this entire area is optimum and should, in theory, result in no adverse impact to a tree.

The CRZ can be further differentiated into the 'Perimeter' and 'Interior' CRZs to help evaluate potential impacts and required post-care.

- c. INTERIOR CRITICAL ROOT ZONE (ICRZ)** – The absolute maximum disturbance allowed for a tree should leave the 'Interior' CRZ undisturbed if the tree is to have any chance of long-term survival. The ICRZ is half the radius of the full CRZ/PCRZ. Disturbance into the ICRZ could destabilize or cause the tree to decline. The ICRZ approximately equals the size of a root-ball needed to transplant this tree, which in turn would require extensive post-care treatments and possibly guying or propping to stabilize the tree. Post Care Treatment includes but may not be limited to; regular irrigation, misting, root treatment with special root hormones, mulching, guying and monitoring during construction and for several years following impacts.

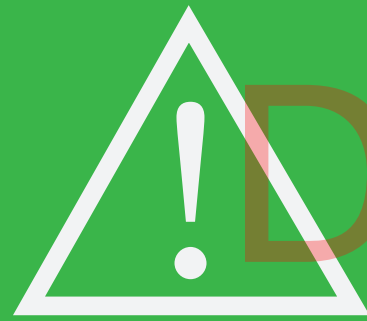
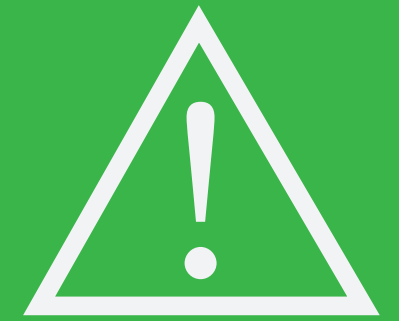
TREE PROTECTION FENCE.

DO NOT ENTER THIS AREA.

**DO NOT PARK OR STORE MATERIALS WITHIN
THE PROTECTION AREA.**

CERCA DE PROTECCIÓN DE ÁRBOLES.

NO ENTRAR A ESTA AREA.

**NO ESTACIONAR O GUARDAR MATERIALES
ENTRE EL ÁREA PROTEGIDA.**

4. **The Tree Assessment and Protection Site Plans and Clearing and Grading Plans** show the recommended location of the Tree Protection Fence (TPF). Immediately after the clearing limits and grading stakes are set in the field, the owner's arborist, during review and discussion with the contractor, will make a final determination on the tree protection requirements depending on construction limits and impact on major roots and soil condition. The arborist may adjust clearing limits in the field so that, in their opinion, tree roots and soils are protected while necessary work can proceed.
