November 7, 2022

## Re: City of Shoreline Parks Bond Projects – Richmond Highlands Park Preliminary Arborist Report

The Watershed Company Reference Number: 220722

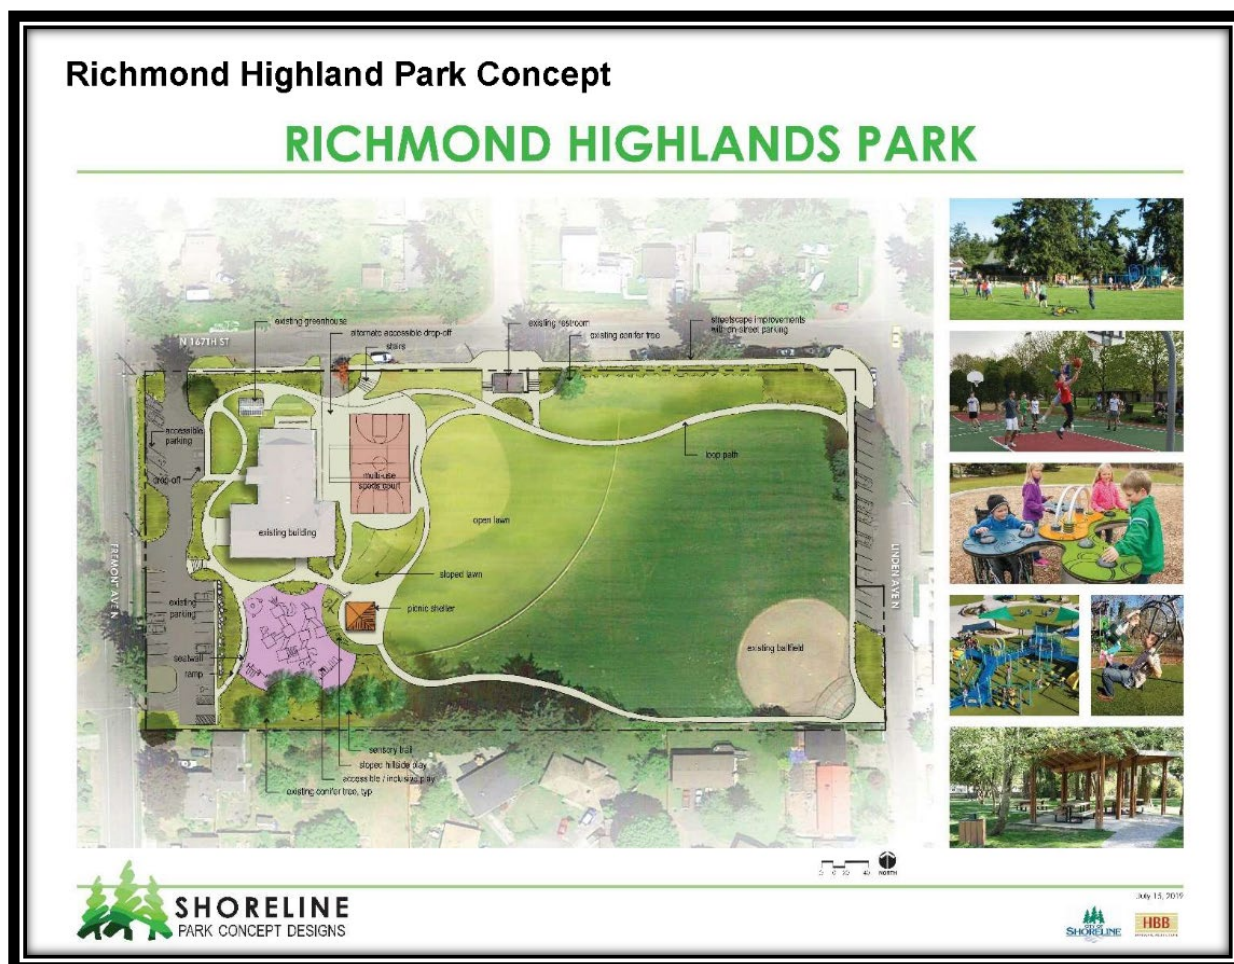
Figure 1. City of Shoreline concept design for Richmond Highlands Park (City of Shoreline, July 2019).

The study area, shown on the attached Tree Inventory Sketch, includes the entirety of Ridgcrest Park, including offsite trees located in proximity to proposed improvements (see Figure 1).

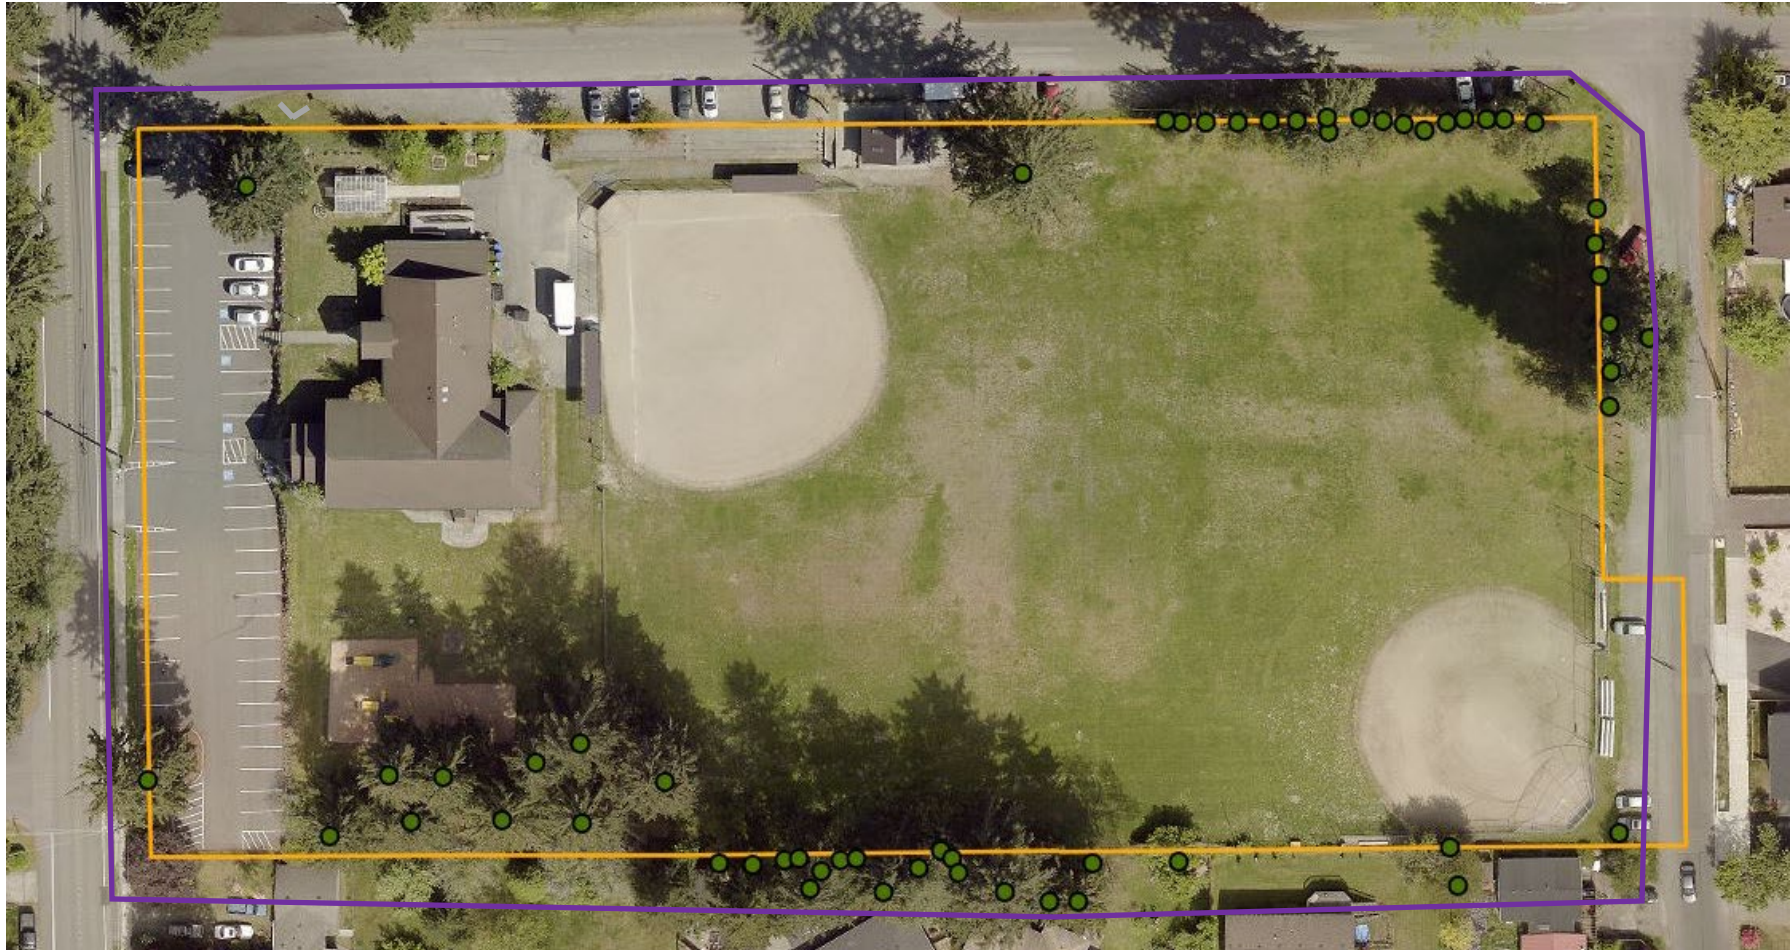
### Tree Inventory Sketch – Richmond Highlands Park

Site Address: 16554 Fremont Avenue N; Shoreline, WA  
Parcel Number: 0726049153  
Site Visit Date: September 1 and 8, 2022

**Note:** Field sketch only. Features depicted are approximate and not to scale. All observations were made from within the subject parcel; adjoining private properties were not entered. Significant trees are marked with 1-1/4 inch round aluminum tags with a unique identification number (trees #1001-1036) permanently affixed to the tree trunk. Offsite trees were not tagged but given a unique identification number (#1-21).
