CRITICAL AREAS REPORT

FIRCREST SCHOOL CAMPUS MASTER PLAN
SHORELINE, WASHINGTON

Prepared by
Herrera Environmental Consultants, Inc.
2200 Sixth Avenue, Suite 1100
Seattle, Washington 98121
Telephone: 206-441-9080

DRAFT
March 7, 2022

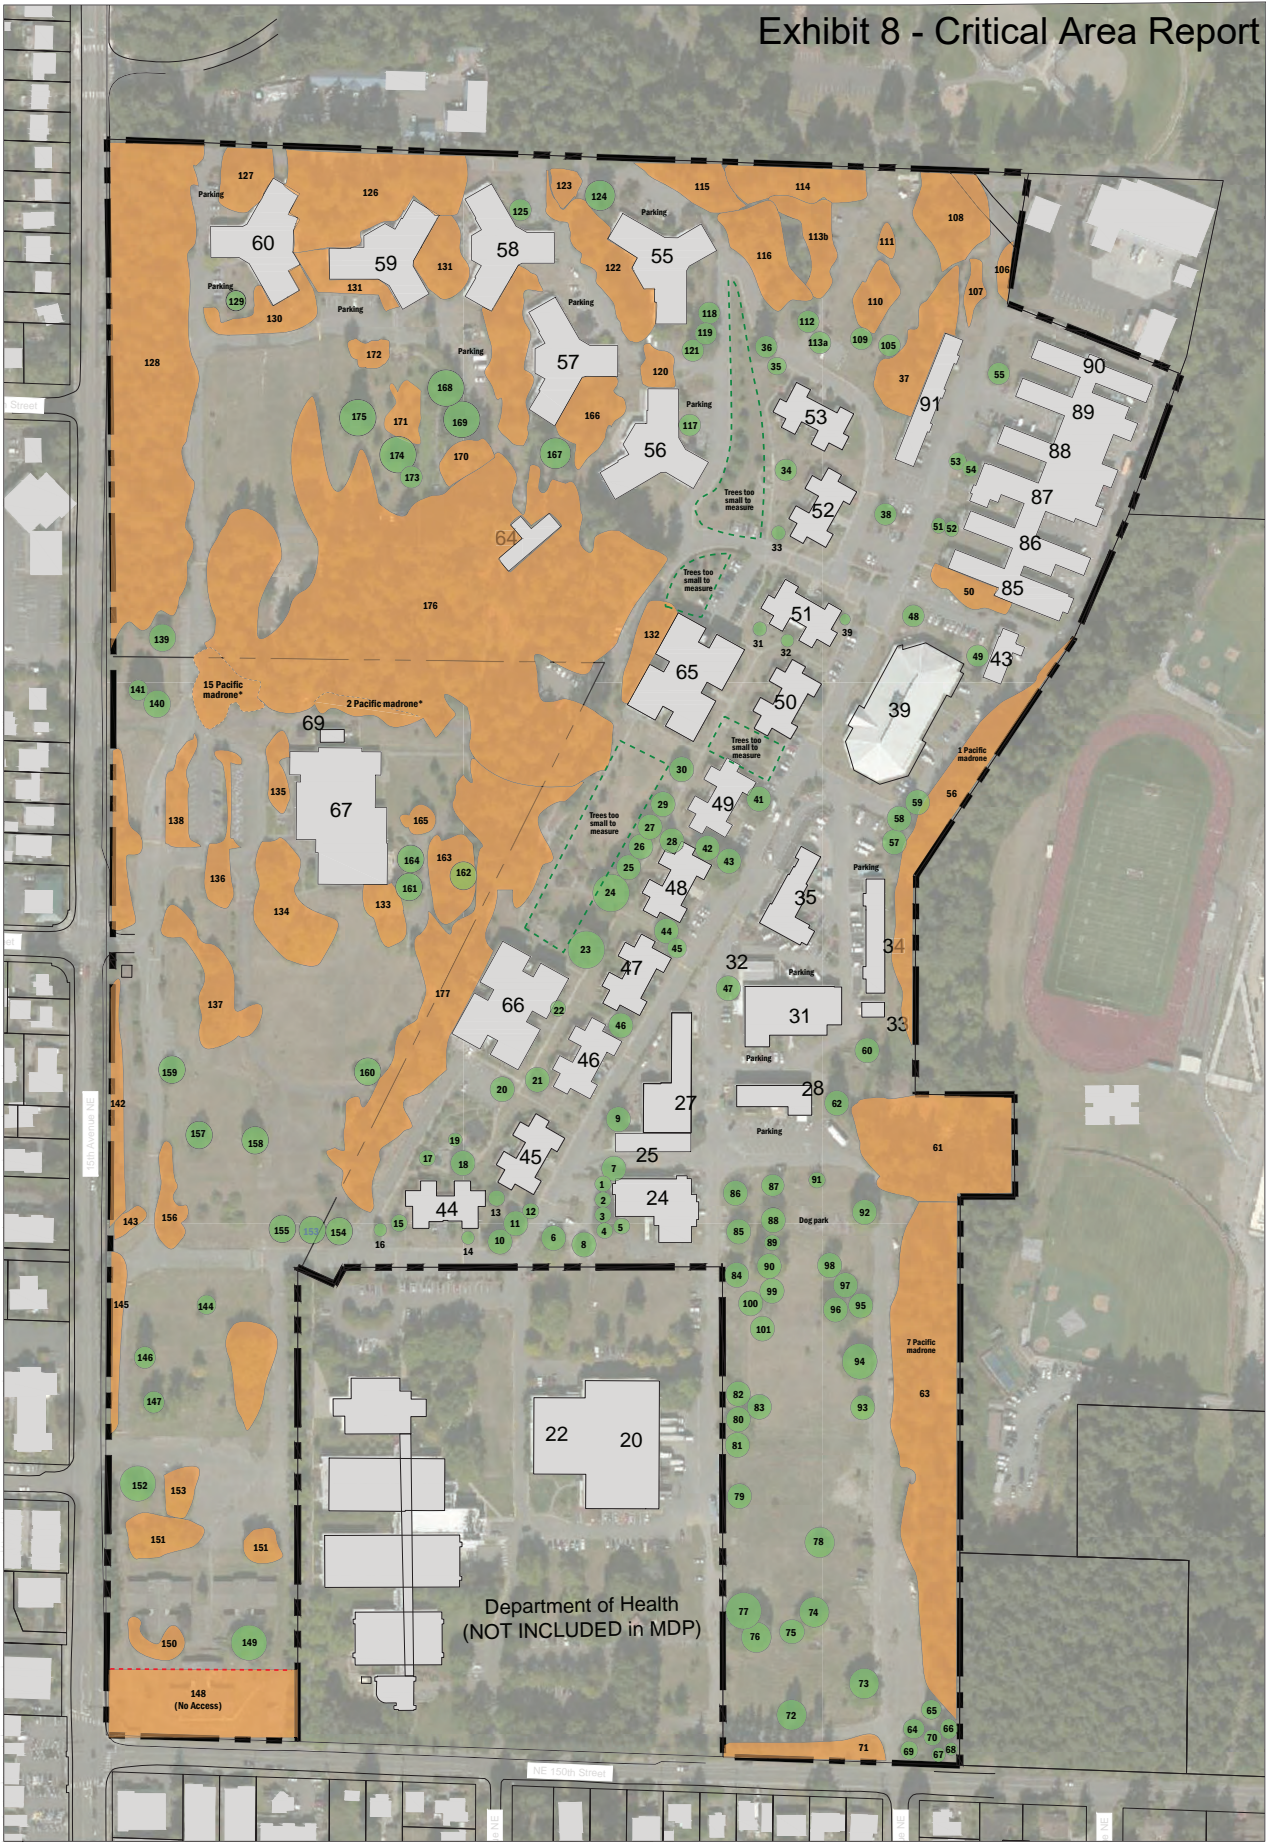
Figure 2. Fircrest Campus Tree Inventory – 2018.

In 2018 a Herrera arborist and a biologist inventoried the entire Fircrest Campus project area, measuring 176 significant trees or tree groves that met the minimum circumference per the City of Shoreline Municipal Code, *Chapter 22.62 Landscaping Regulations*. Within the code, *Chapter 22.62.009 Retention and protection of significant trees*, states that "significant trees are healthy evergreen trees with a minimum 12-inch DBH and healthy deciduous trees with a minimum nine-inch DBH (diameter at breast height)."

The final tree inventory spreadsheet (see Appendix B) shows the Tree ID Number, Species, Common Name, DBH, Significant Tree per City Standards (Yes or No), whether the tree species is native, nonnative, on the Washington State Noxious Weed Board's invasive monitor list or its invasive list, Tree Grove vs Tree Specimen, General Tree Health (Good, Fair, Poor), Risk of Physical Failure (Low, Medium, High), Location by Building Number, and Notes.¹

Prior to the construction phase of the Master Plan, it is recommended that an updated tree survey be generated for all trees that will be removed. Tree sizes, health, and replacement ratios should be updated; and an in-depth analysis of all tree groves may be required per City code.

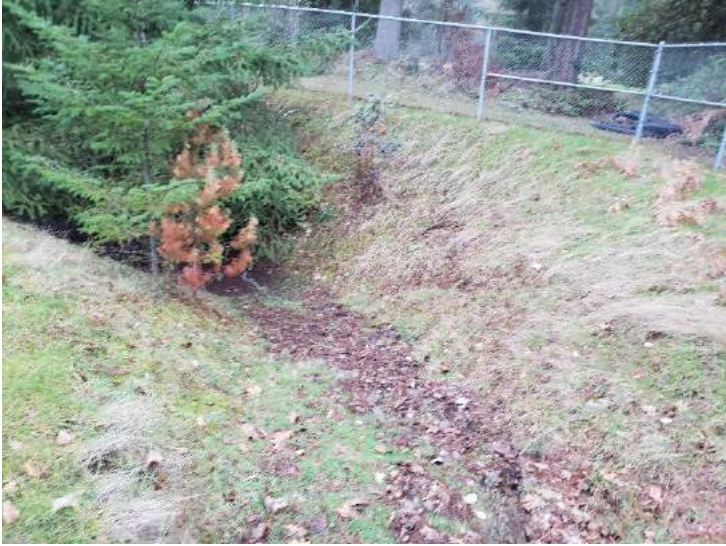
Table 1. Stream Summary Table—West Hamlin Creek.

The small segment of West Hamlin Creek that was not piped in the study area did not have any bed or bank characteristics and instead was observed to be a vegetated swale that conveys the stream flows from mapped piped stream segments to the north and south. A majority of the small segment of East Hamlin Creek that was not piped in the study area displayed characteristics consistent with those observed in West Hamlin Creek; however, a small segment of the vegetated swale appeared to have been maintained, resulting in bed and bank characteristics likely caused by human intervention, rather than by natural flow processes. Piped stream segments and segments without OHWM but that convey naturally occurring streams are regulated as FWHCAs per SMC 20.80.270(B)(5) and SMC 20.80.270(B)(5)(E). Stream conditions are summarized in Tables 1 and 2.

Photo showing the non-piped section of West Hamlin Creek lacking OHWM at the northern boundary of the study area.
Local Jurisdiction	City of Shoreline	
DNR Stream Type	Type Ns	
Local Stream Rating	Type Ns	
City of Shoreline Buffer Width	45-foot buffer on non-piped section, 10-foot buffer on piped sections	
Documented Fish Use	No known fish use (WDFW 2022b and 2022c). Mapped natural barriers downstream.	
Location of Stream Relative to Project Corridor	Stream flows south from Hamlin Park through the eastern portion of the study area. At the southeastern corner of the study area, West Hamlin Creek flows into East Hamlin Creek.	
Riparian/Buffer Condition	The buffer in the northernmost portion of the study area where West Hamlin Creek is conveyed through an open channel consists of mature trees and a mowed, grassy understory. West Hamlin Creek is then conveyed through pipes that are within the paved development of the Fircrest School Campus.

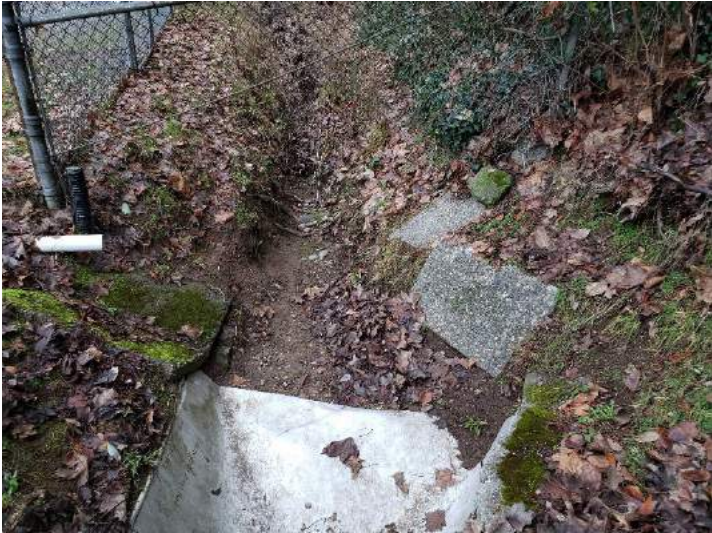
Table 2. Stream Summary Table—East Hamlin Creek.

Photo showing the non-piped section of East Hamlin Creek lacking OHWM at the eastern boundary of the study area.
Local Jurisdiction	City of Shoreline
DNR Stream Type	Type Ns
Local Stream Rating	Type Ns
City of Shoreline Buffer Width	45-foot buffer on non-piped section, 10-foot buffer on piped sections
Documented Fish Use	No known fish use (WDFW 2022b, 2022c). Mapped natural barriers downstream.
Location of Stream Relative to Project Corridor	East Hamlin Creek flows south into the study area at its northeast corner. East Hamlin Creek flows south out of the study area at its southeast corner after joining with West Hamlin Creek.
Riparian/Buffer Condition	The buffer within the study area consists of narrow strips of managed, upland lawn. Beyond this vegetation, the buffer is comprised of paved surfaces associated with the buildings on the Fircrest School Campus.

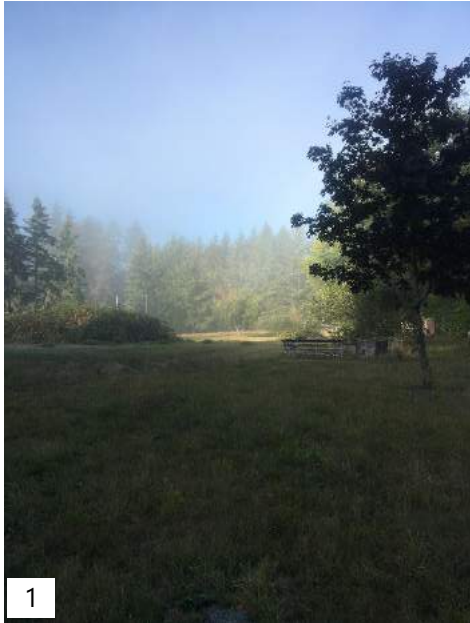
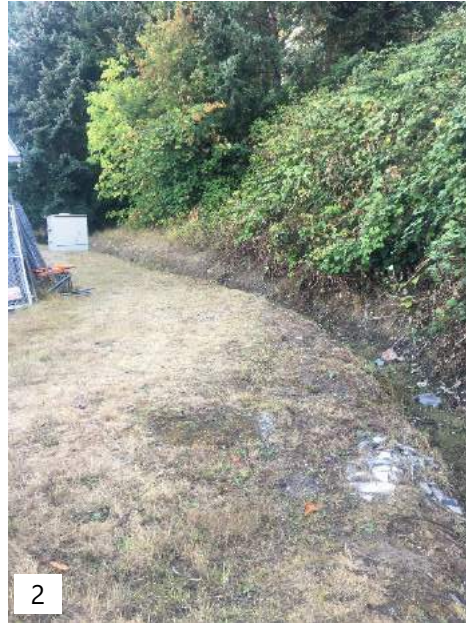
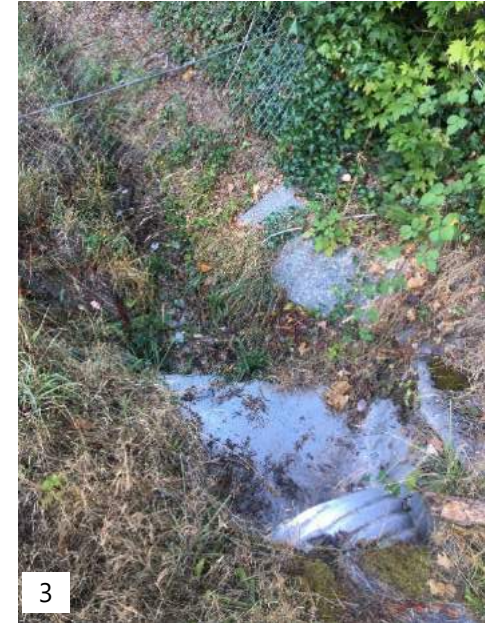
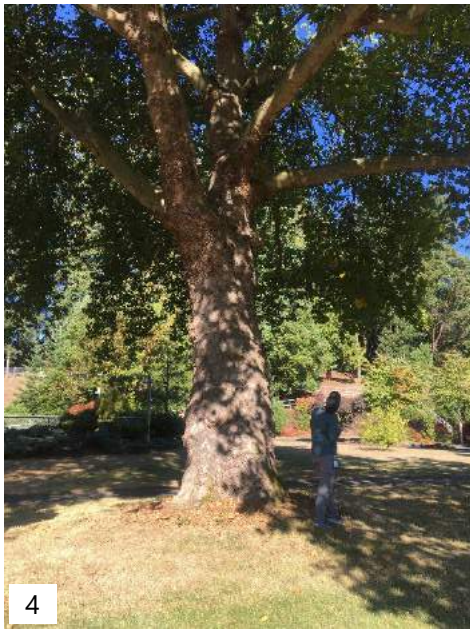
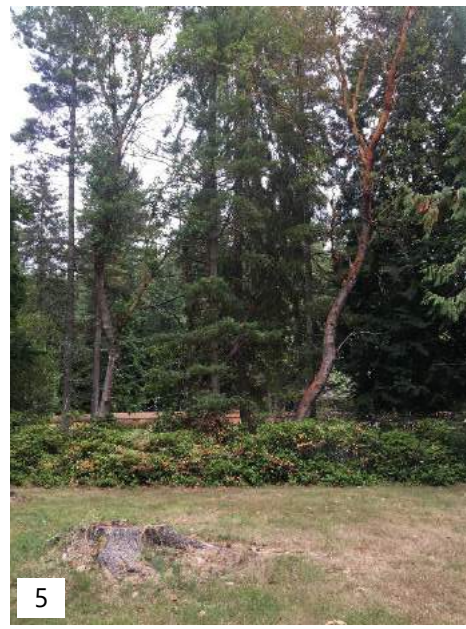
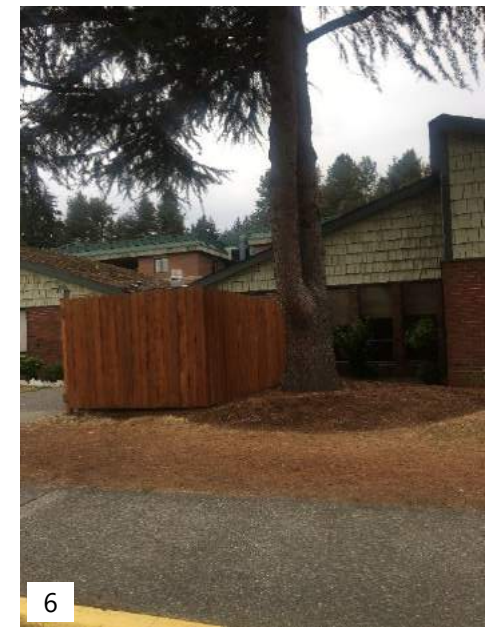
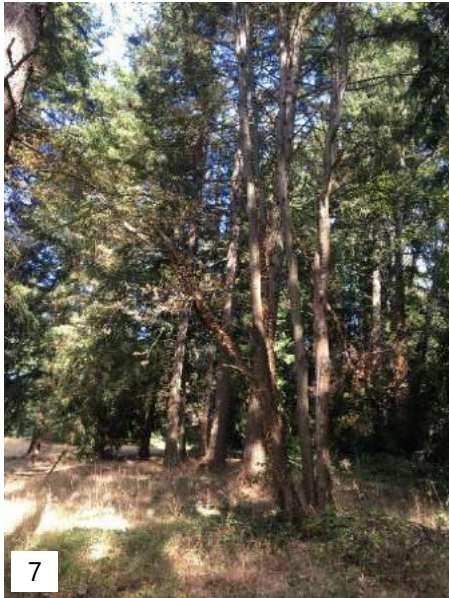
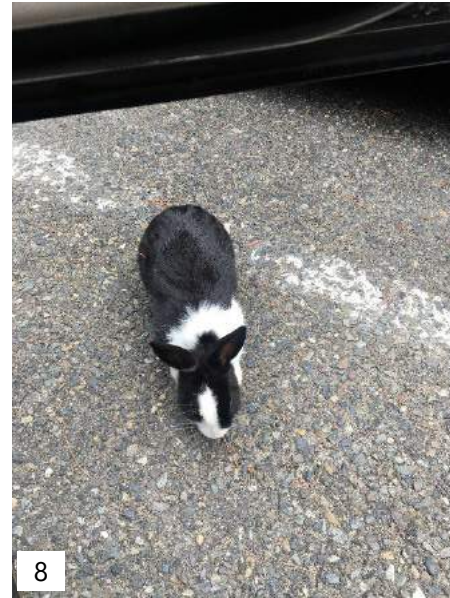
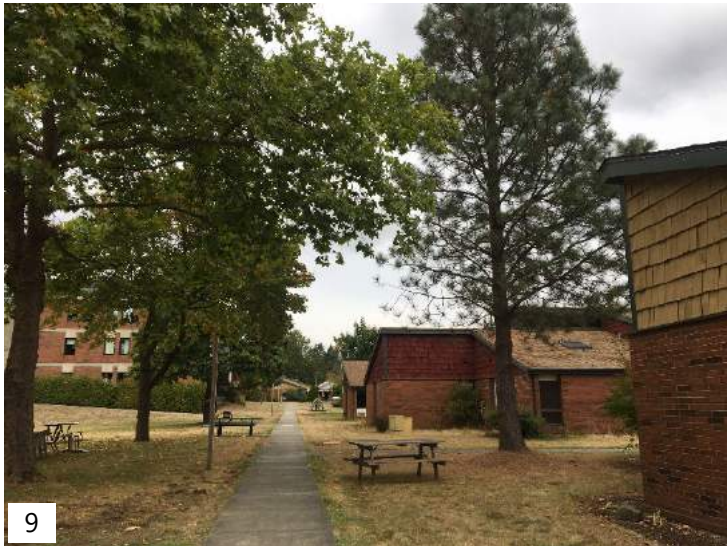
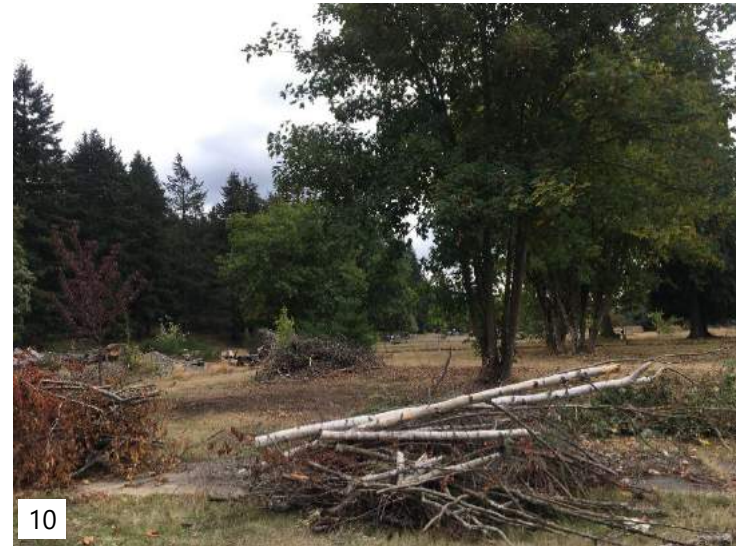
CRITICAL AREAS REPORT: FIRCREST SCHOOL CAMPUS MASTER PLAN— PHOTOGRAPHIC LOG

Photo Number	Photo Description
1	Fircrest campus overview
2	East Hamlin Creek site investigation
3	East Hamlin Creek site investigation
4	Typical specimen tree—London planetree (<i>Platanus x acerifolia</i>) on campus
5	Typical tree grove—mix of species and sizes with an understory
6	Example of a specimen tree growing close to campus buildings
7	Typical tree grove with Pacific madrone (<i>Arbutus menziesii</i>) and Scotch pine (<i>Pinus sylvestris</i>)
8	Population of domesticated rabbits that are feral on campus
9	Typical specimen trees adjacent to buildings
10	Specimen trees and tree groves in the outer campus
