MEMORANDUM

RE: 10th Ave NE from NE 165th St. to NE 175th St.

Roadway Drainage Review Shoreline On-call Services SvR Project No. 13044.10

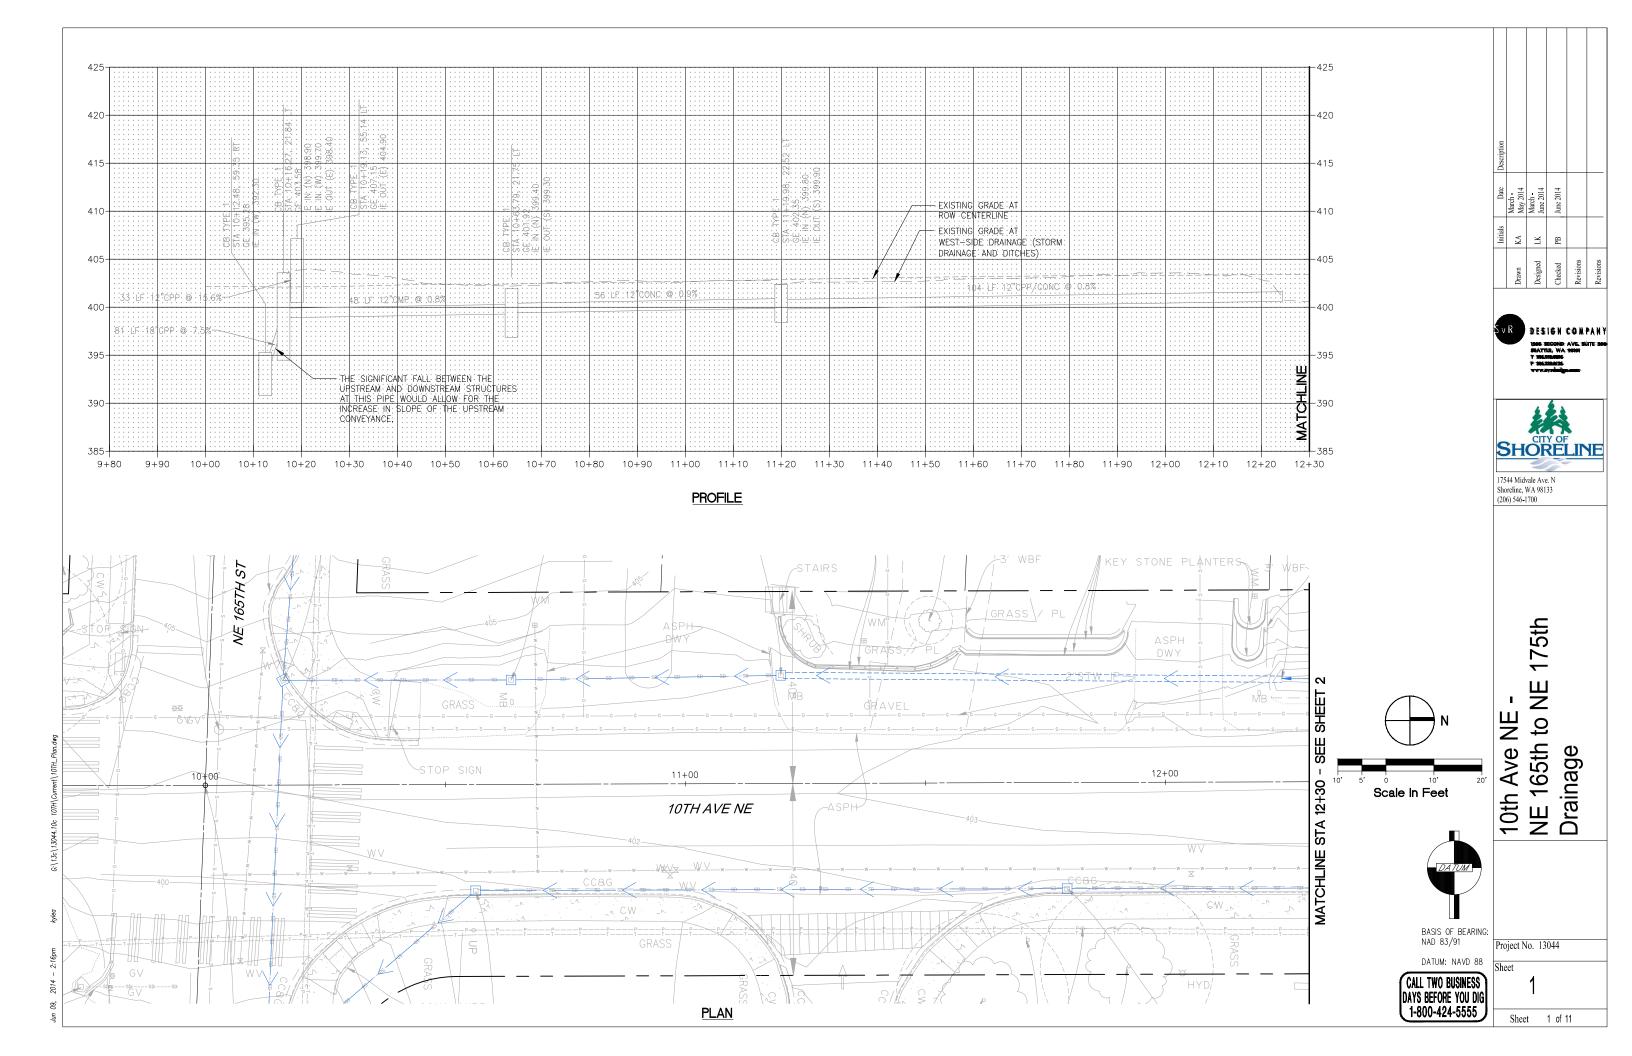
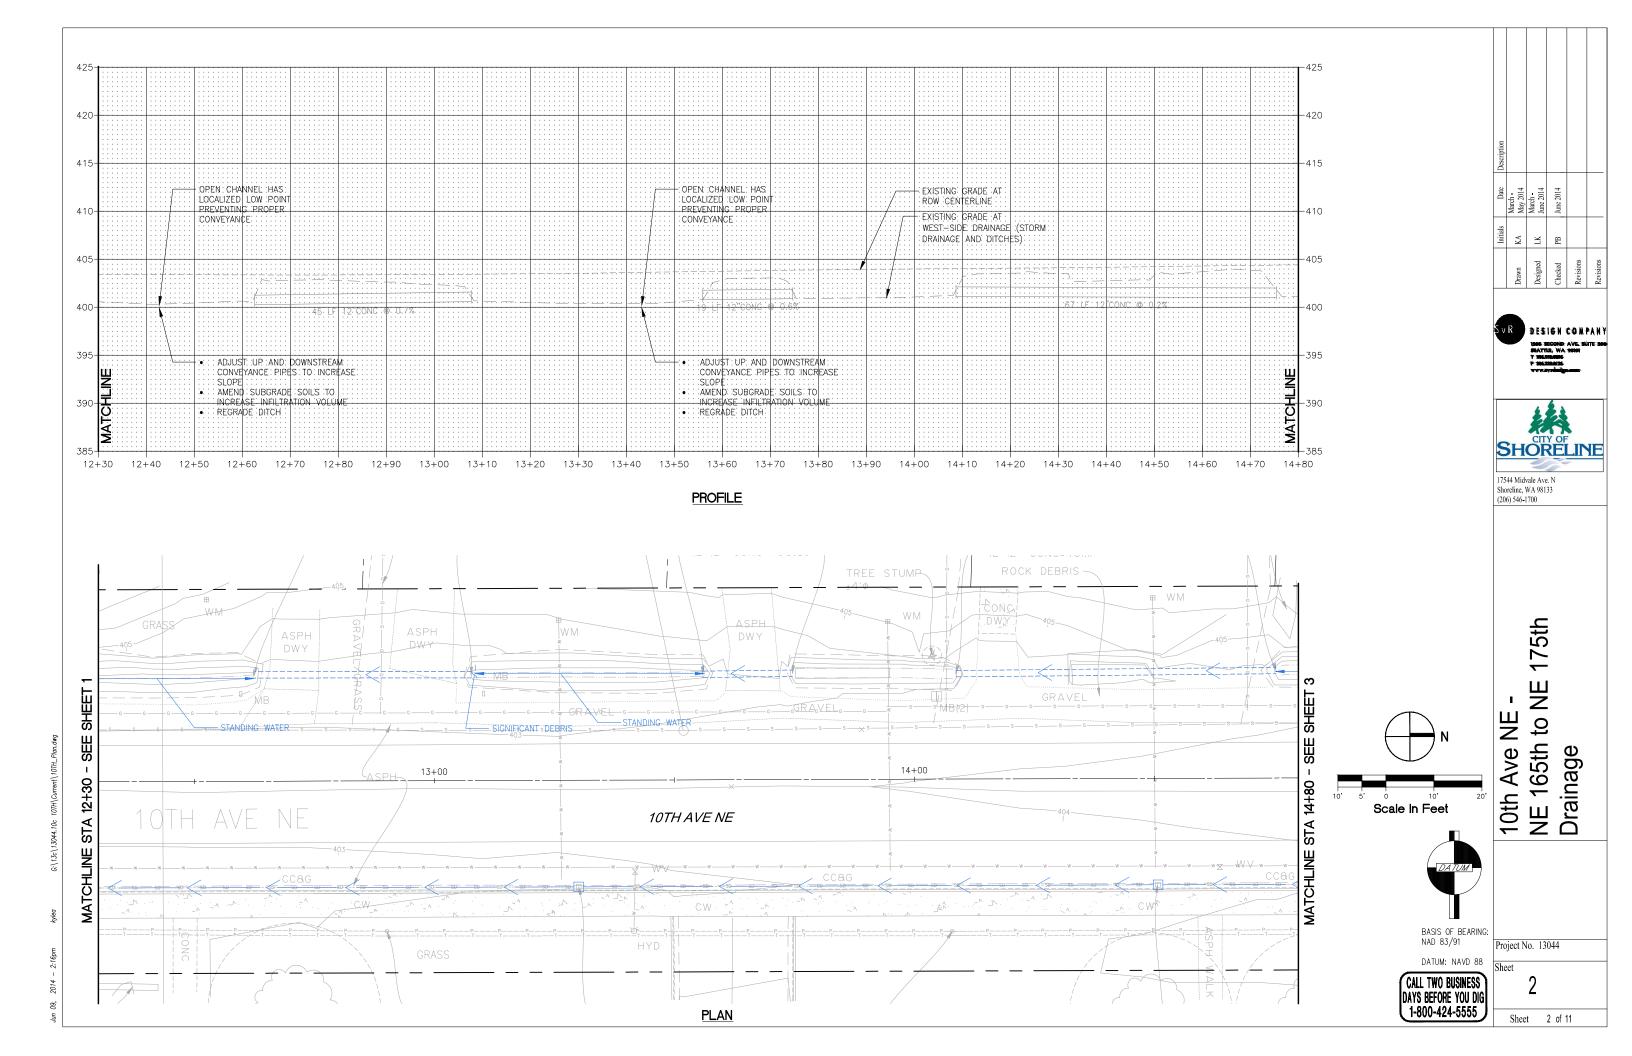
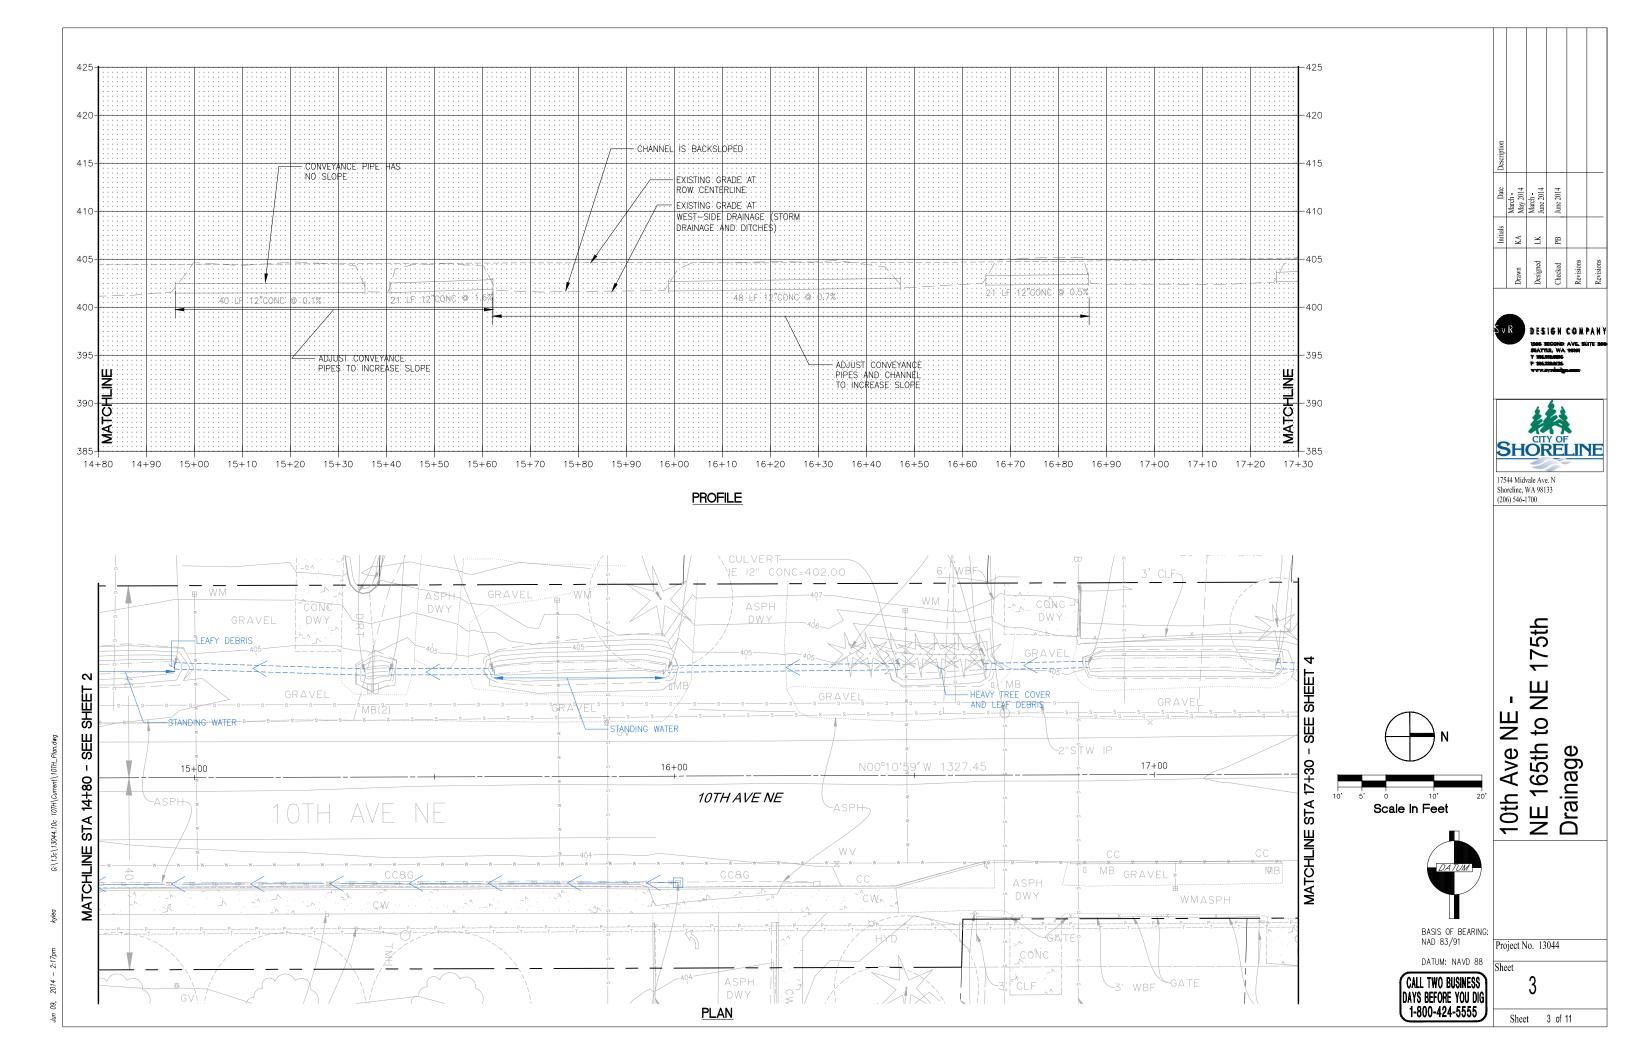
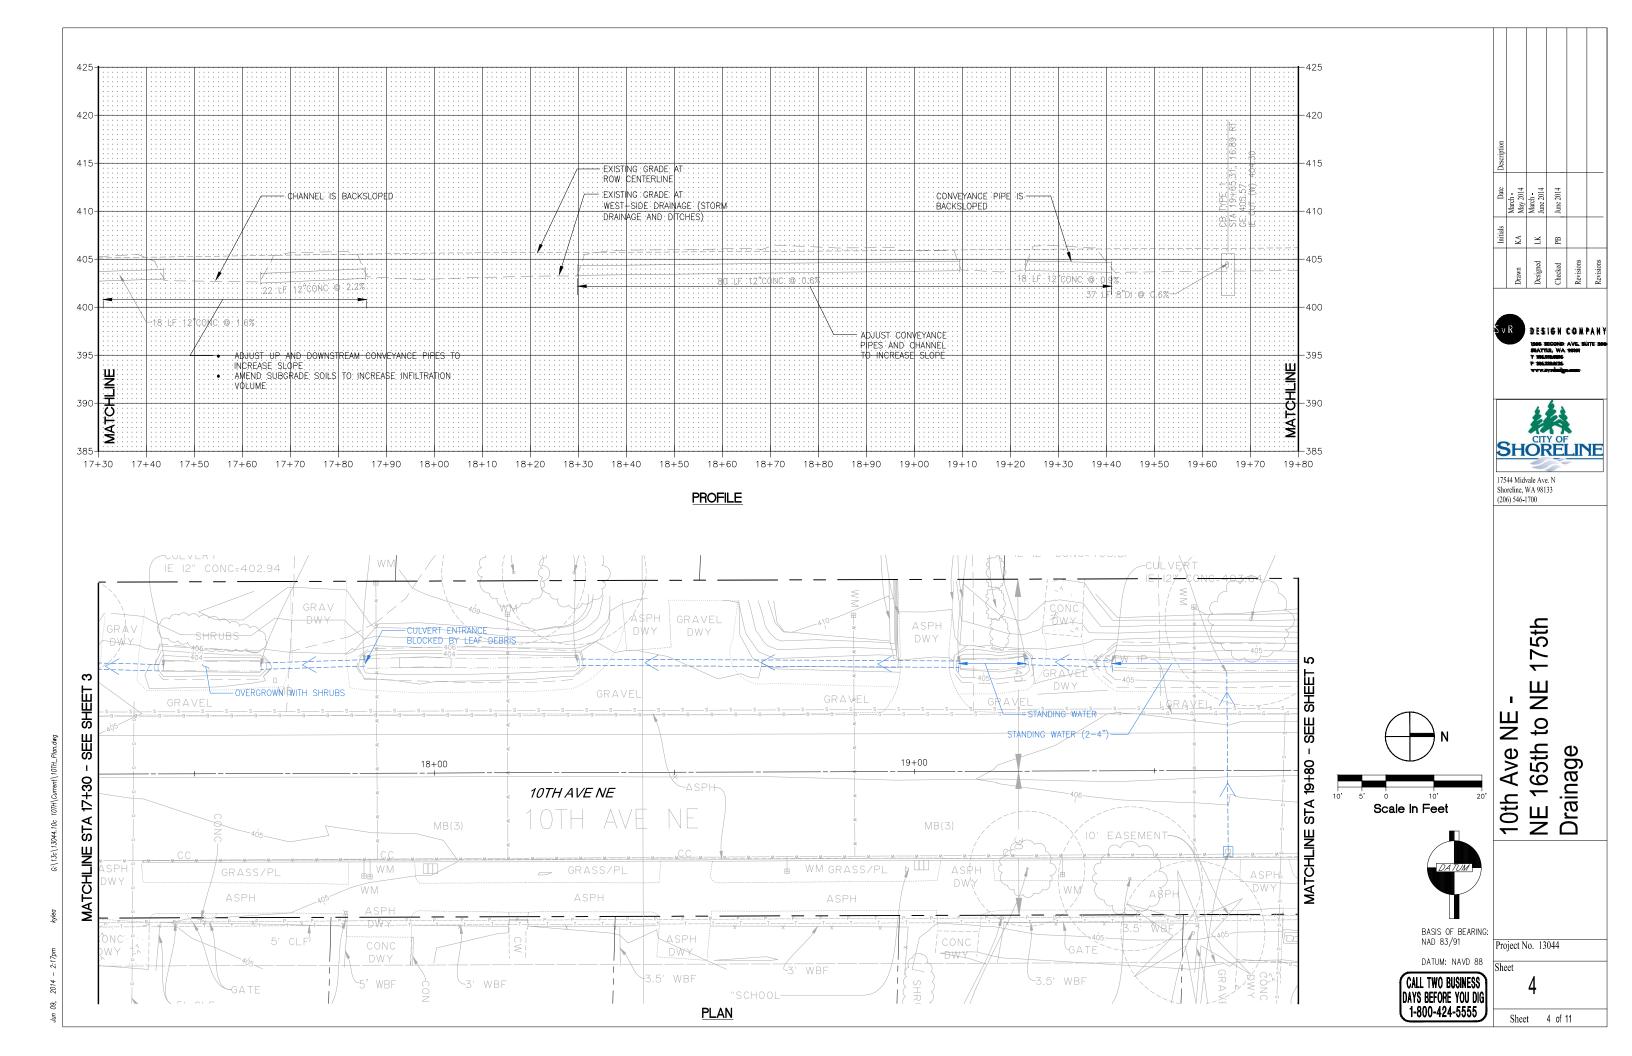
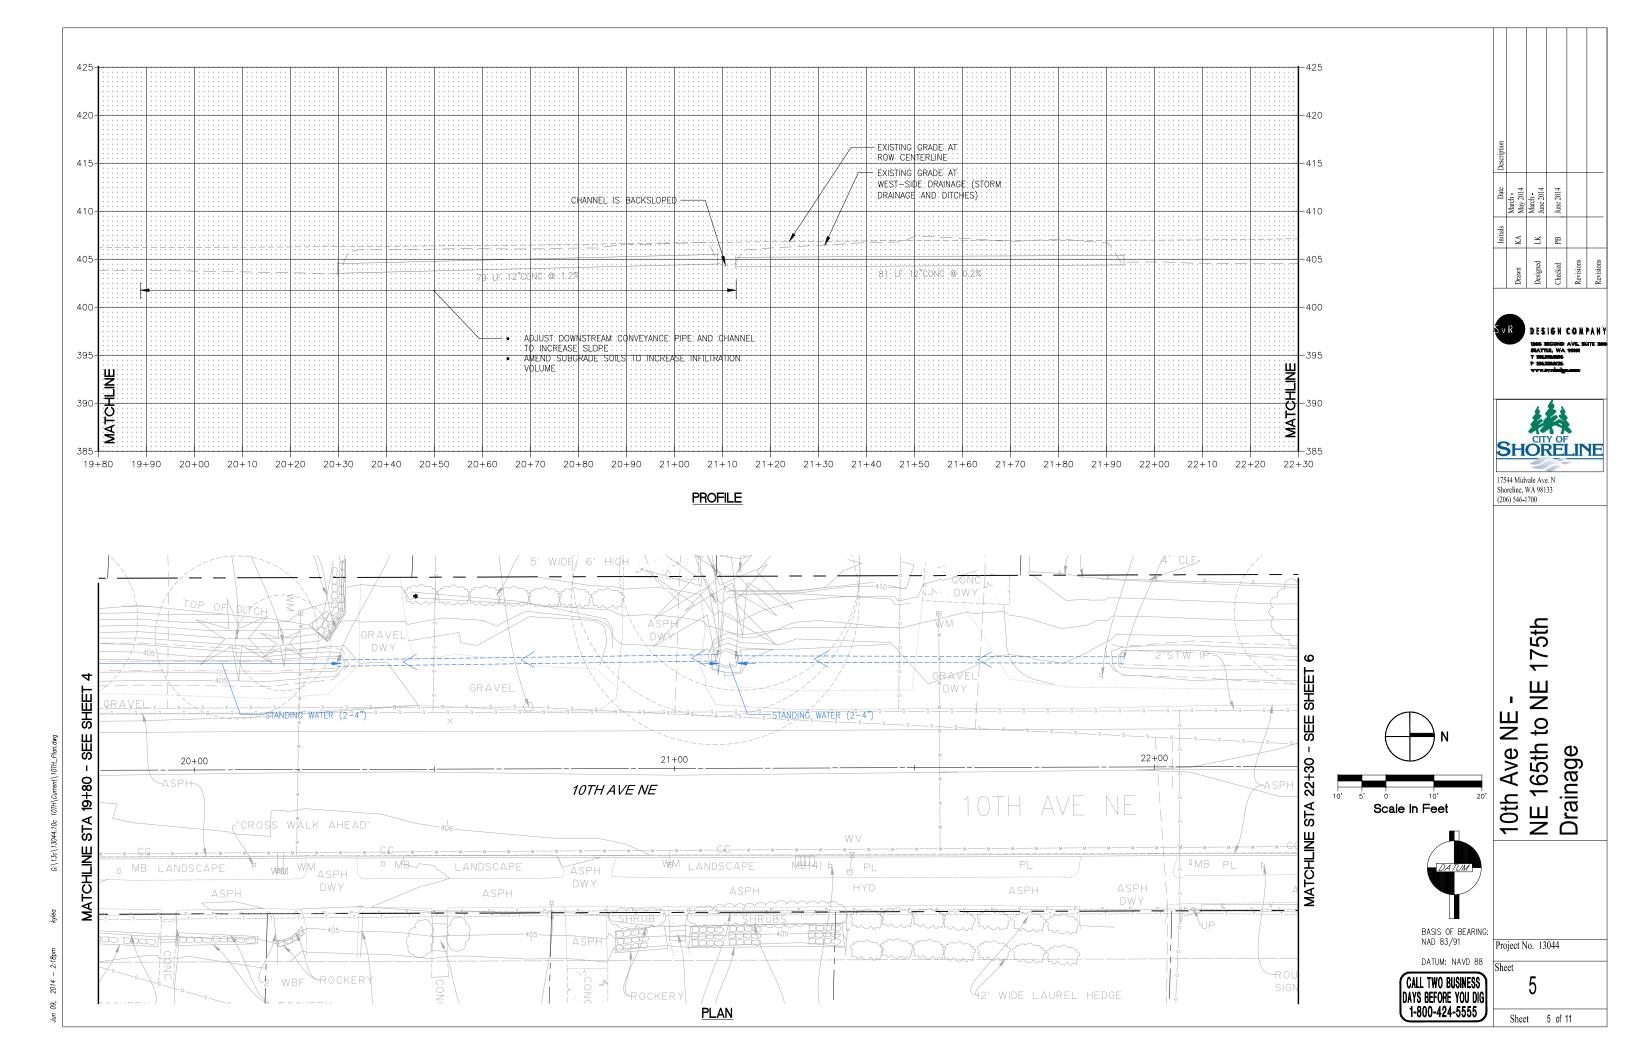
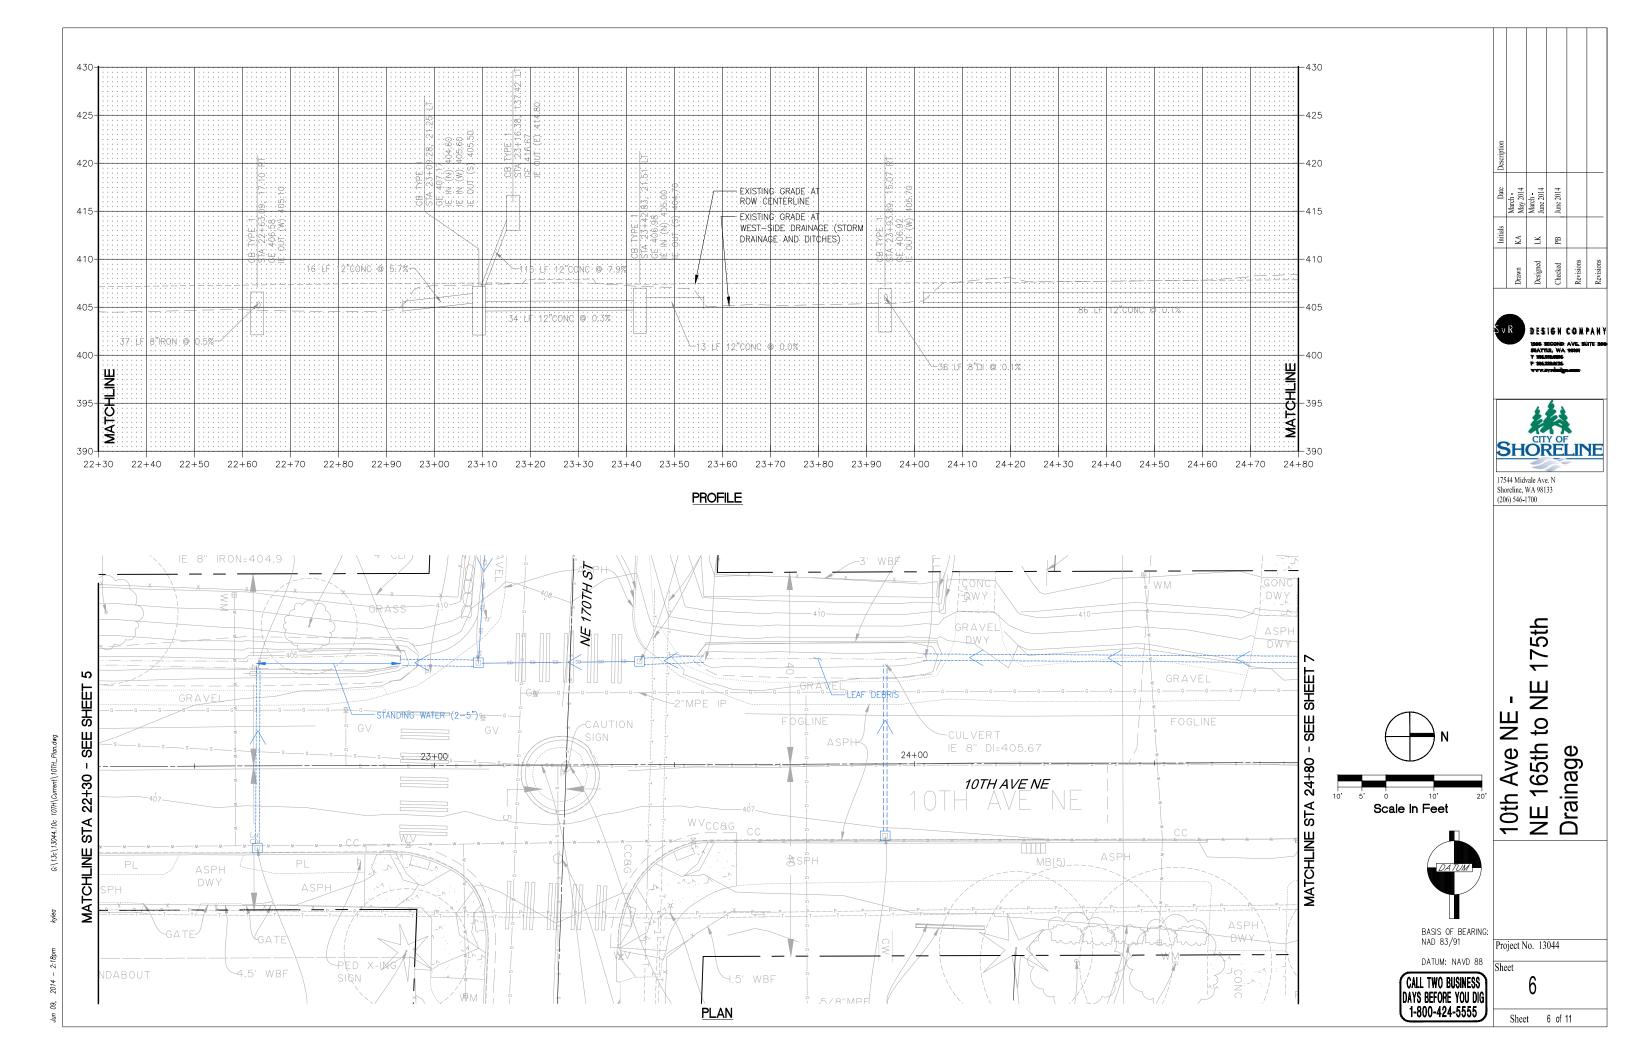
10TH AVENUE NE DRAINAGE PROFILE

As noted above Attachment A "10th Avenue NE Drainage Profile" summarizes the findings of this memorandum including the profile of the existing drainage system, identifies existing or potential drainage concerns, and includes field observations taken during a February 13th site visit. Table1 summarizes the drainage concerns identified in Attachment A.

W/ IDENTIFIED PROBLEMS AND POTENTIAL SOLUTIONS
