ARBORIST MEMORANDUM

To: City of Shoreline
 CC: Elizabeth Gibson, Project Landscape Architect, KPG
 From: Tristan Fields, ISA Arborist #PN-8826A & Tree Risk Assessment Qualified, KPG
 Date: October 21, 2021
 Re: N 148th Non-Motorized Bridge Project
 Project No: 19019

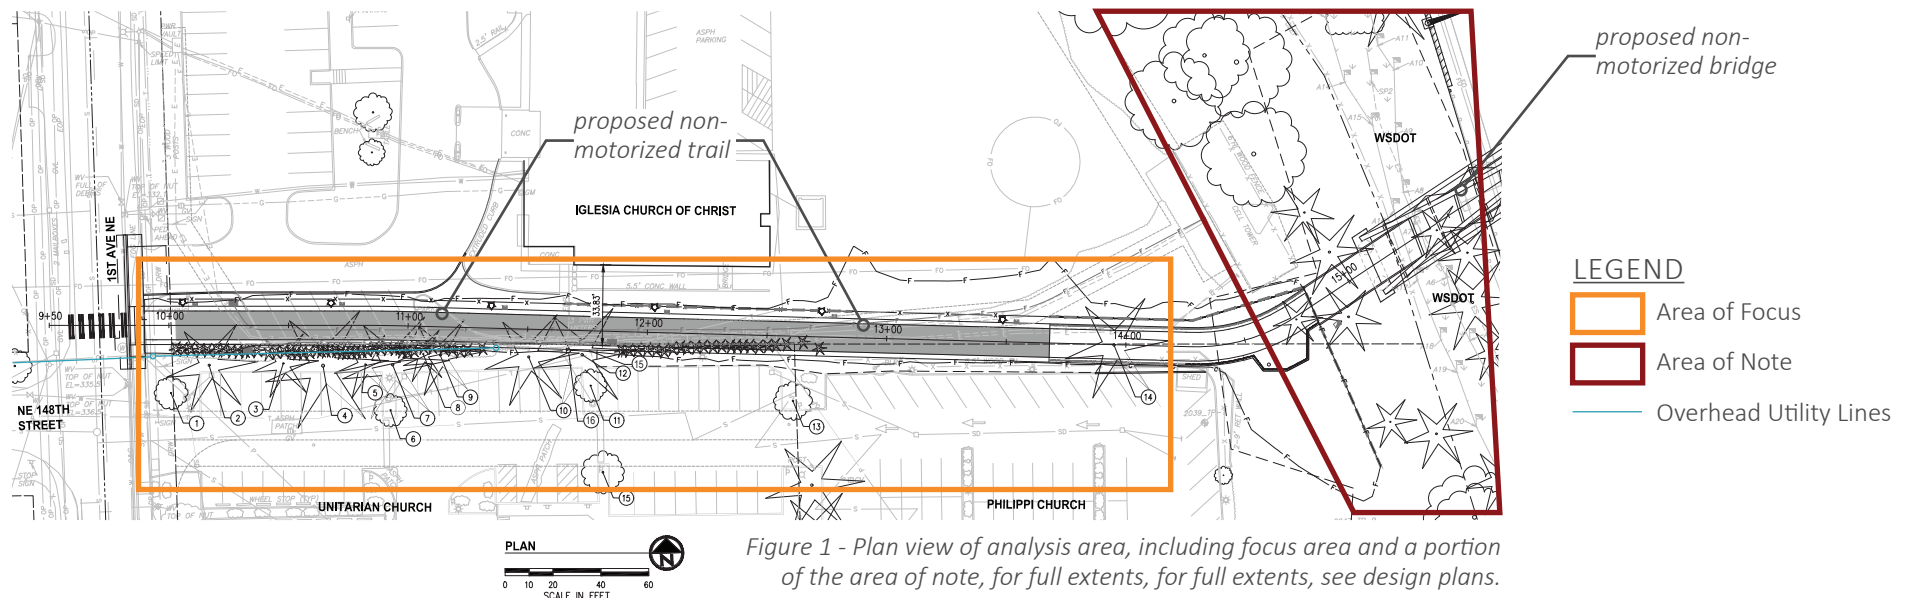
Figure 1 - Plan view of analysis area, including focus area and a portion of the area of note, for full extents, for full extents, see design plans.

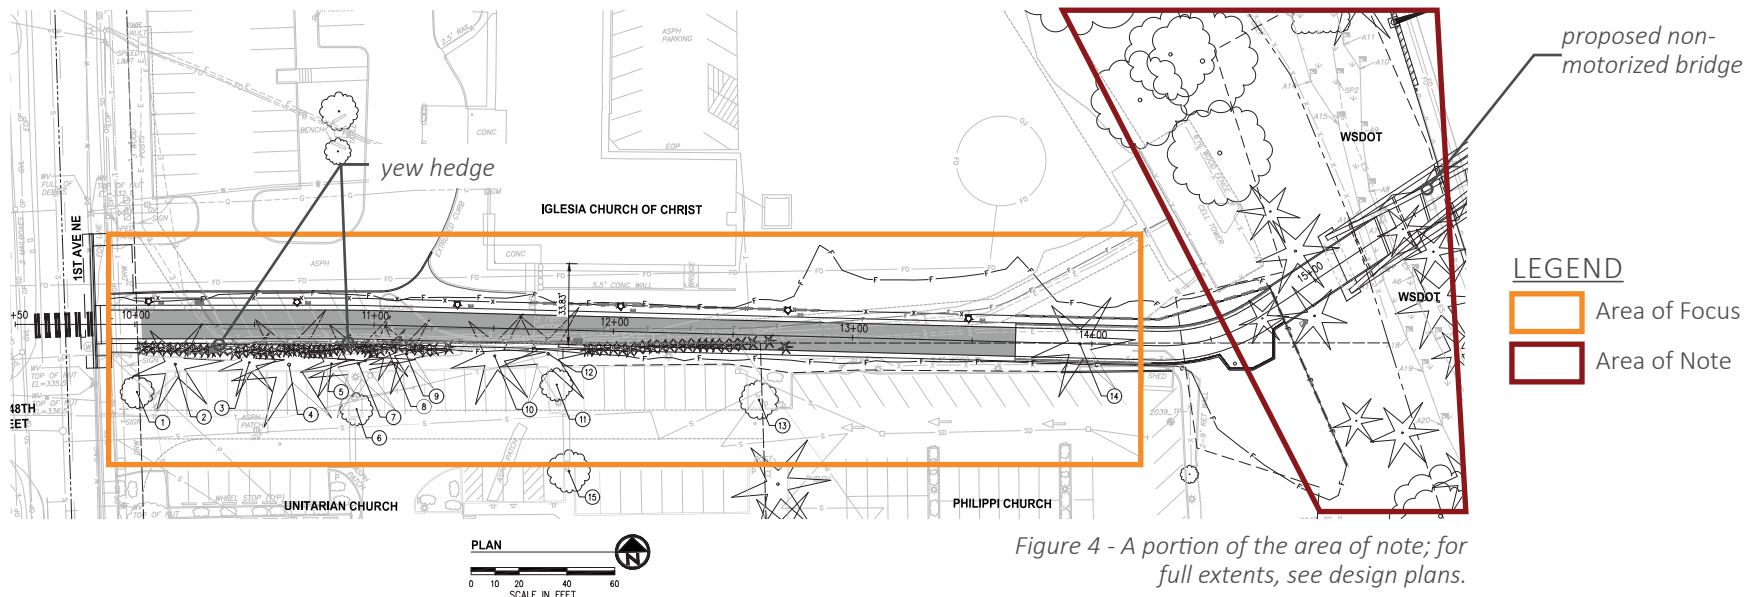
Figure 4 - A portion of the area of note; for full extents, see design plans.
