McAleer Creek Basin Plan

November 2015

OSBORN
CONSULTING
INCORPORATED

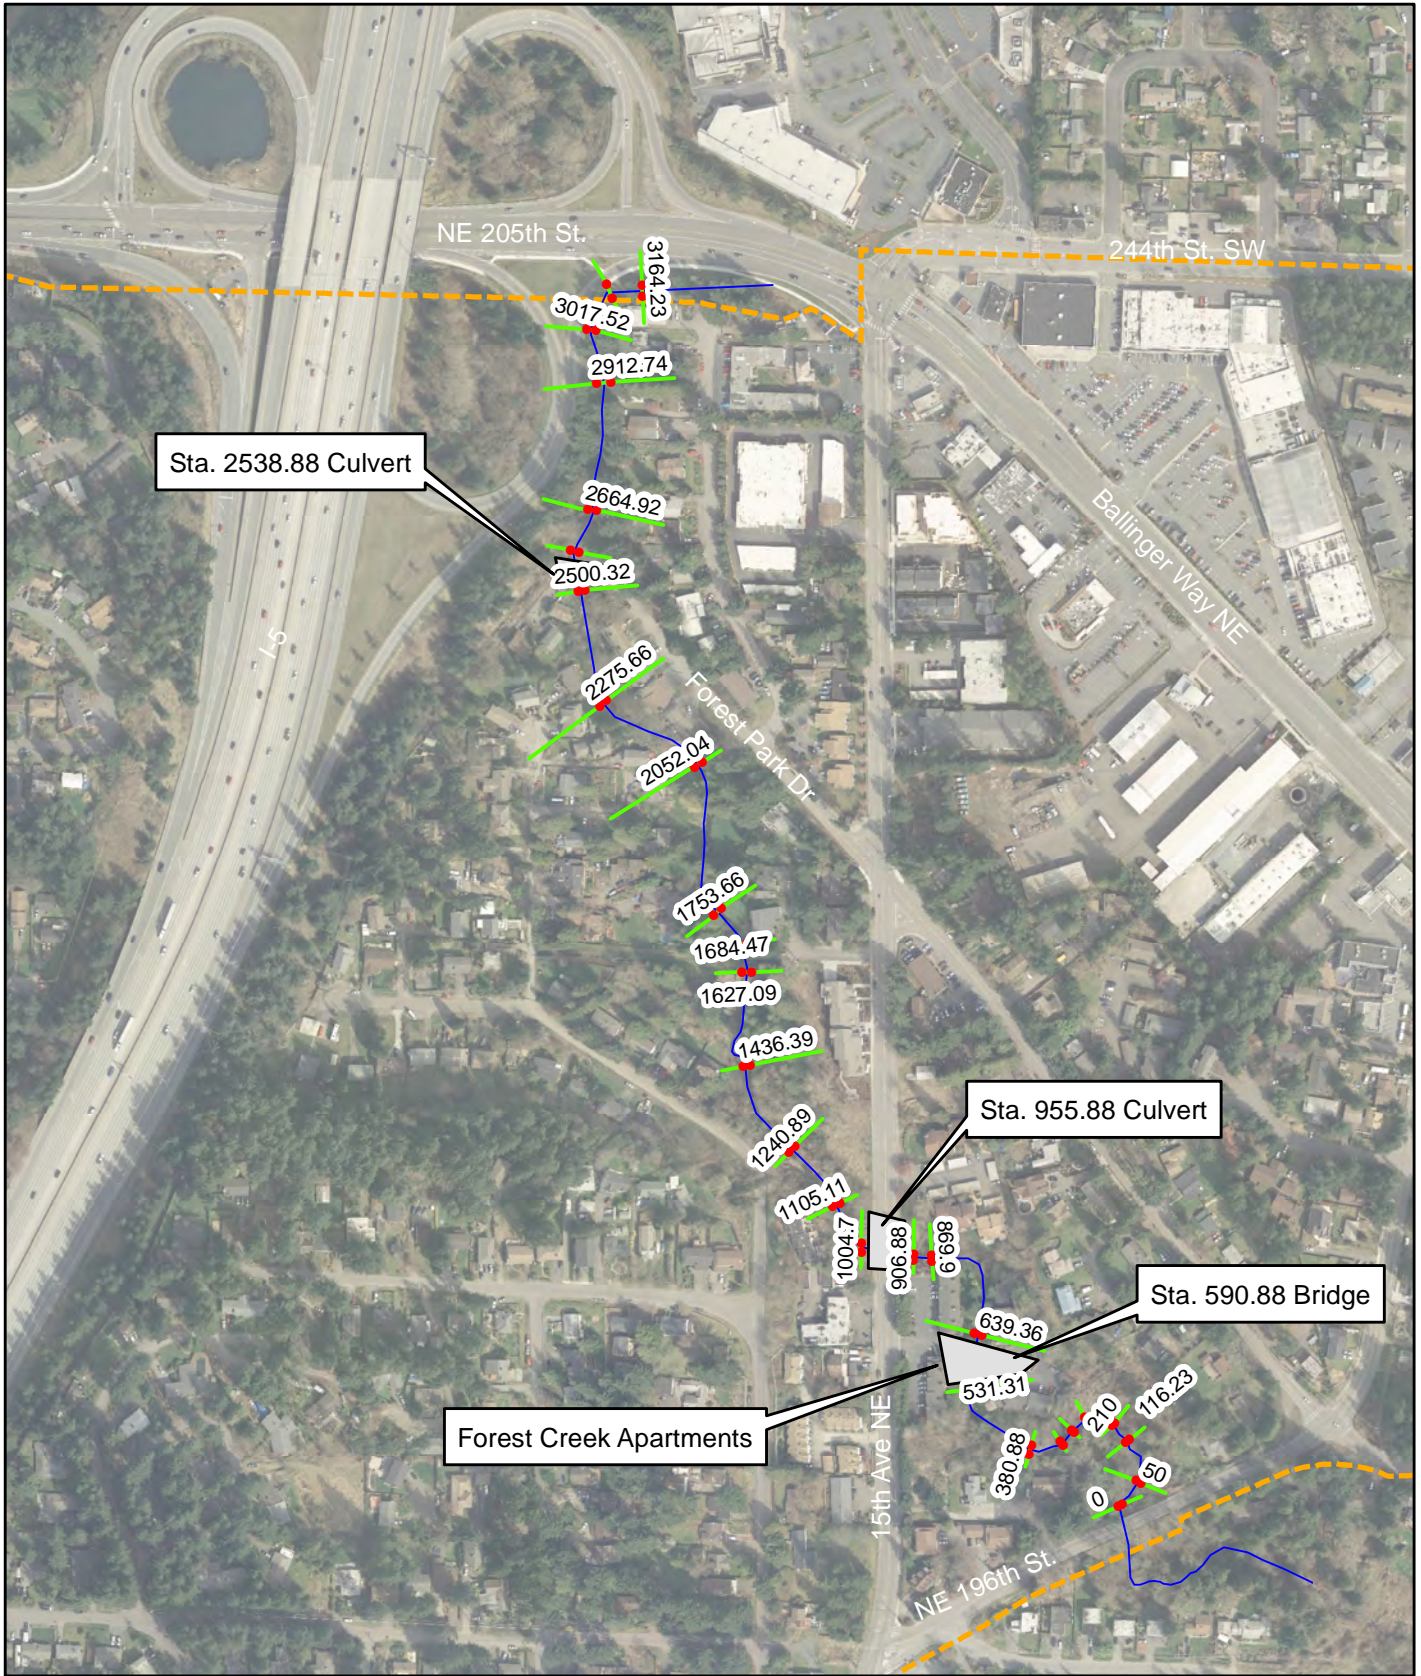
Figure 2: McAleer Creek Plan View

- Bank Station
- Cross Section
- McAleer Creek
- Culvert
- City Limit

The HEC-RAS River Station locations are shown on **Figure 2** located in Section III. Results of the HEC-RAS modeling are also presented in Section III.

The resulting model simulates 3,165 linear feet of McAleer Creek, including two culvert crossings and a bridge crossing, in the City of Shoreline. See **Figure 2** for the plan view showing river stations and culvert crossings. The HEC-RAS flow data is presented in **Table 2** located in the previous section. See **Appendix A-2** for field notes and site photos.

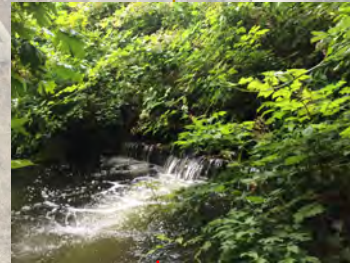
Box culvert under 15th
4'Wx4.5'H with
windwalls and apron
(photo on ds end)

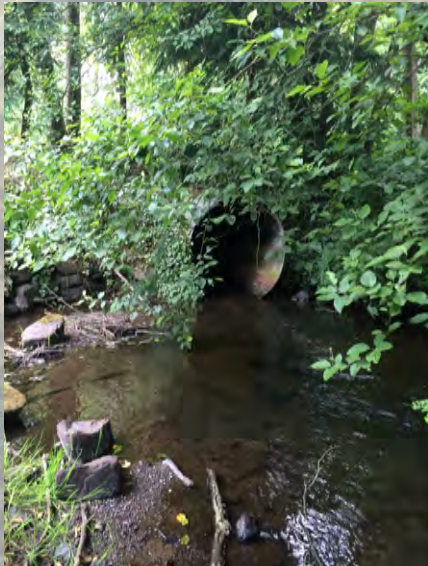
6' Diam CMP culvert under driveway

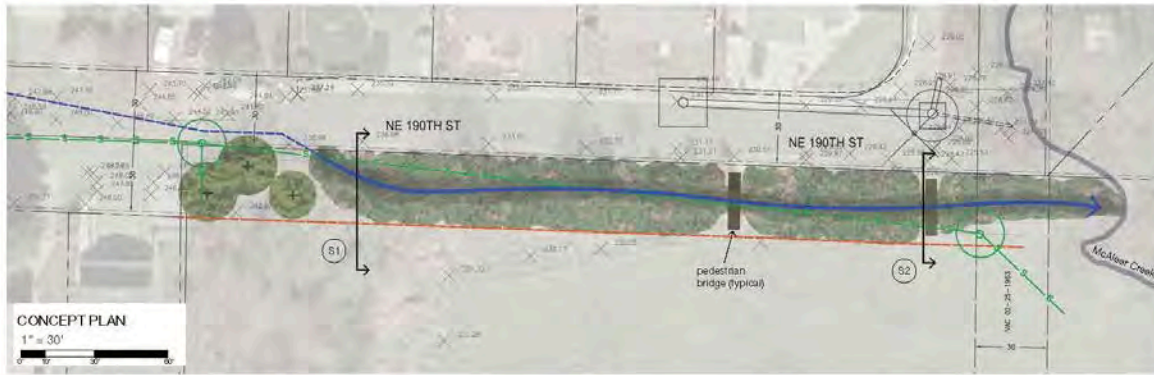
# Schematic:

This project was developed to alleviate flooding at three homes along NE 190<sup>th</sup> Street. A conceptual design was completed by SvR Consulting (schematic provided below) to re-route flow from a tributary of Whisper Creek to a stormwater management swale along NE 190<sup>th</sup> Street, taking flow out of the backyards of homes where the flooding occurs and moving it into City right-of-way and a newly constructed stream channel on Shoreline school district property that re-connects with Whisper Creek. Assumptions and considerations shown below are based on the schematic provided by the City and SvR, and the cost estimate and design considerations should be considered preliminary. Hydrologic analysis, consultation with natural resource agencies and negotiations with property owners and the school district for necessary easements will be required to develop a more complete project and accurate cost estimate.

- Design considerations include the following:
1. Environmental permitting, including Corps Permit, WDFW HPA, and SEPA, will be required because flow from an existing stream channel will be re-routed and a new stream channel will be re-constructed.
  2. An existing sewer line is 7 feet below existing grade. Potholing may be required to confirm the location and depth of the sewer line.

## CONCEPT SECTIONS

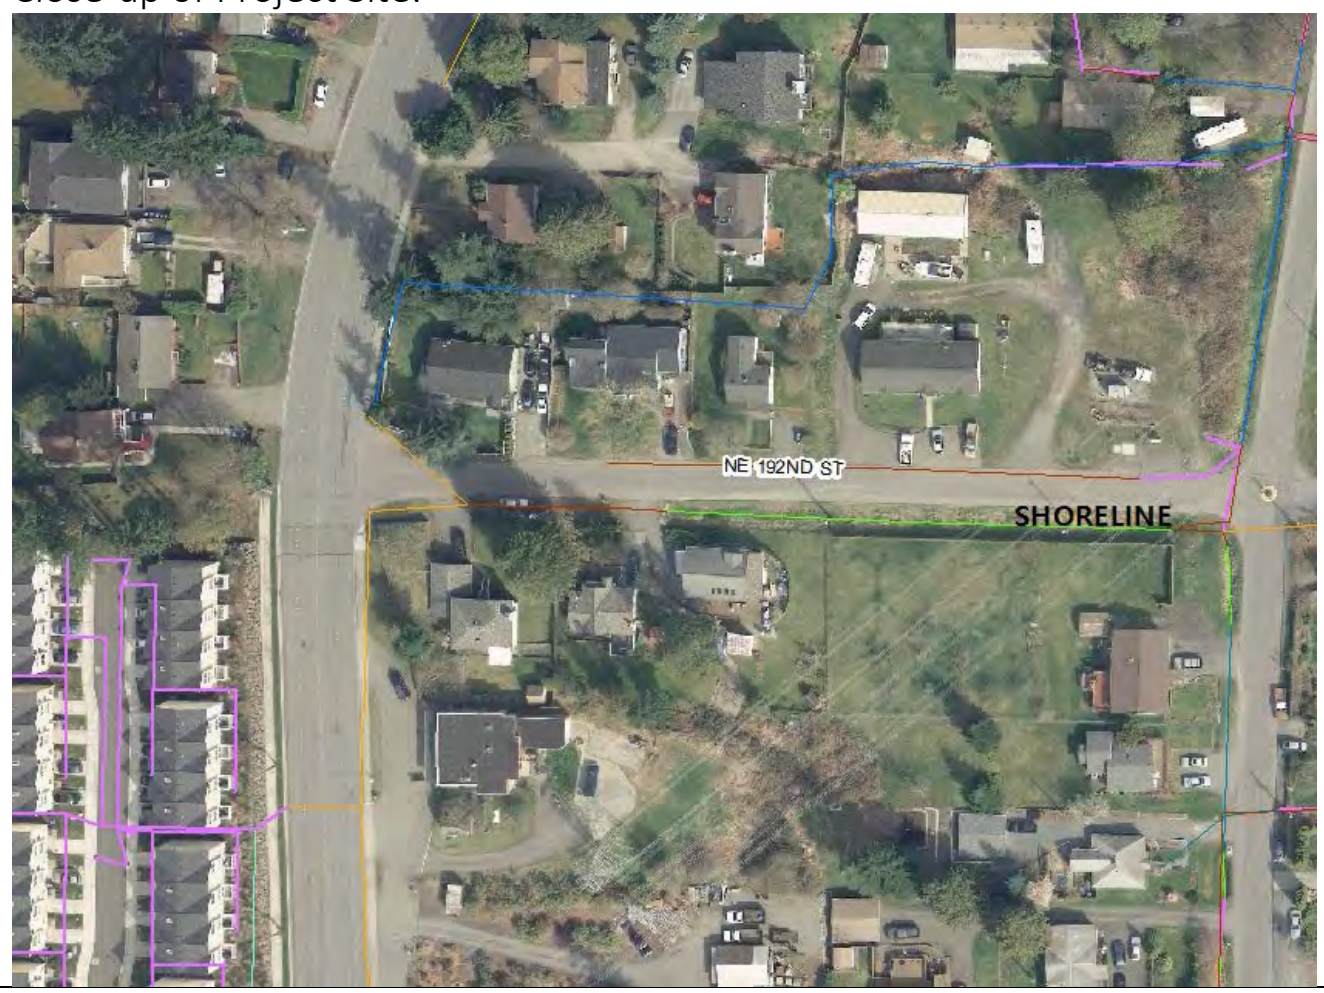
Close-up of Project Site:

This project addresses a ditch with on-going erosion problems on the south side of NE 192<sup>nd</sup> Street. The ditch has a large contributing drainage area, is very steep, and has a history of erosion and sedimentation issues associated with high energy open conveyance systems such as this one. Previously installed energy dissipation filled in with sediment. The City recently excavated the ditch to restore the previous configuration; however, a long-term solution is needed to prevent future erosion in the ditch.
