# TECHNICAL MEMORANDUM

**Date:** July 18, 2017  
**To:** John Featherstone, City of Shoreline  
**From:** Ian Mostrenko and Mark Ewbank  
**Subject:** Concept Design Evaluation of Fish Passage Improvements in Lower Boeing Creek

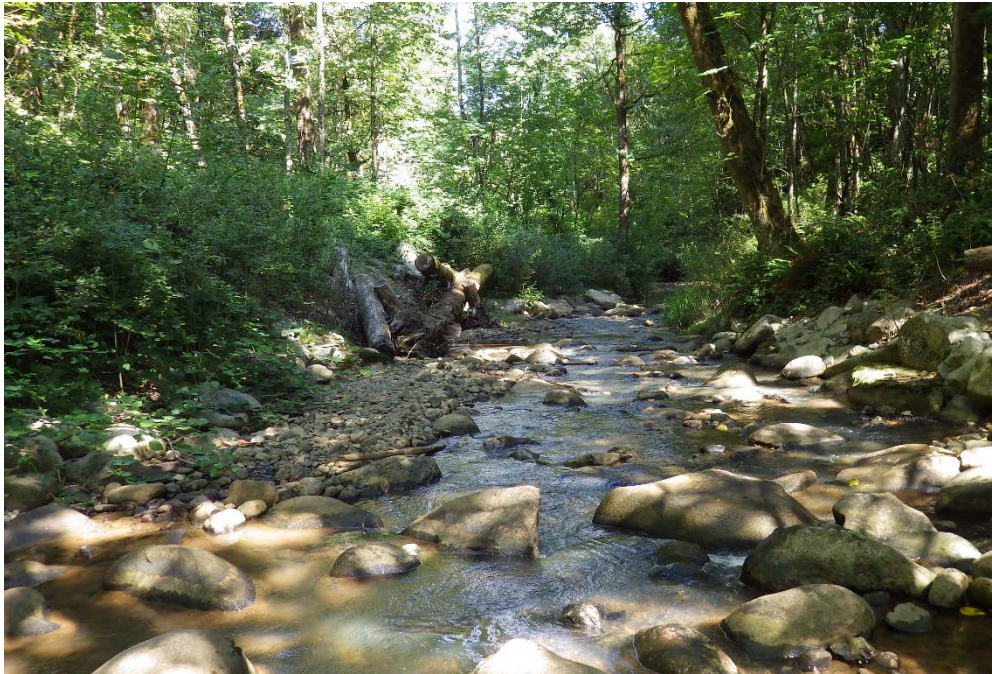
**Figure 4. Roughened Channel Section in Coal Creek, Bellevue, Washington.**

Roughened channels use large rock (e.g., boulders or riprap) mixed with smaller cobbles, gravel, and sediment to create hardened substrate that resists deformation under high-flow conditions while creating numerous micro-scale pathways for flow conveyance and fish passage under low-flow conditions and also providing substrate suitable for spawning in many locations. Figure 4 shows an example of a recently constructed roughened channel in Coal Creek in the city of Bellevue, Washington. That project created over 400 feet length of roughened channel extending from a new roadway culvert through a section of channel where there were previously a series of weirs that impeded upstream fish passage. The average slope of the roughened channel segments in Coal Creek is 5 percent, and those are interspersed with 1.4 percent slope

segments. The 1.4 percent riffle segments emulate the natural channel gradient in Coal Creek to support formation of pools and riffles that are vital for fish resting. The average gradient in the entire restored Coal Creek reach is approximately 3.8 percent, which is flatter than the reach of Boeing Creek described herein.
