## Memorandum - Final

To: Neil Jensen – City of Shoreline c/o Darren Murata - DOWL  
Site: 20<sup>th</sup> Ave NW Sidewalk Project  
Re: August 2, 2023 Site Meeting  
Date: August 11, 2023  
Project Arborist: Tyler Bunton  
ISA Certified Arborist PN-8715A  
ISA Qualified Tree Risk Assessor  
Attached: Table of Trees  
Tree Site Map

**CITY OF SHORELINE**  
20TH AVENUE NW  
(NW 190TH ST-NW 195TH ST)  
NEW SIDEWALK PROJECT  
ALTERNATIVE 1B

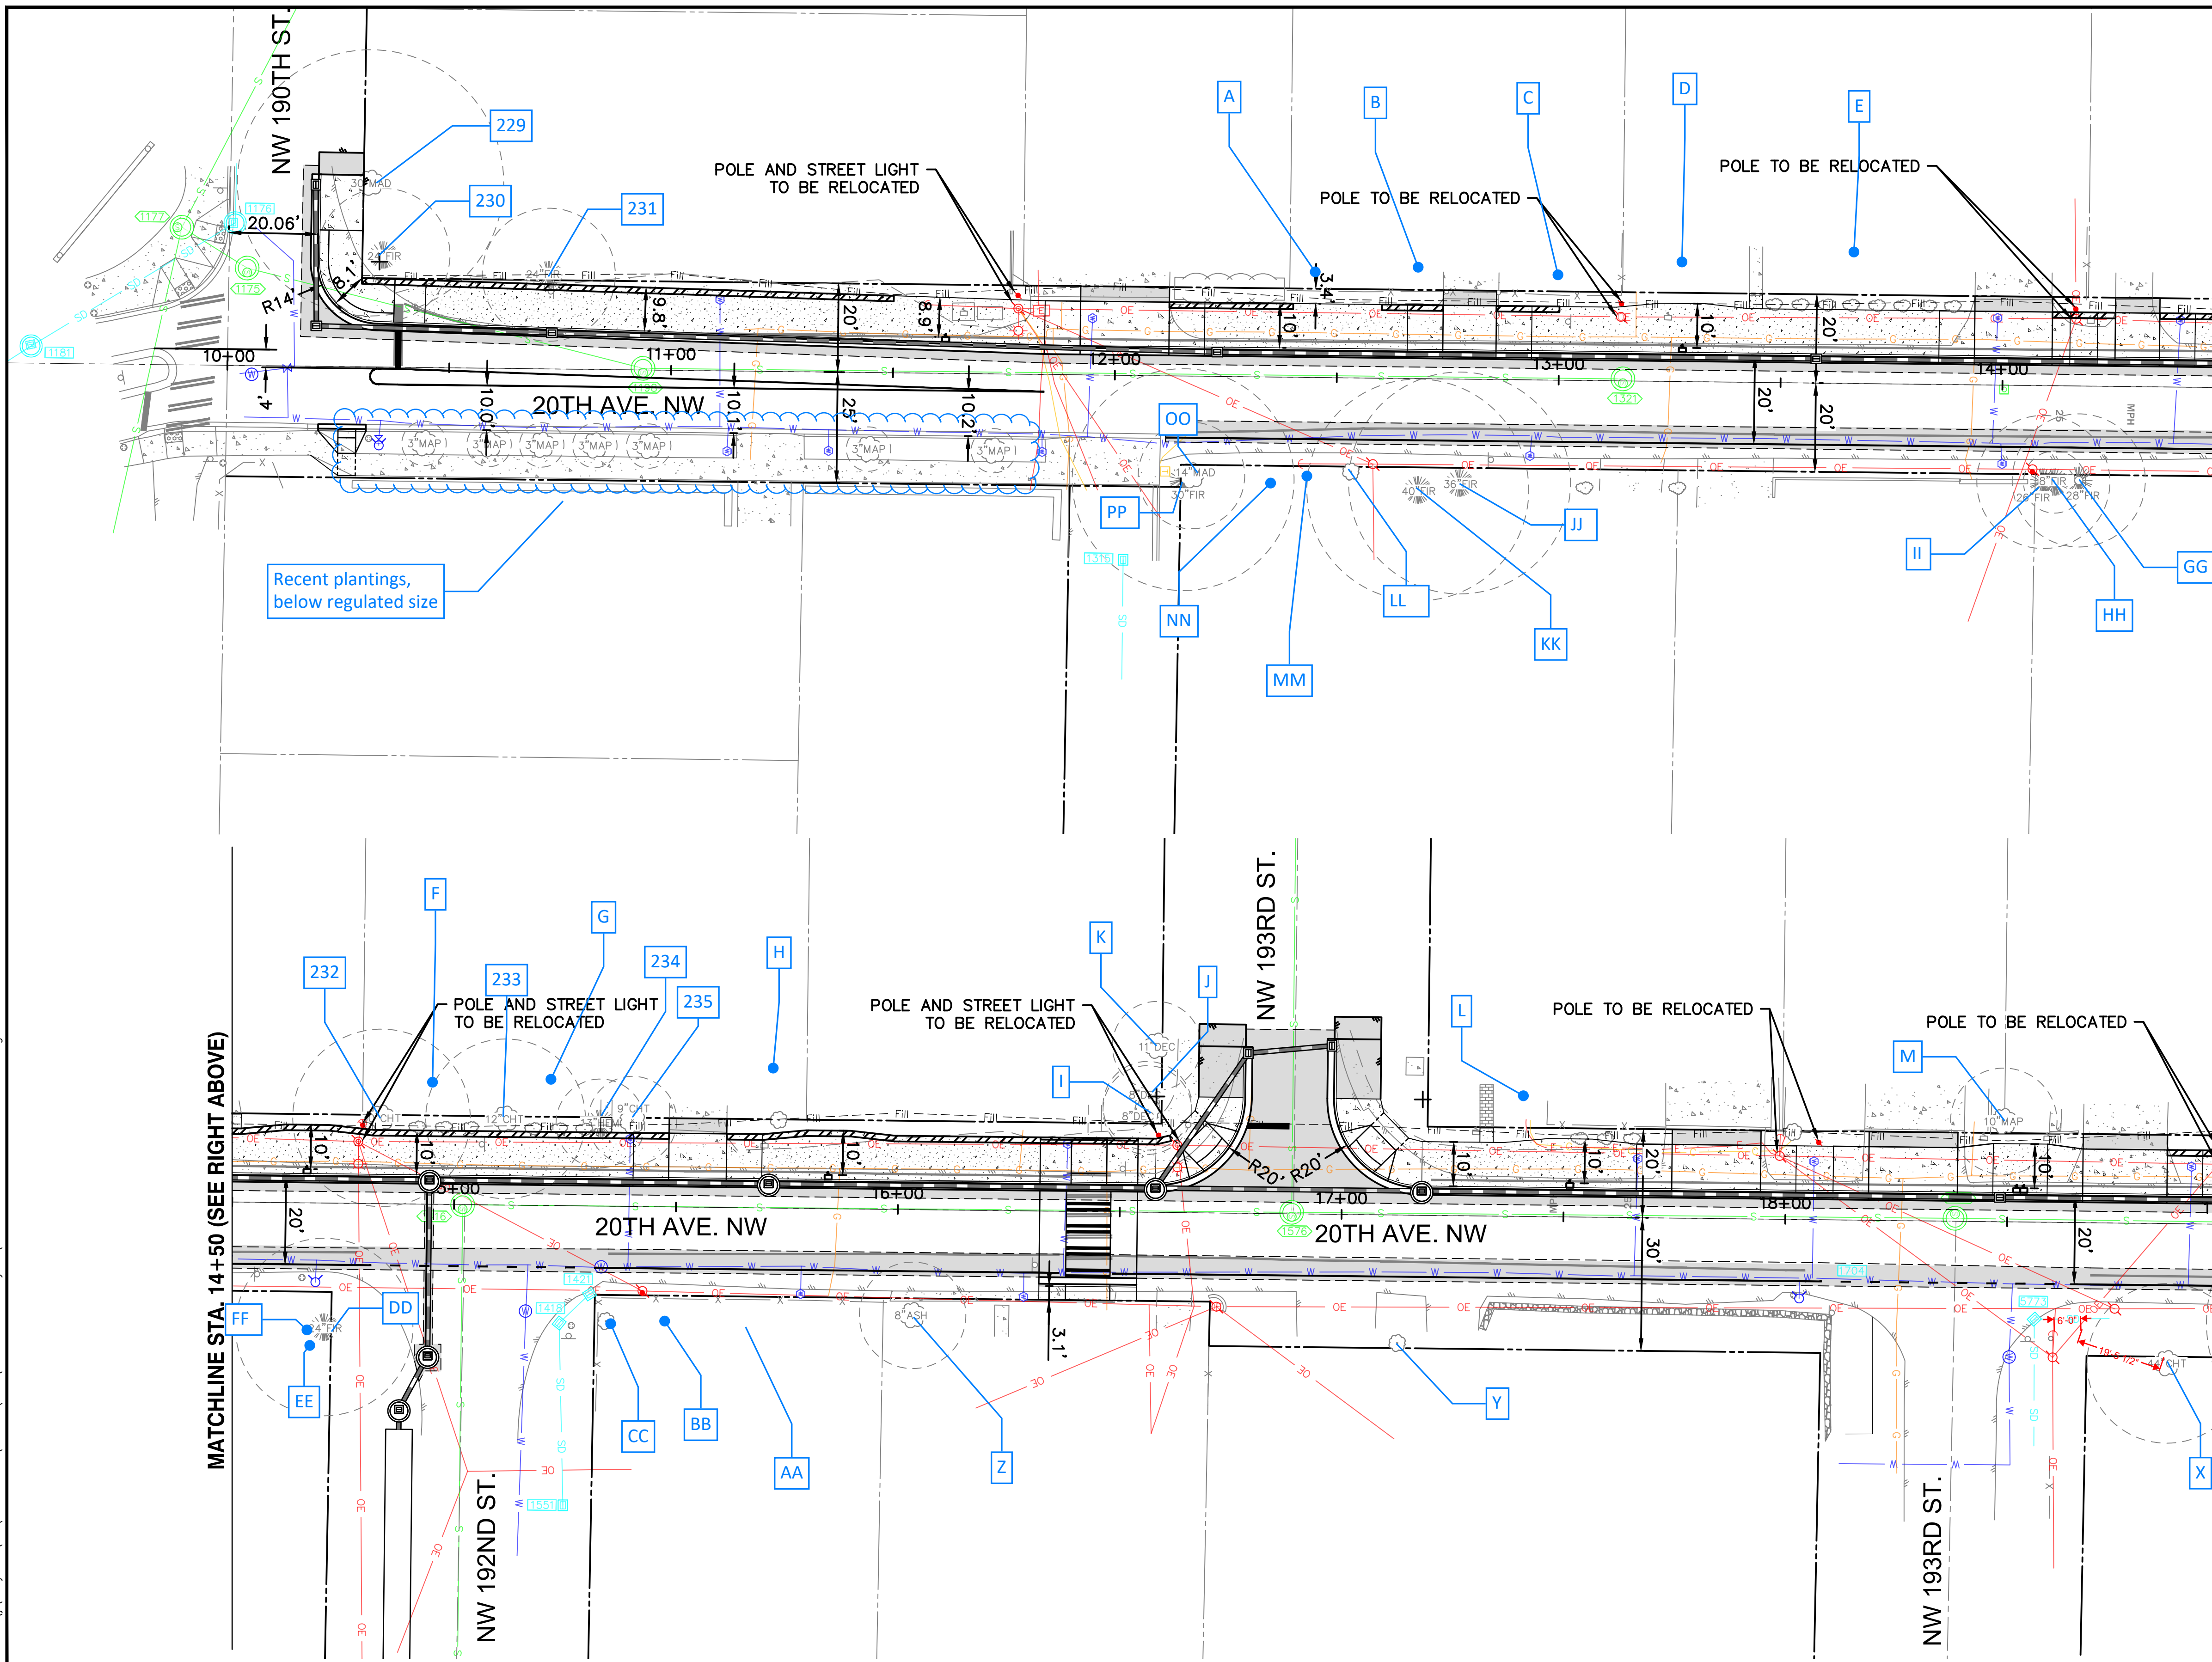
DRAWING NO. \_\_\_\_\_  
PROJECT NO. 9967  
FED AID NO. \_\_\_\_\_  
DATE: 2/4/2022  
SHEET NO. 1 OF 22

Regulated trees on the site are identified with a number. This number corresponds with the metal tree tag unless otherwise noted.

Inventory also includes all regulated off-site trees that had overhanging canopies or that were likely to be impacted by site work. Off-site trees are identified by a letter unless otherwise noted.

*\*Tree locations added to the survey are approximate and should be confirmed and added to the survey.*

This memorandum documents my site meeting with Neil Jensen of the City of Shoreline and the property owners of 19308 20<sup>th</sup> Ave NW, Shoreline, WA on August 2, 2023. At this meeting we discussed the planned work within the right-of-way adjacent to their property on 20<sup>th</sup> Ave NW. I have attached the table of trees for this project and our most recently review annotated plans which show the locations of the trees for reference.

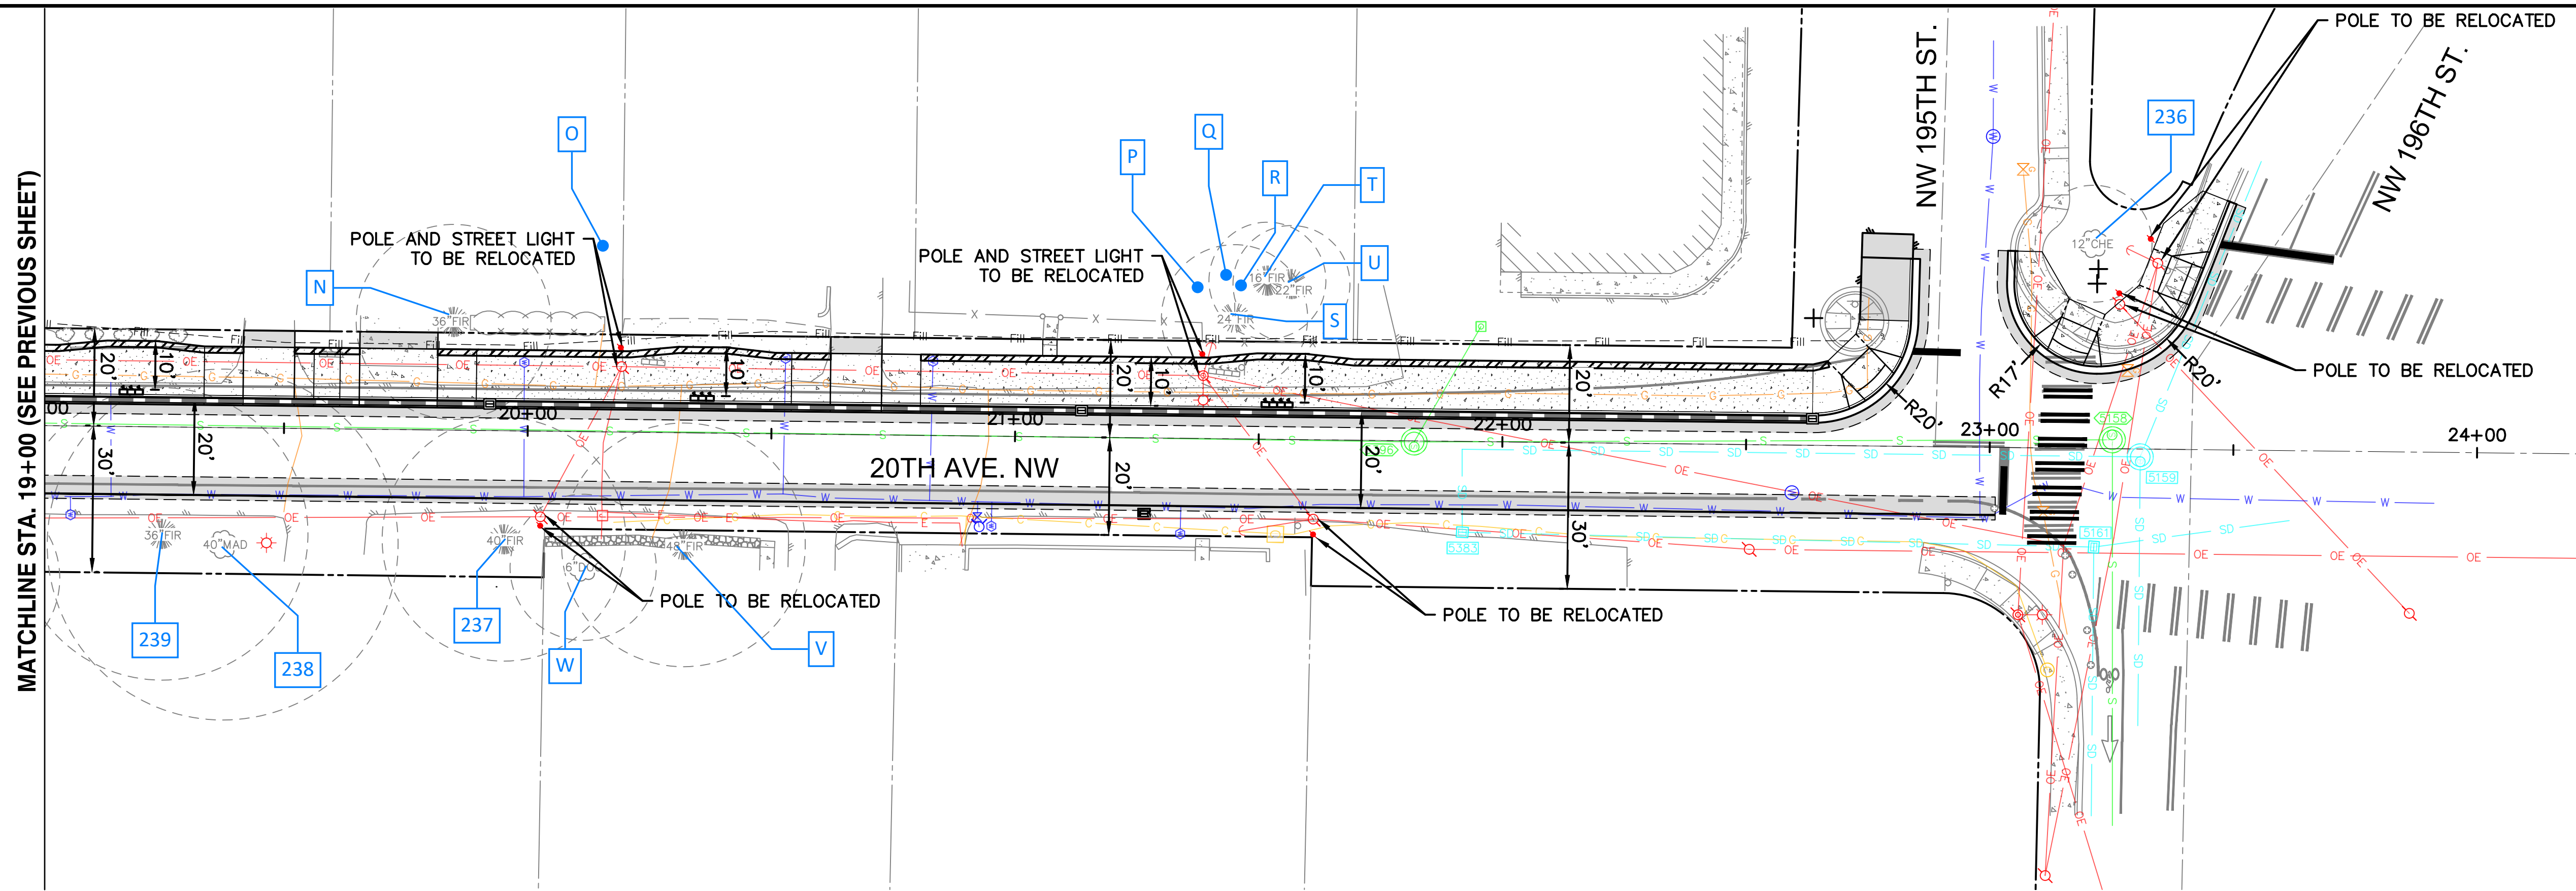
**CITY OF SHORELINE**  
 20TH AVENUE NW  
 (NW 190TH ST-NW 195TH ST)  
 NEW SIDEWALK PROJECT  
**ALTERNATIVE 1B**
